WILLEY HOUSE RESTORATION JOURNAL VOLUME 2 ■ ISSUE 1 ■ WINTER 2003 ■ ■ ■

THE STATE OF THE HOUSE WINTER 2003

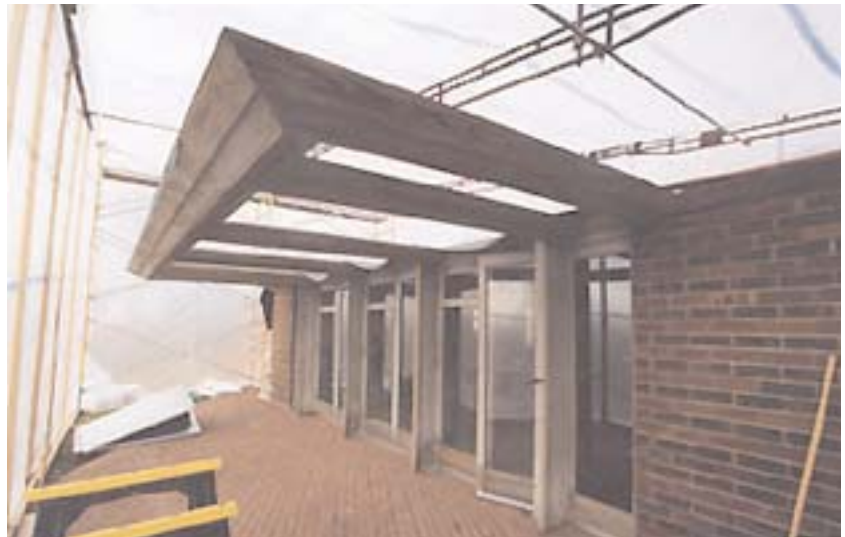
Inside the scaffold tent structure.

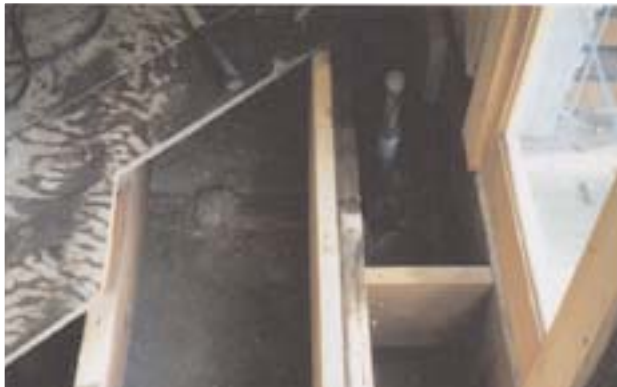
RIM AND FLOOR JOISTS

Rim and floor joists as well as cement foundations required extensive repairs due to water entering the house over existing thresholds. Three causes were determined and are being addressed; the height and pitch of the south terrace, a splash factor that allowed water to run down and under the French doors and the thresholds themselves which were not water tight. 📍

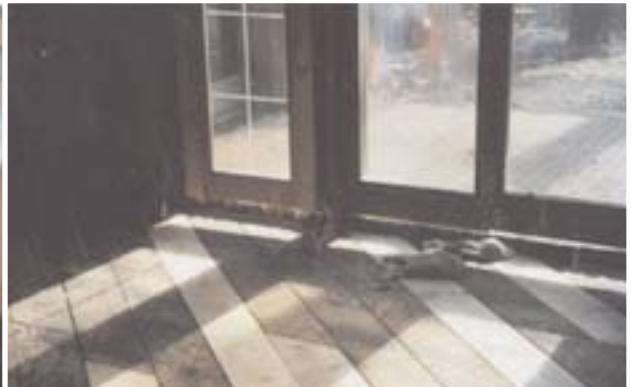
SUBFLOOR

Replaced subflooring where required. 📍

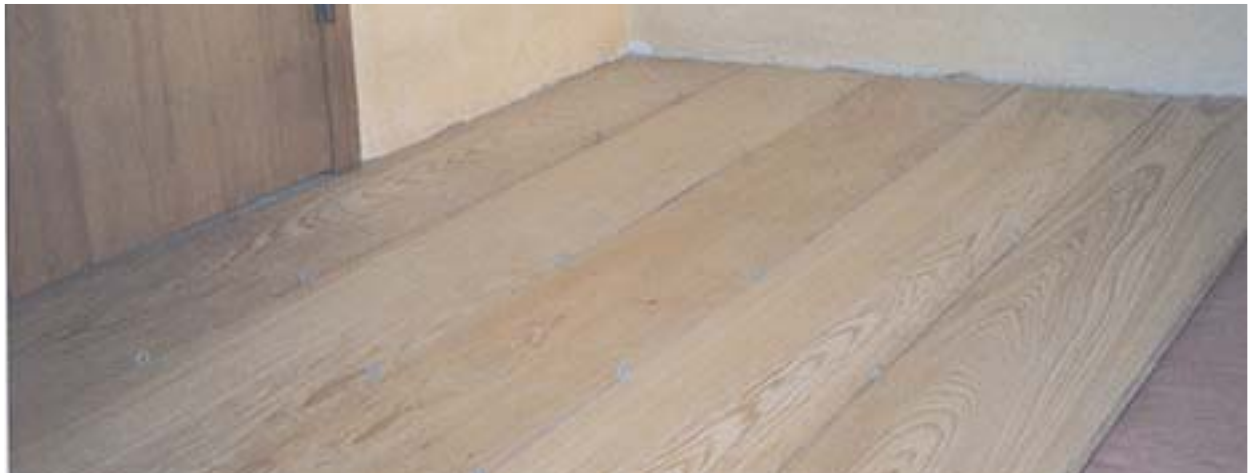
PLANK FLOORING

Several 9" cypress floor planks needed to be replaced. The entire floor was planed so new and old flooring matched. Cypress is dimensionally unstable, shrinking and expanding

greatly from season to season. When floors were laid spacers were utilized to increase the gaps between planks so floors did not buckle when humidity reached summer levels. 📍

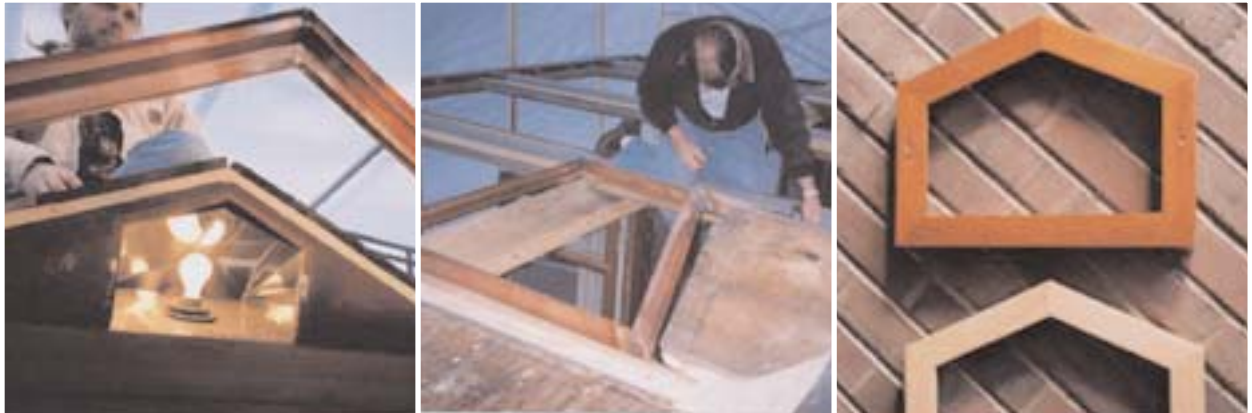
INSTALLING SKYLIGHTS

The photo on the left shows Stafford on the roof as new skylight is being fitted. The middle photo is Steve Johnson of the Rainville-Carlson company test fitting a skylight frame.

The last photo is of the Cypress frames for recessed skylight fixtures. One frame was missing and needed to be recreated to match originals. 📐

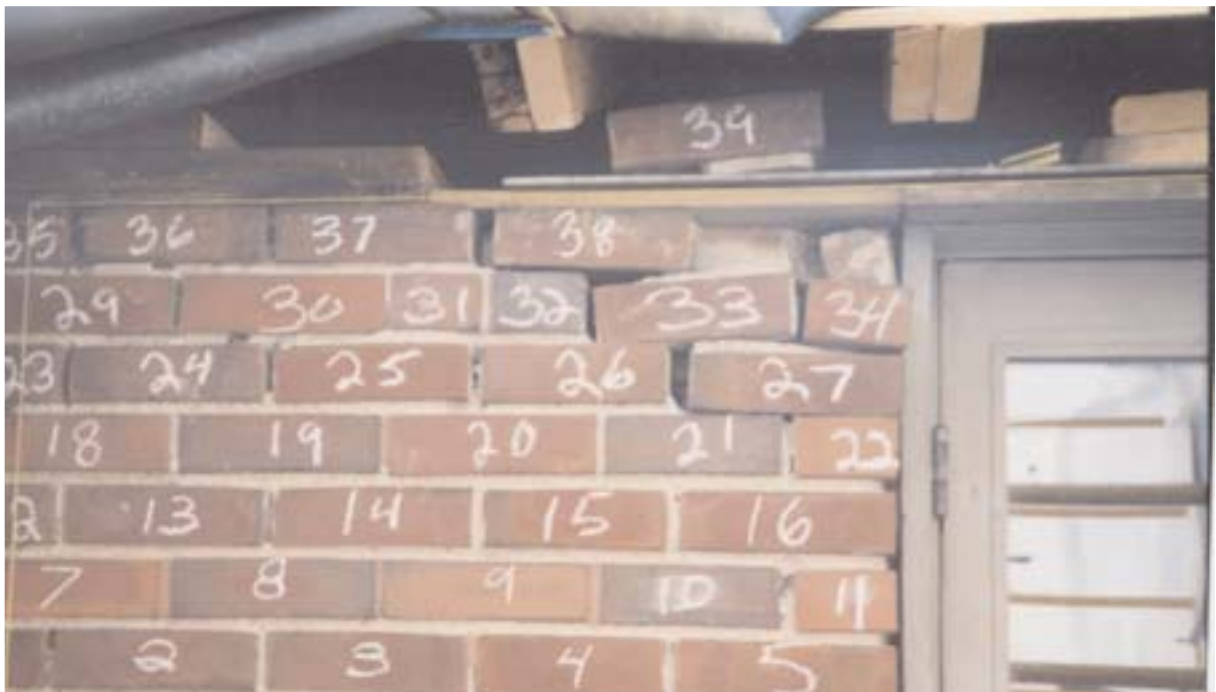
STEEL LINTEL

Often what seemed like small decisions lead to major discoveries and redirected priorities. A decision to introduce steel "L plates" above the sagging study and guest bedroom doorways turned up earlier roof repairs that needed to be properly re-addressed. It also demonstrated the fragile state of the brick mortar. Two masonry restoration companies had recommended a total grind back and re-tuck pointing. Which was a

low priority for us, until course after course of bricks proved to be loose in their failing mortar as the soffit was jacked up to insert the steel "Ls". A complete brick restoration was slated for spring. 📷

Steel "L" extending over guest bedroom door opening.

Bricks were carefully numbered to be reset in new mortar. 📐

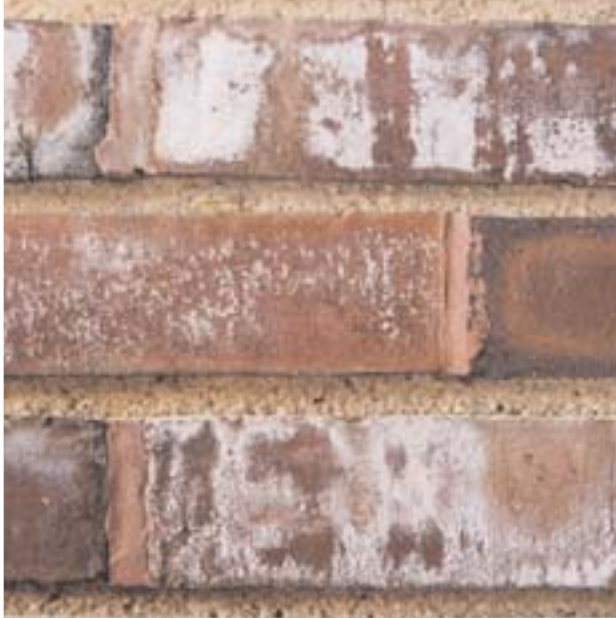
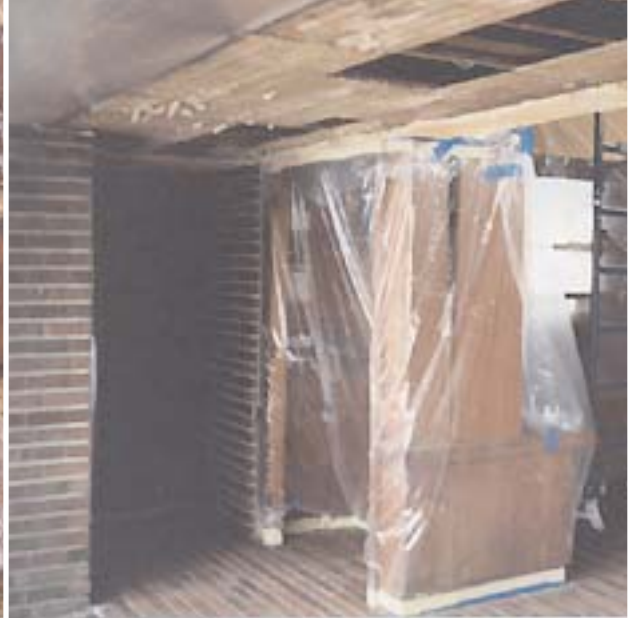
CLEANING INTERIOR BRICK

The interior brick badly needed cleaning. The chimney mass was blackened from decades of smokey fires and chalky with efflorescence from water seeping through the

brick from the leaky the inner cavities. All interior wood was carefully prepped prior to cleaning. 📷

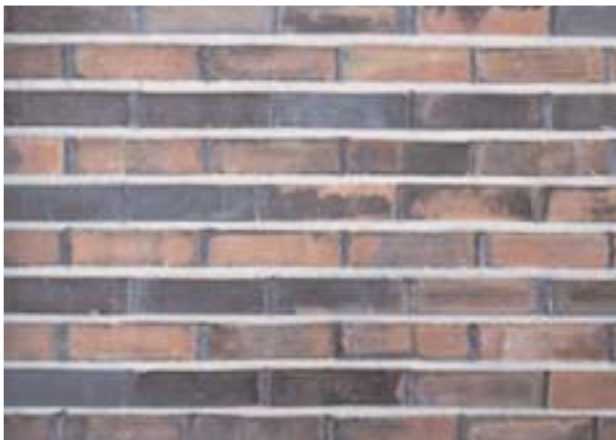
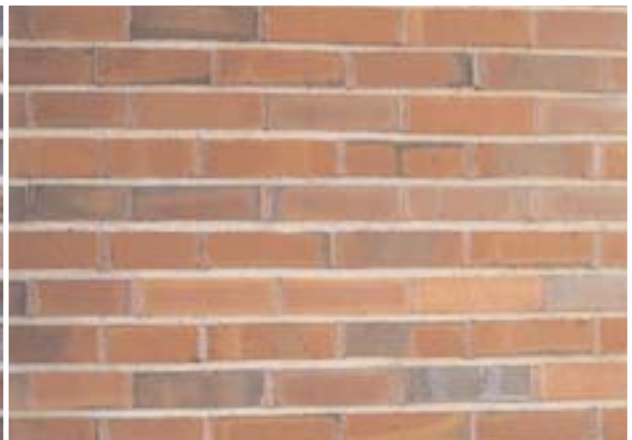
PIT WALL

Radiator pit wall before (left) and after (right) cleaning. 📷

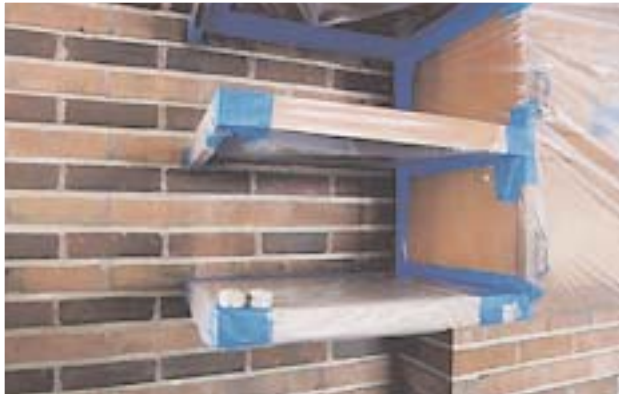
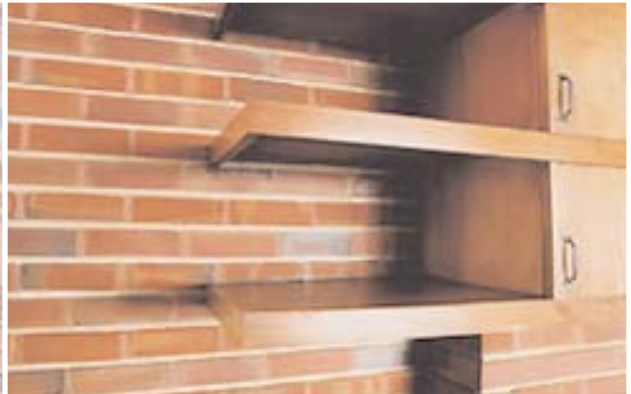
DINING ALCOVE

Dining alcove wall before (left) and after (right) cleaning.

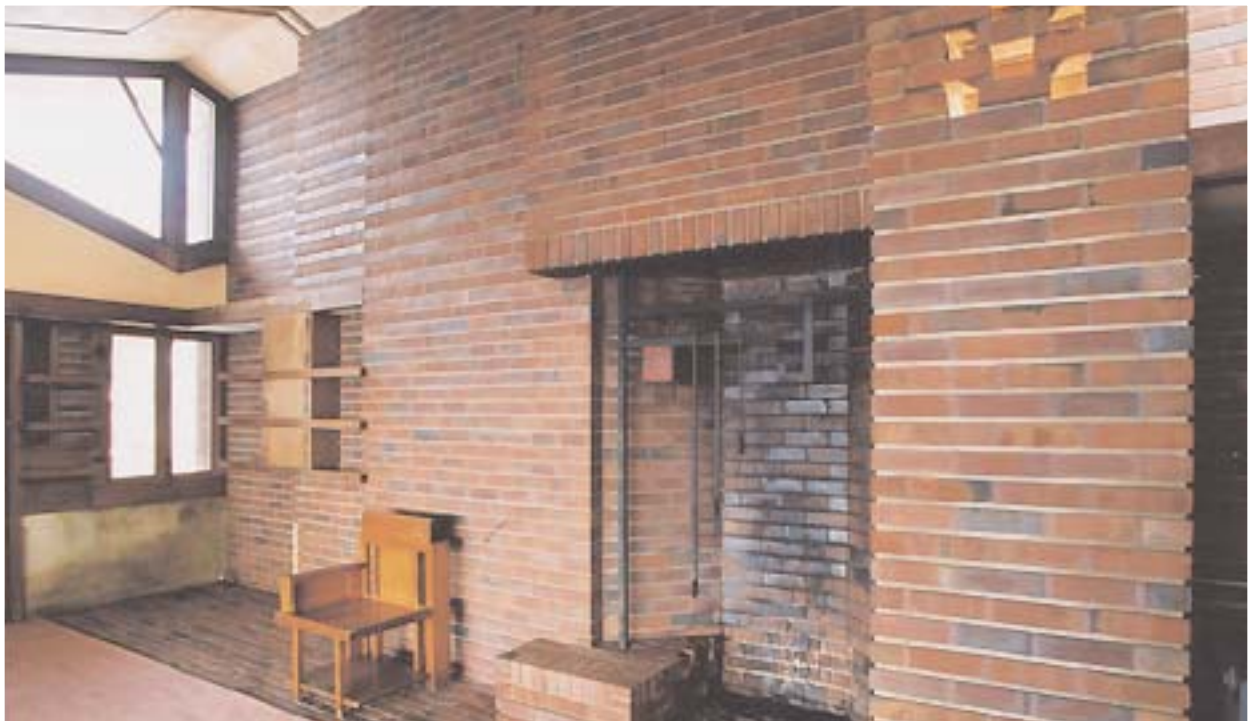
LIVING AREA

Living area after brick cleaning. Note the alternating bands of brick next to the kite window. The striping effect of the Willey House brick seen in early photos was due

to a textural change from shiny Twin Cities Shale Brick to matte Menomonie Common Sand Mold Brick.
