WILLEY HOUSE RESTORATION JOURNAL VOLUME 2 ■ ISSUE 2 ■ SPRING 2003 ■ ■ ■

## THE STATE OF THE HOUSE SPRING 2003

Exterior brick restoration, returned mobility to the fireplace arm and miscellaneous interior work waiting for warm weather.

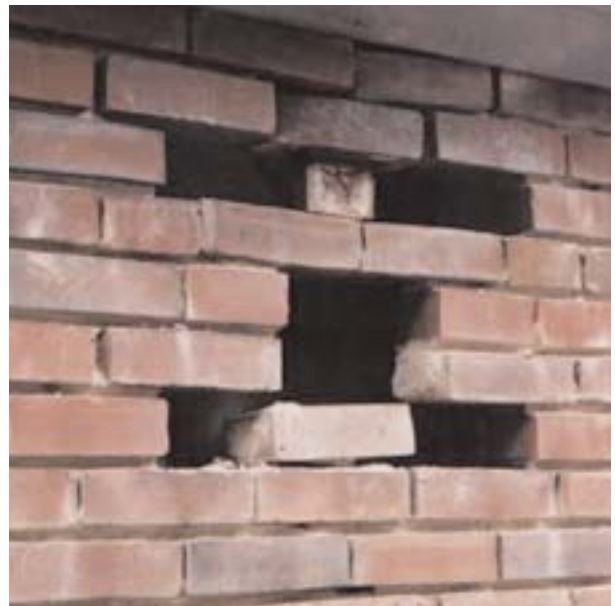
Deteriorated gallery brick screen.

The raked back joints and colored vertical head joints, an acute learning curve even for the professionals.

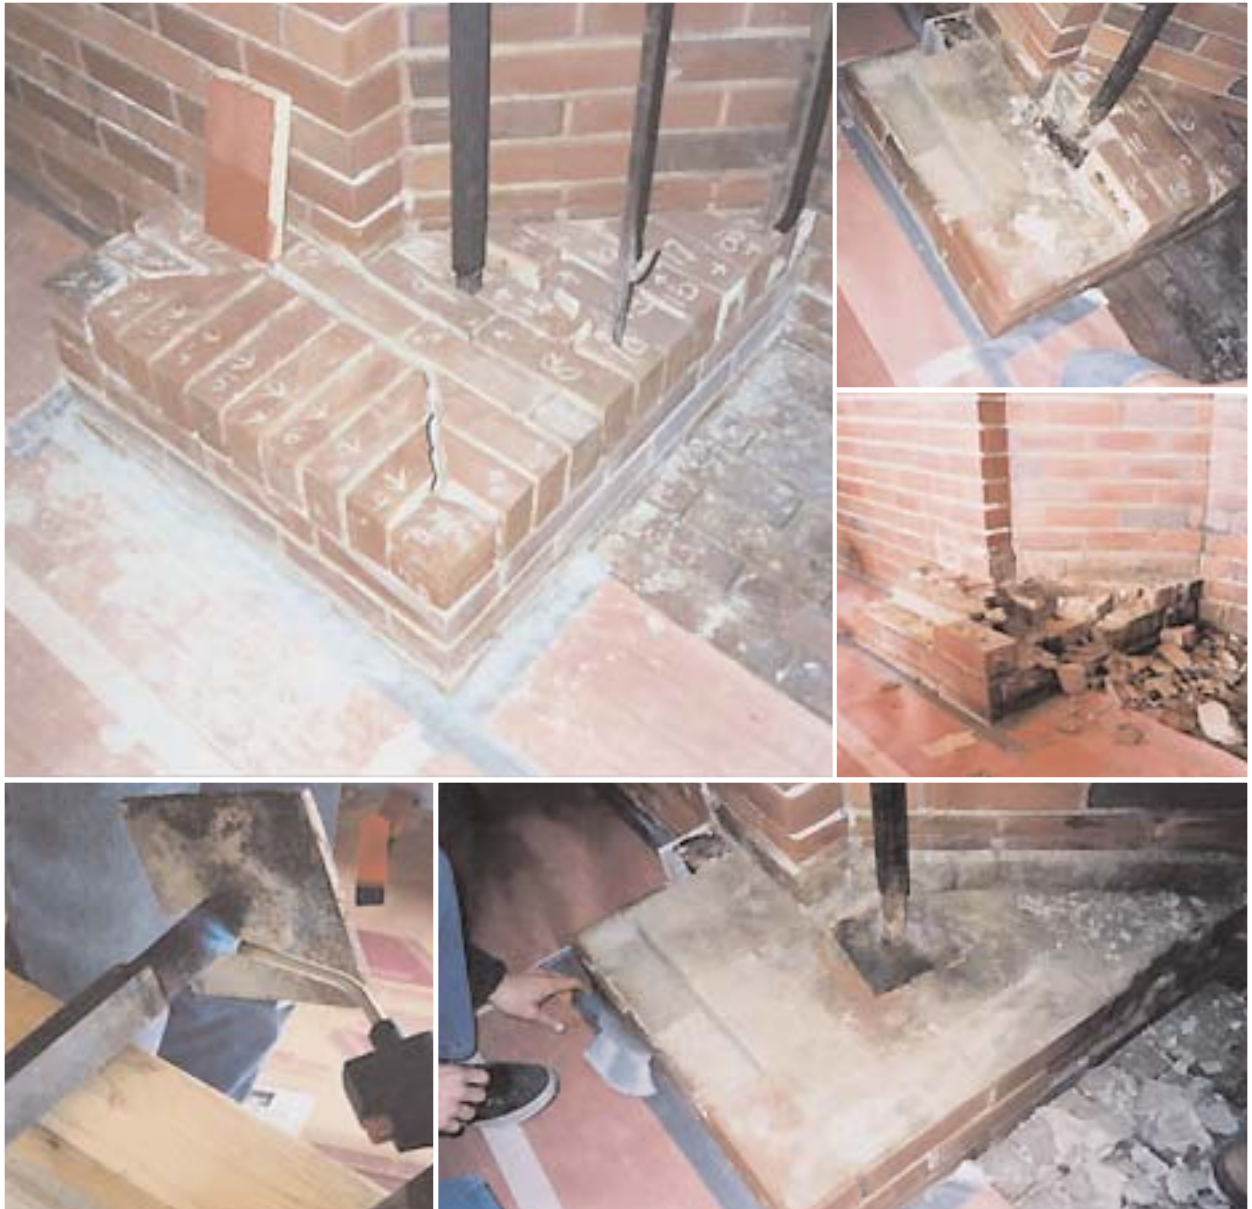
### FIREPLACE CRANE AND HOB

Disassembly of the fireplace hob to free up the swinging arm. All bricks are numbered to return to original position. (photo 1). Entire top layer of brick was loose due to torquing action of the seized arm (photo 2). All loose

brick are removed (photo 3). Arm is broken free with a torch (photo 4). Freed arm is reset, bricks to be relayed over Summer (photo 5).

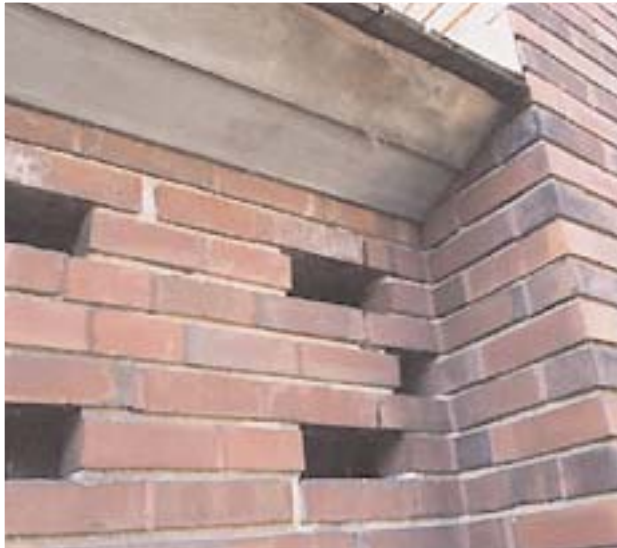
The brick is dirty and discolored, mortar is mismatched from previous repairs and the colored mortar in the head joints is faded to pink, no longer matching the brick (top left). The need for restoration is evidenced here in the missing

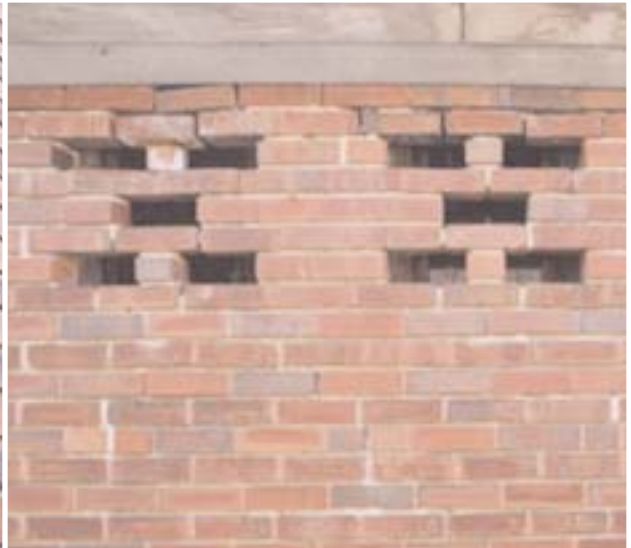
and deteriorated mortar in the gallery window screens (top right). Dirty brick (bottom left). Vertical crack in the garden wall runs top to bottom (bottom right).

Weep holes long mortared over were reintroduced to the gallery window screens.

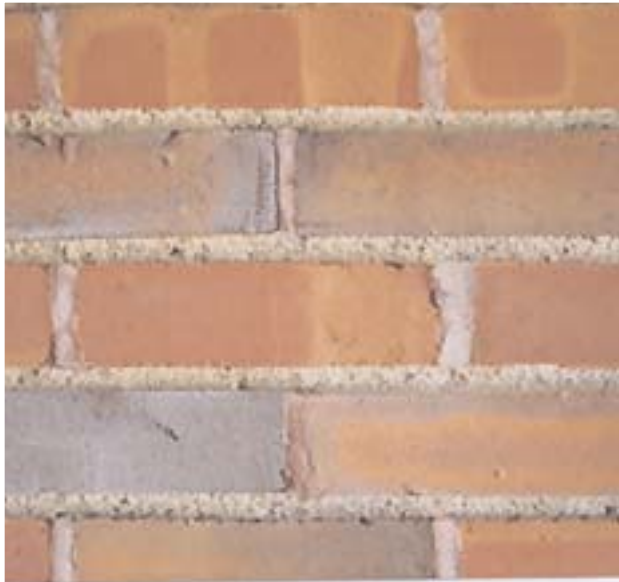
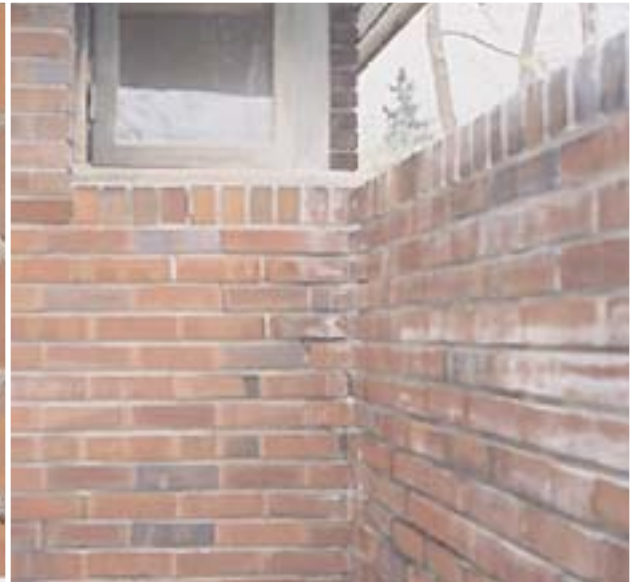
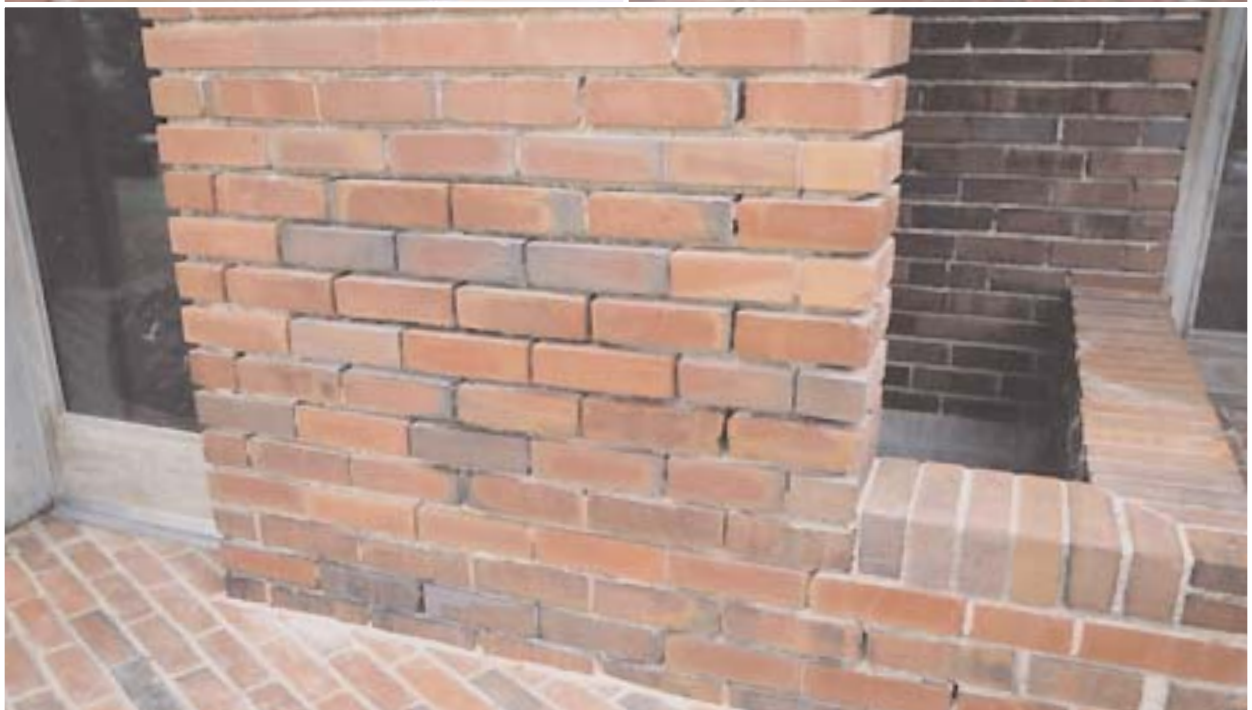
## EXTERIOR BRICK CLEANING

Section of exterior brick wall after cleaning (photo 1).  
Cleaning highlighted weak mortar and necessary repairs.

Photo 2 was taken at the junction of the garden wall and  
master bedroom. Photo 3 is of a terrace pier/planter.

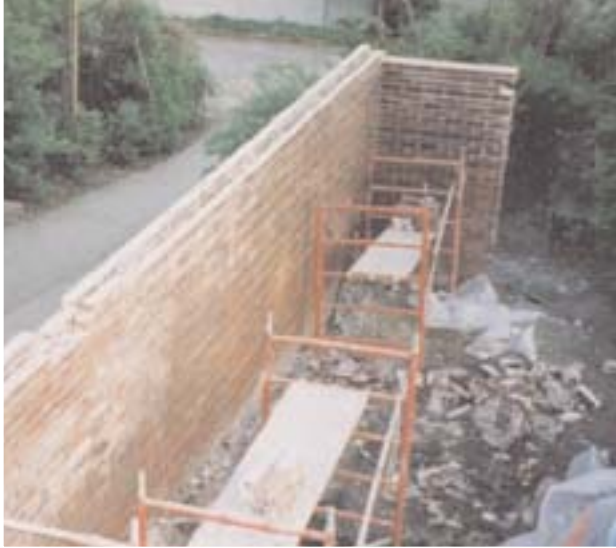
The deteriorated rowlock and a part of the second brick course were removed from the top of the garden wall.
