T H E G A R D E N W A L L

WILLEY HOUSE RESTORATION JOURNAL VOLUME 2 ■ ISSUE 3 ■ SUMMER 2003 ■ ■ ■

## THE STATE OF THE HOUSE SUMMER 2003

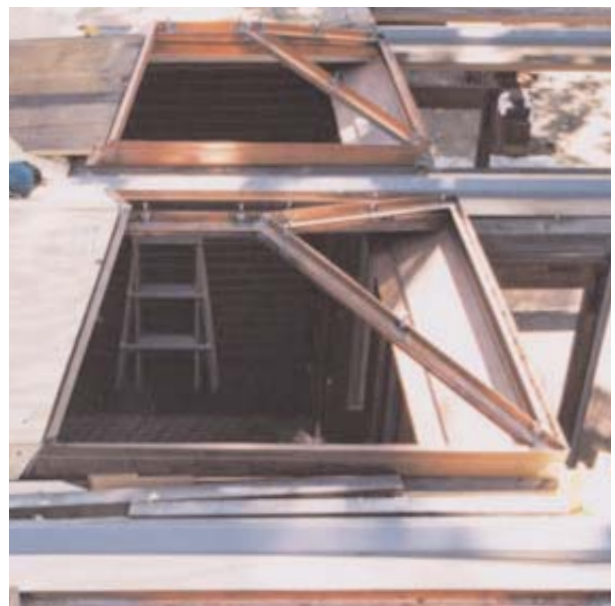
Newly installed skylight frames.

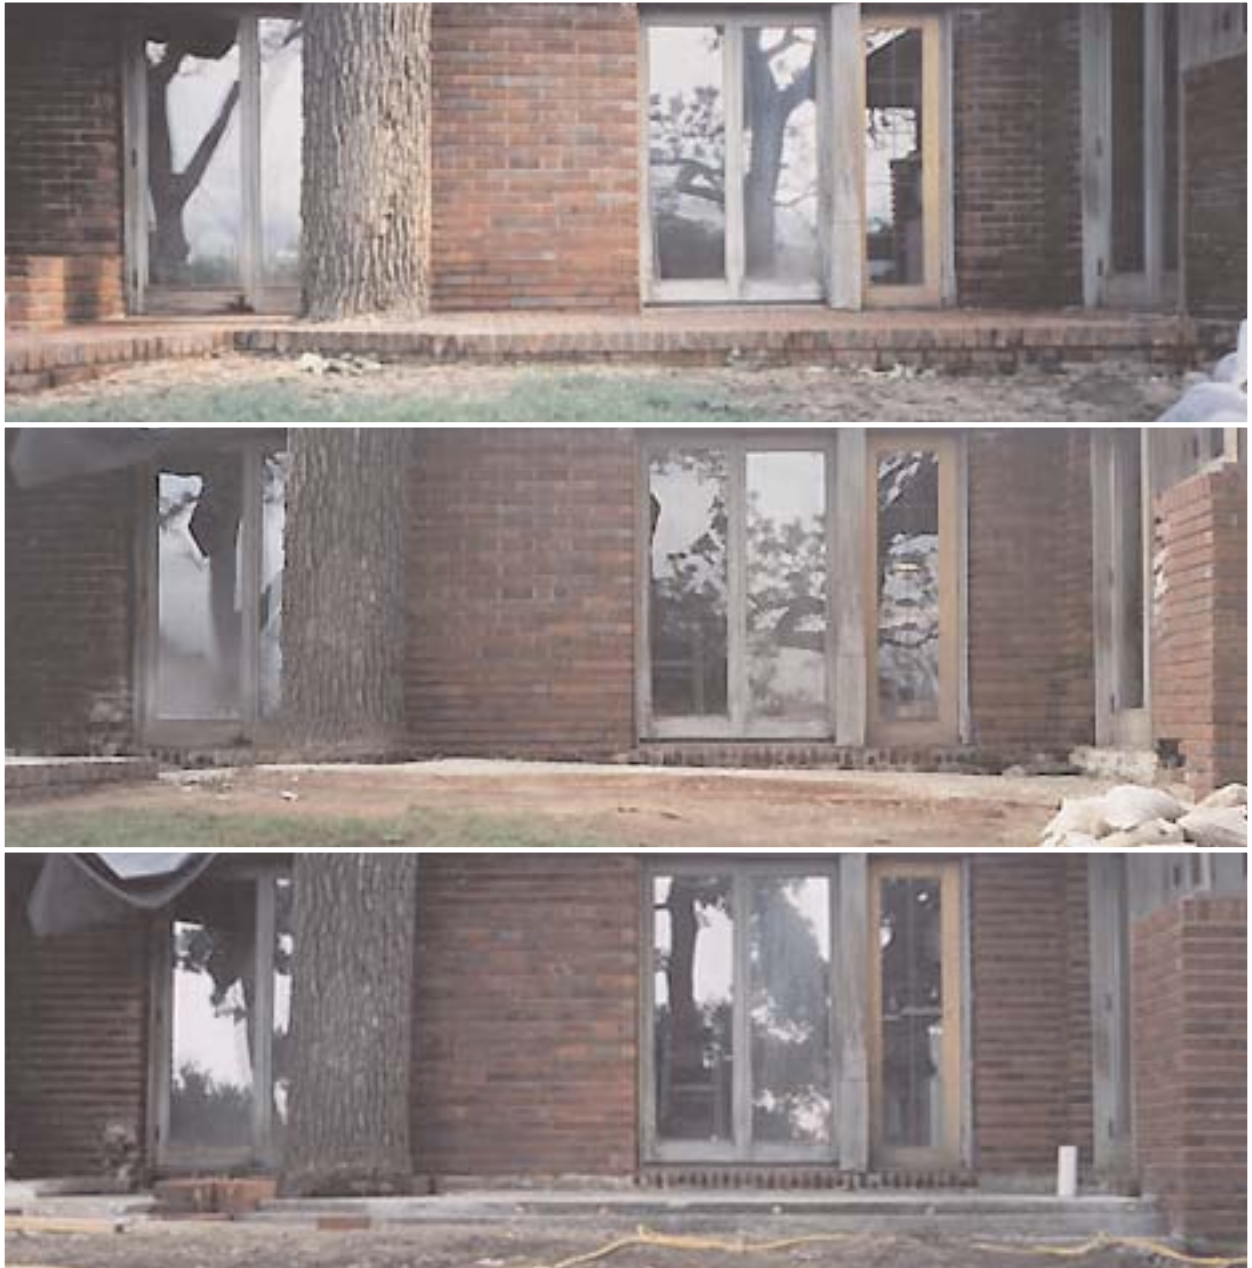
## REBUILDING THE BEDROOM TERRACE

Terrace before tear out (top). Slab after tearout (middle). Note the angle of the original slab. It was probably affected by the large Burr Oak growing through the east

terrace. New slab with drainage pipe and the addition of a previously missing step to the garden (bottom).

In order to stave off future water problems at the study and bedroom thresholds it was decided to remove the east terrace bricks in an attempt to reset them below threshold level with an increased pitch away from the house. As per usual, the task grew in ambition and magnitude. The original slab as it turned out was not sound. It was demoed and since we were starting with somewhat of a clean slate it did not seem out of the question to consider a drainage system designed specifically for the area. At the same time, since a new slab was going to be poured, it was decided to add a missing step down to the garden that appears in many of the house plans.

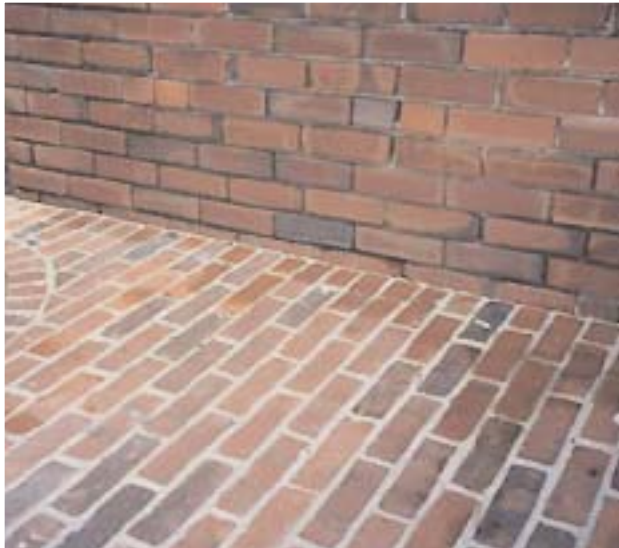
### TERRACE INSPECTION

Pitch of brick terrace where terrace meets the wall.

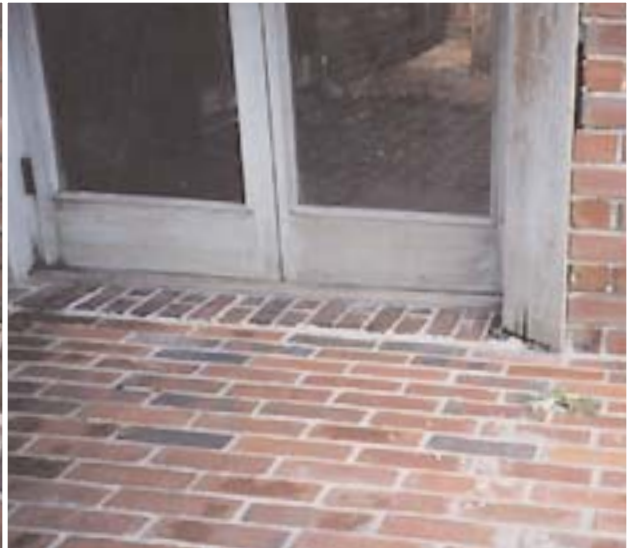
Low thresholds allowed water to enter bedrooms. 📍

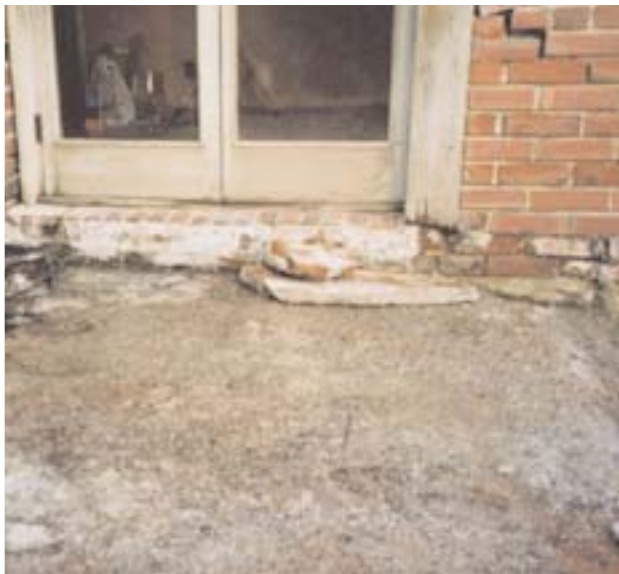
### STRIPPING BRICKS

Bricks stripped off the terrace show the original slab in poor condition.

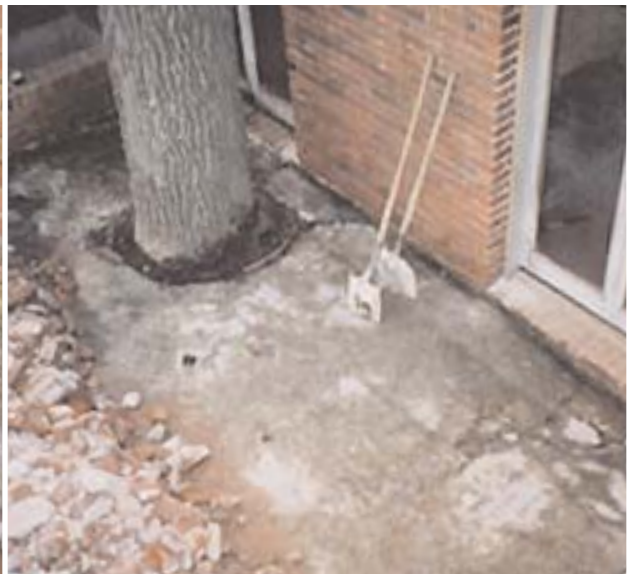
All brick removed from east terrace. 📍

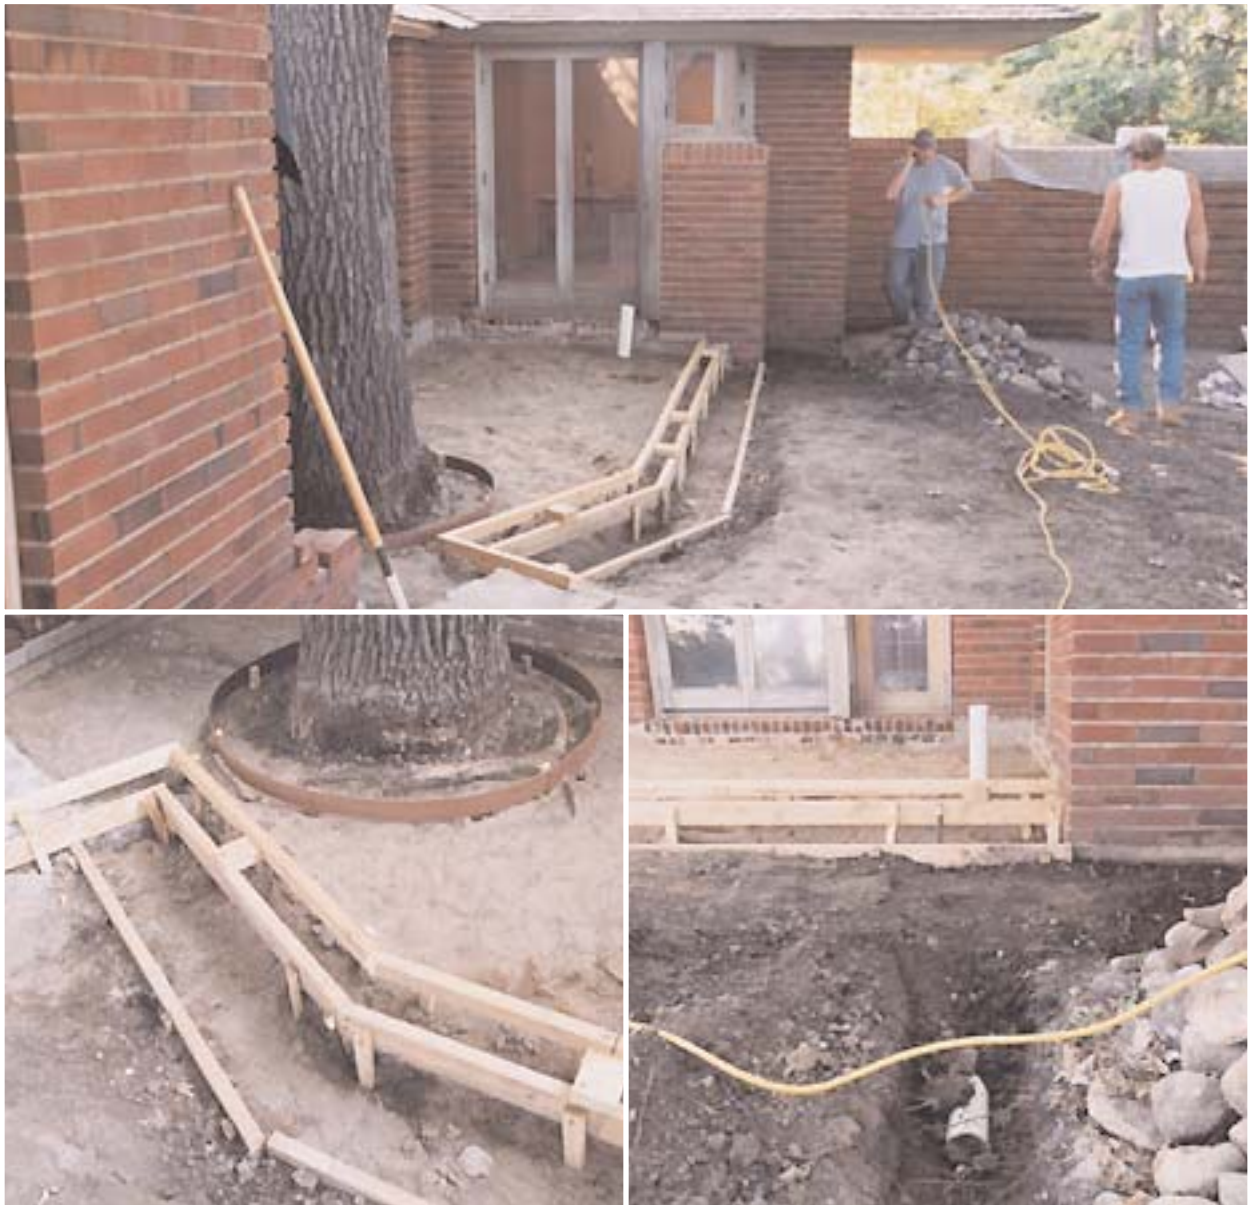
## CONCRETE PREPARATION

Photos 1 and 2 show concrete formwork for the new terrace. The drain pipe is visible in photo 3.

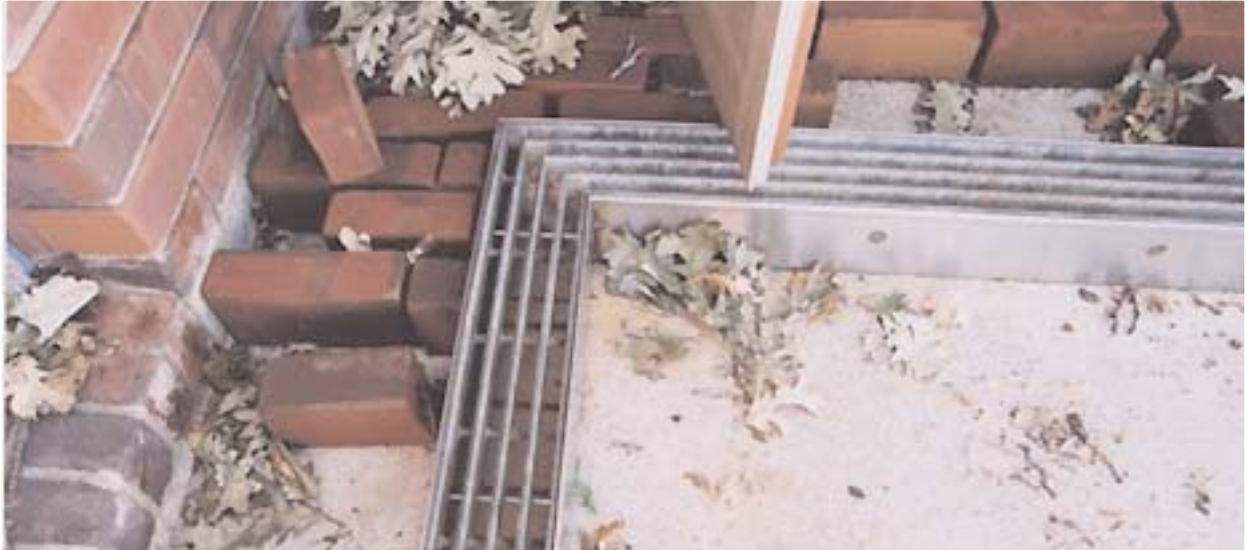
#### DRAIN TROUGH

Custom made stainless steel drain trough runs in front of study and bedroom doors to diffuse splatter and drain

off standing water.

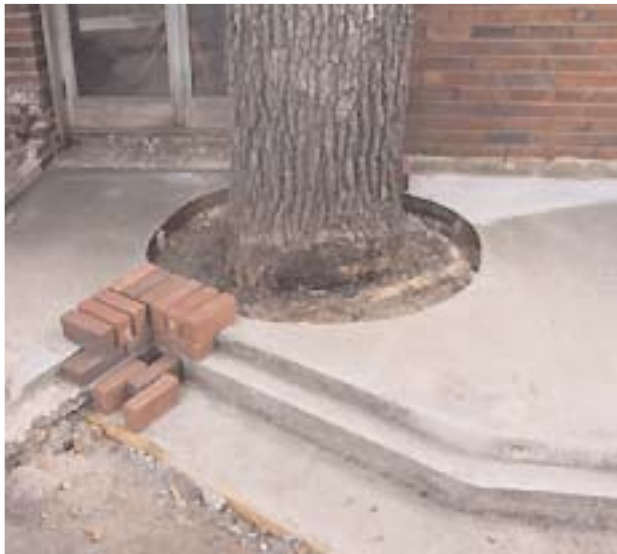
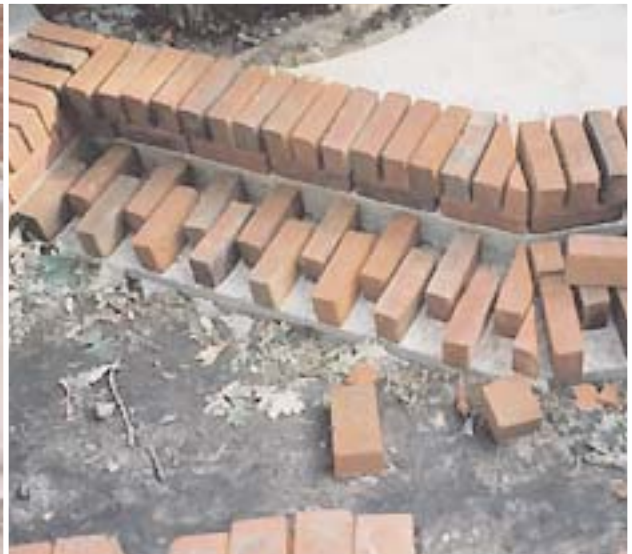
#### POURED SLAB

Step details.

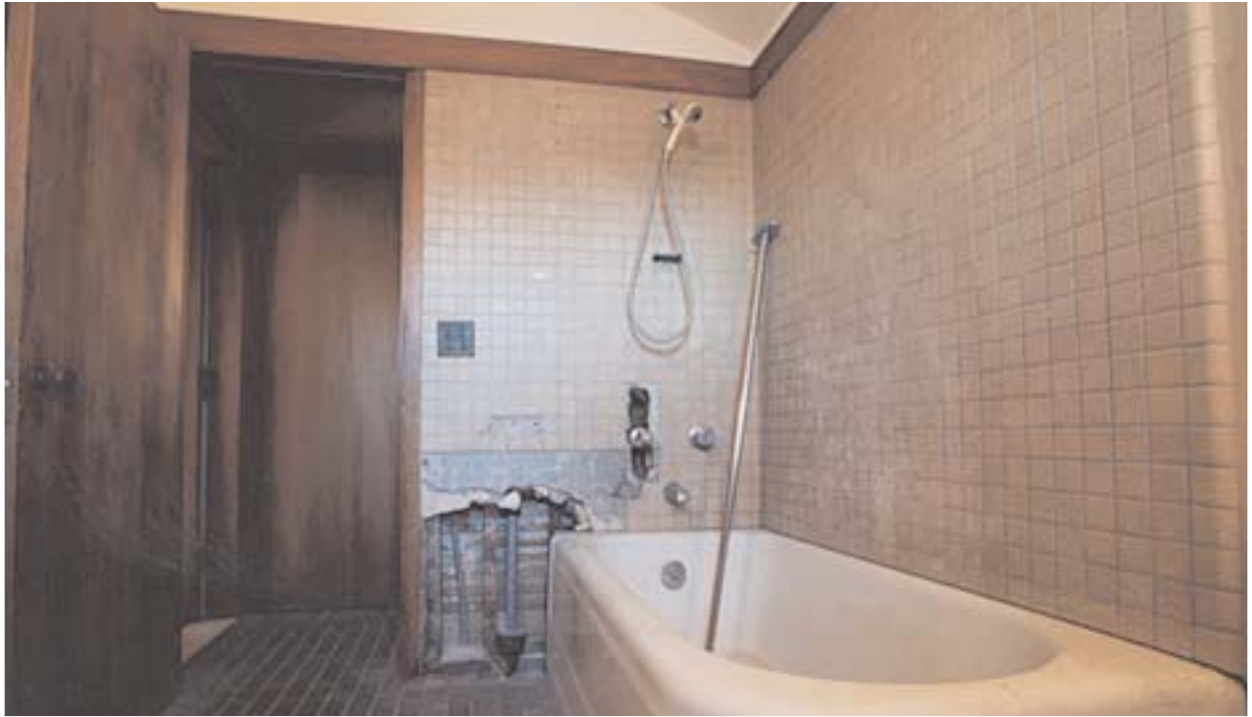
## BATHROOM

Bathroom pre-demo shows 1970's vintage tile.

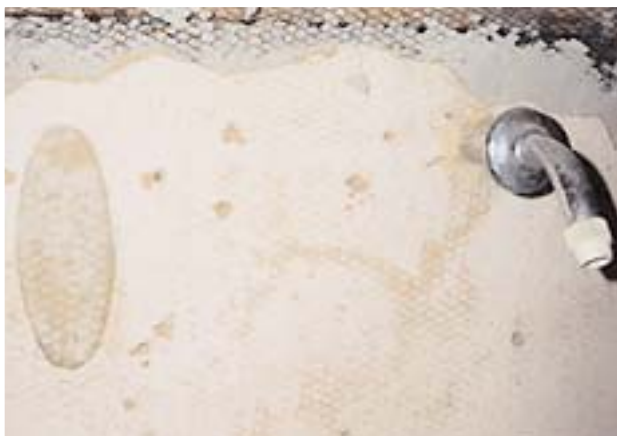
The shower in this bathroom was not believed to be original. However, the original cement plaster wall under the tile shows the ghost of the shower rod plate.

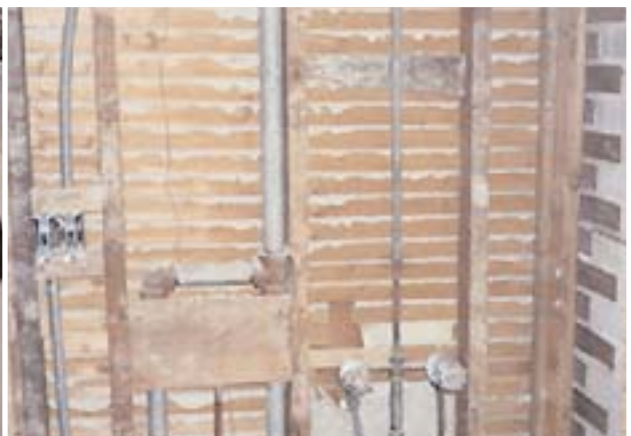
Plumbing for the shower head was held in place by a wooden brace that appears to be made from a piece of construction scrap. 📐

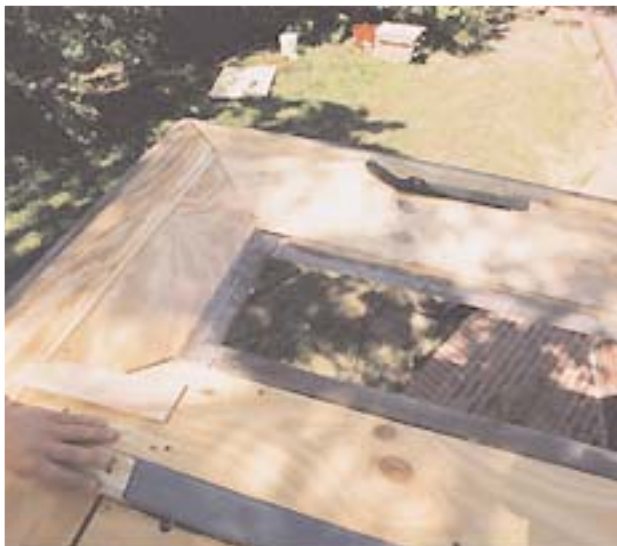
## NEW SKYLIGHTS

Wood crickets are built up to the height of the new skylights.

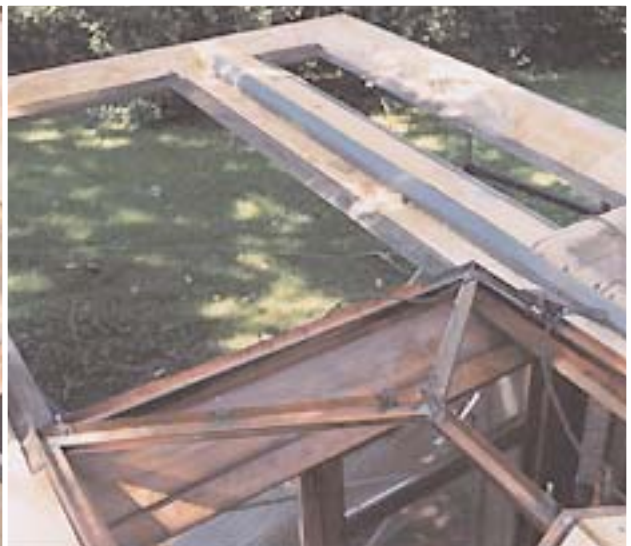
Completion of the plywood underlayment on the trellis. 📷
