# T H E   G A R D E N   W A L L

WILLEY HOUSE RESTORATION JOURNAL VOLUME 1 ■ ISSUE 1 ■ SPRING/SUMMER 2002 ■ ■ ■

## THE STATE OF THE HOUSE SPRING 2002

### Restoration of mechanical systems and sealing up the envelope.

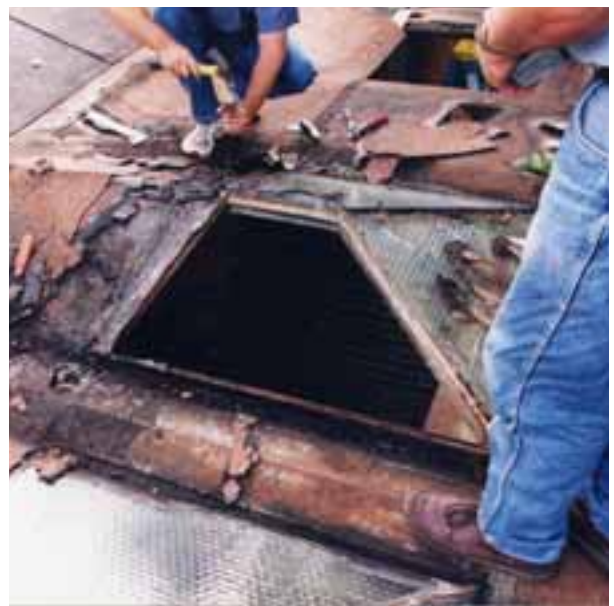
Removing a skylight for restoration.

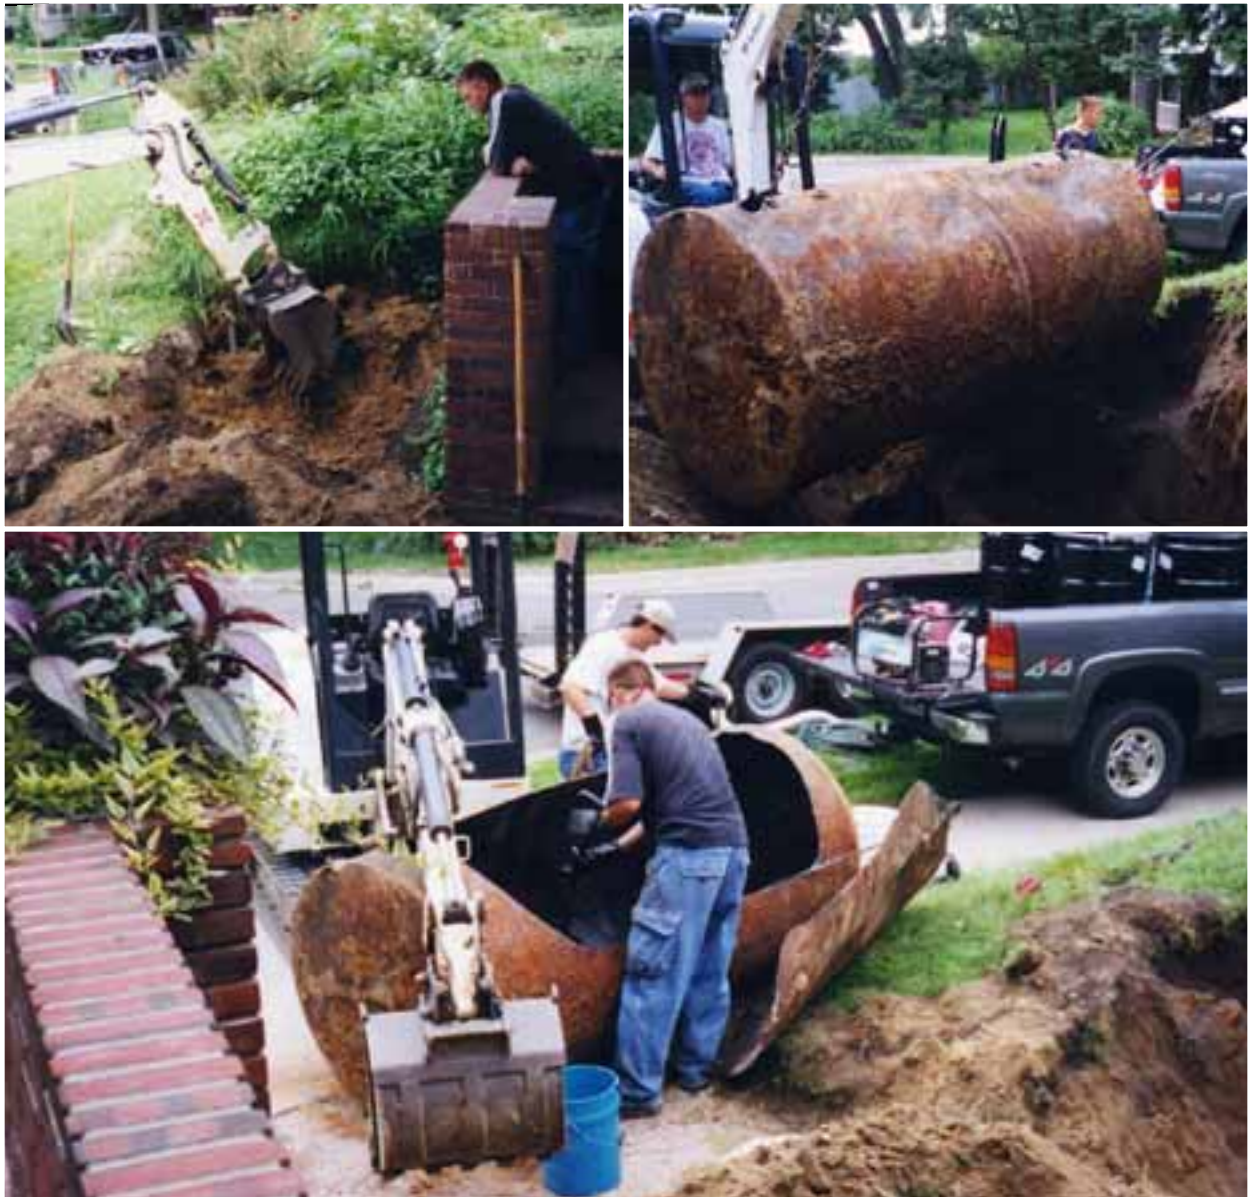
## FUEL OIL TANK

It could have been ignored but would have come back to haunt us sooner or later. The original fuel oil tank was buried deep in a slope next to the drive way. The tank was found to hold oil, a good sign because it meant no leaks, cracks or rust perforation. After the remaining oil

was pumped out the 1000 gallon tank was exhumed, sawed into manageable pieces and hauled away. Now the brick drive can be set without fear that it will by necessity be torn up later. 📍

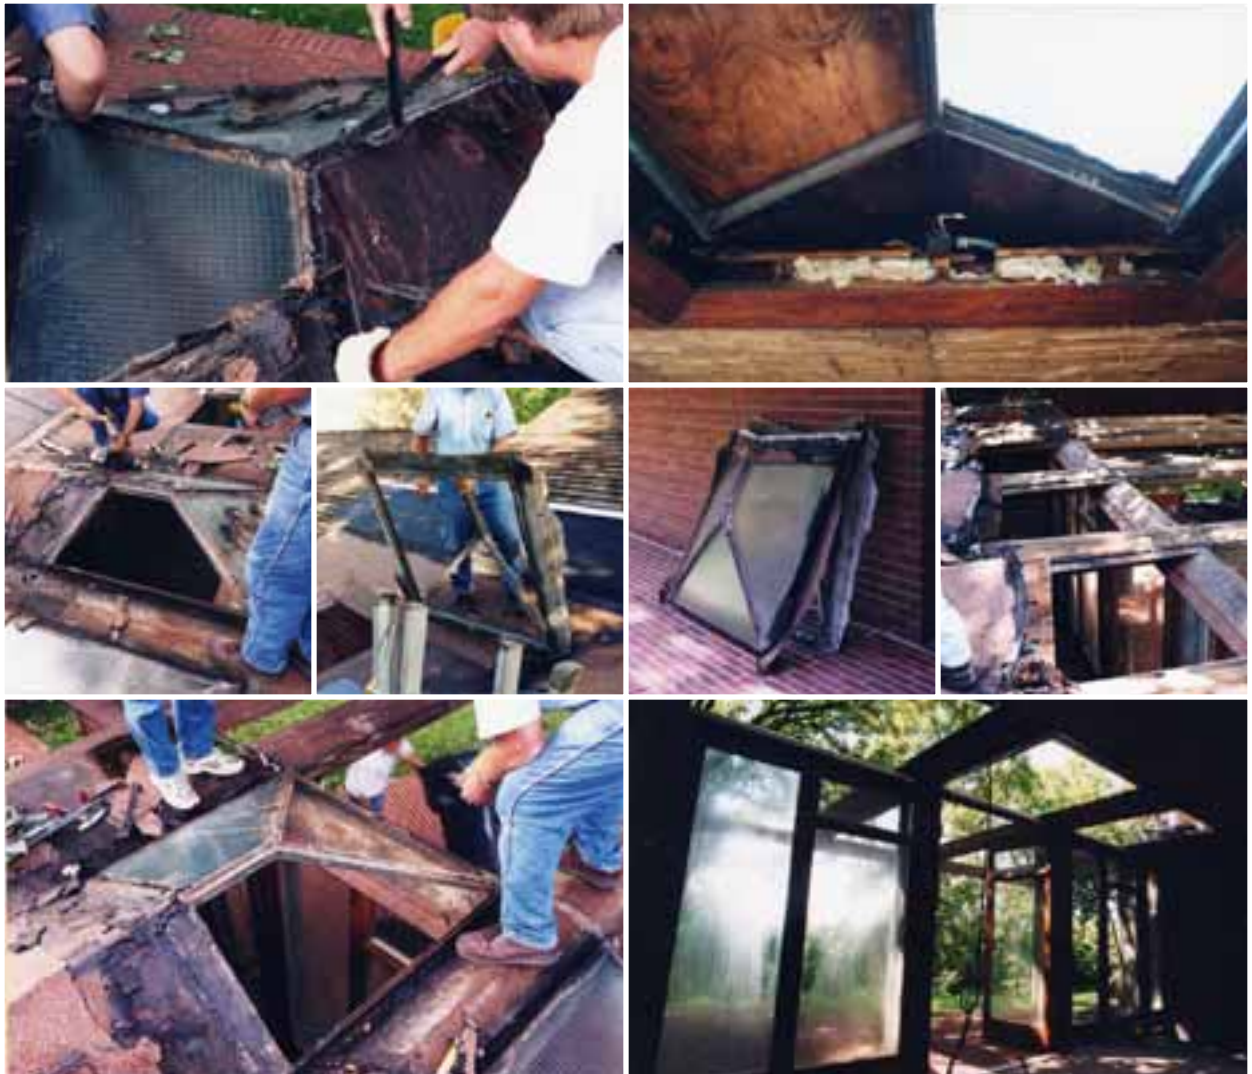
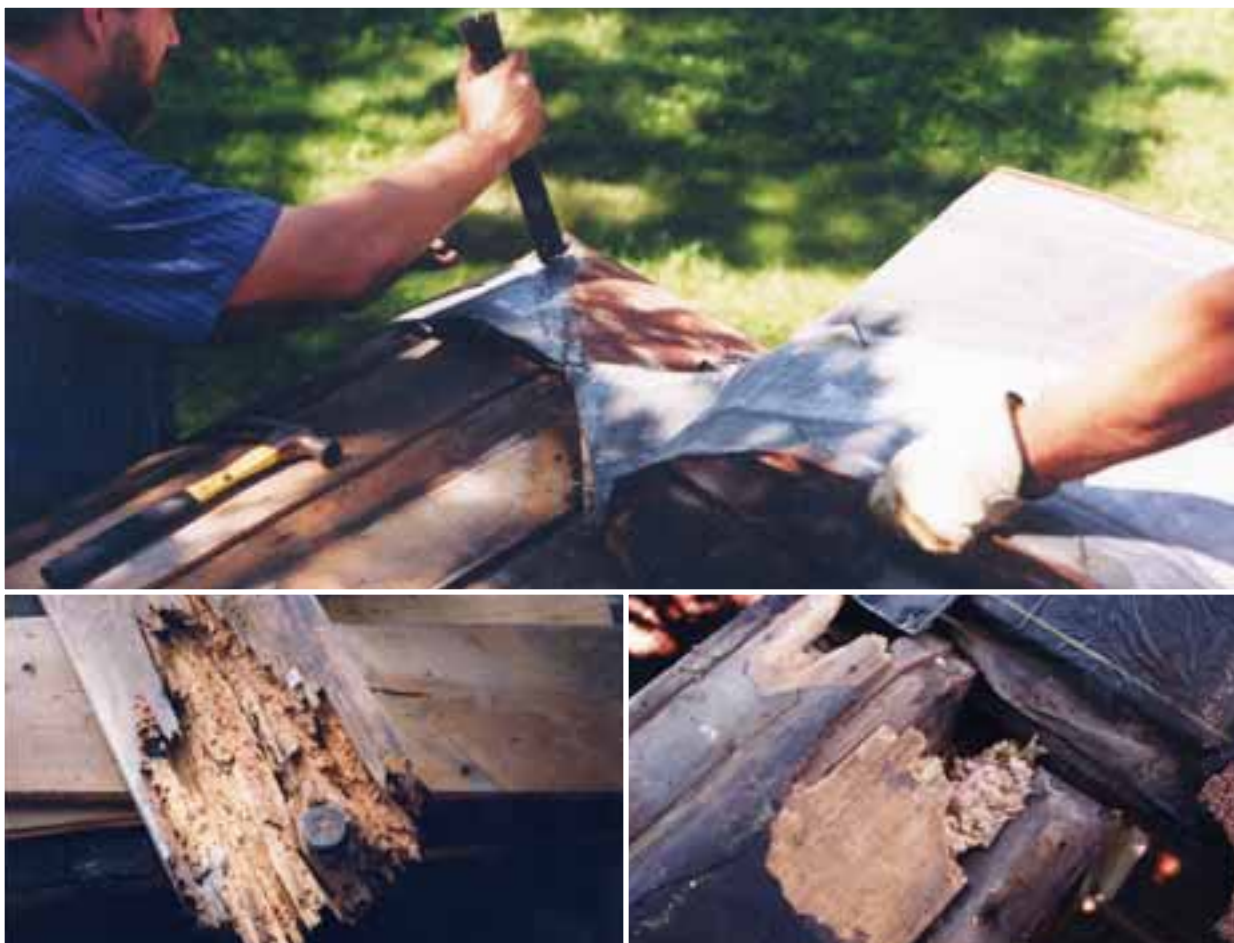
## REMOVAL OF SKYLIGHTS

The original skylights were constructed from galvanized steel. Over time they rusted in places where water collected. Channels in the flat sheet metal roofing between the skylights have typically dammed up with acorns, leaves and branches. Water pooled there and rose high enough to seep through the skylights. The glass panes had been tarred repeatedly to seal them against leakage. Several panes

were broken and one was missing. The skylights had been designed with a 1/2" interior channel and drainage tubes for condensation to run down and escape. While refitting the new units we discovered that the skylights had been out of level by over 3/4" which caused the collected condensate to run back toward the interior. Rotting and staining interior wood trim in the process. ☐

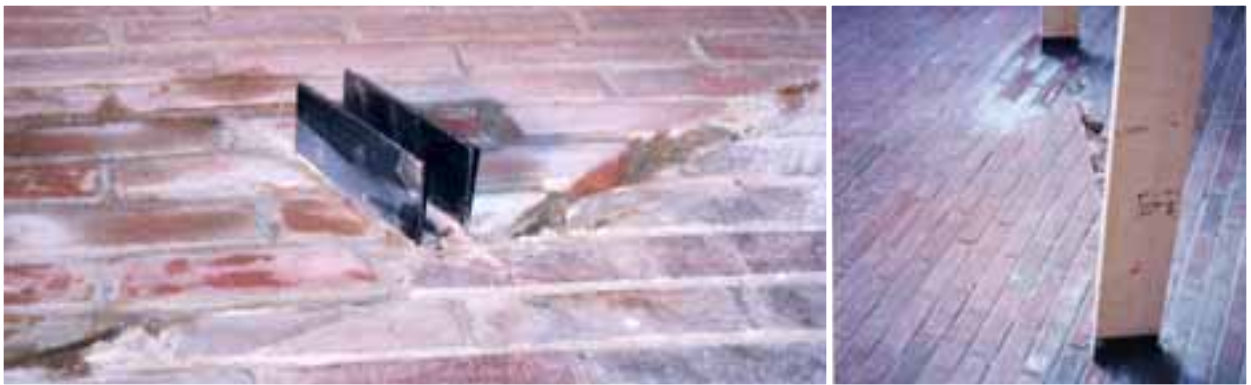
## PLINTH

The vertical dividers between the banks of French doors carry the horizontal beam that acts as a fulcrum for the cantilevered trellis above. The original 2 x 6 supports rested directly on the concrete mat and were set in mortar between the terrace bricks for stability. Seven decades of rain water ran down between the bricks and wicked its way up the fir 2 x 6s rotting them away well above floor level. The weight of the trellis was transferred over time to the door jambs and exterior mullions which fortunately were

constructed of 2 3/4" thick cypress. It is by the grace of cypress that this house remains standing. The old 2 x 6s were upgraded to 2 x 8 and rather than plant them between bricks, steel plinths were designed to utilize a wider base of support on the concrete mat and lift the wooden supports off the ground. The terrace bricks were set around the plinths as they hold the bottom of the new 2 x 8s above floor level and diminish the potential of any further wicking action. 📷

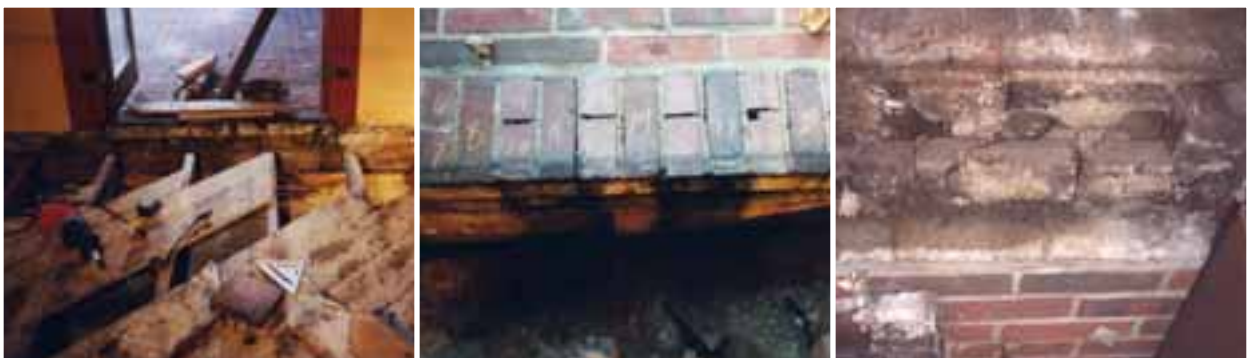
## MASTER BEDROOM THRESHOLD

The threshold has leaked water for many years. The height of the most recent terrace (there have been three) exacerbated this problem by encouraging water to pool in front of the doors. The cement bricks below the threshold

were deteriorated and the ends of every floor joist which met the threshold were rotted. The old wood was cut away and joists repaired. 📷

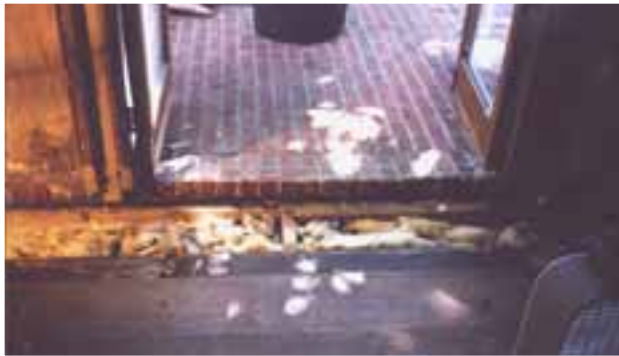
#### GUEST BEDROOM THRESHOLD

The guest bedroom threshold allowed water to pass in and under the floor. Floor joists and some cypress flooring required replacement. 📐

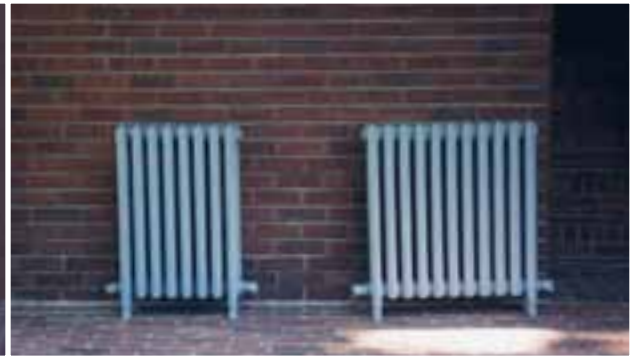
#### RADIATORS CRACKED AND RUSTY

The heating system was shut down without being fully drained. As a consequence more than half of the radiators in the house were cracked and need to be replaced. These two radiators shown above were just a little rusty so they have been sandblasted and repainted. 📐

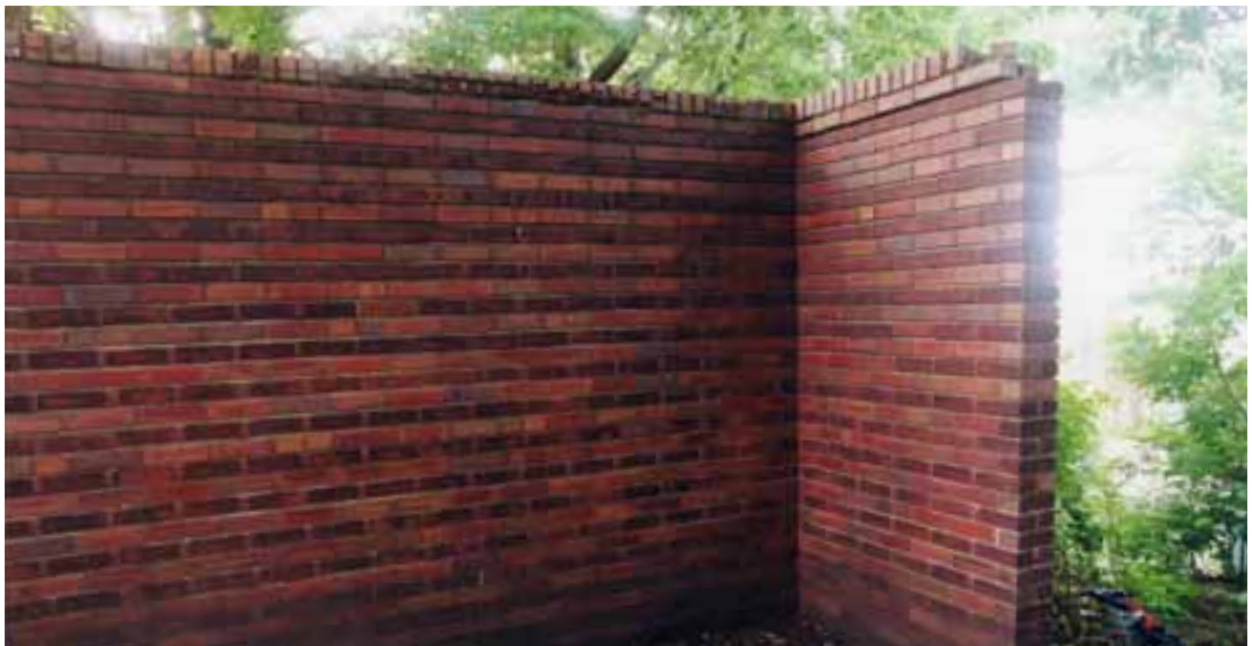
#### DETERIORATED GARDEN WALL

The rowlock course along the top of the wall is in particularly bad condition, cracked, spawled and broken.

A severe crack through the center of the wall needs to be repaired and the grout joints tuck pointed. 📐
