T H E G A R D E N W A L L

WILLEY HOUSE RESTORATION JOURNAL VOLUME 1 ■ ISSUE 2 ■ FALL 2002 ■ ■ ■

THE STATE OF THE HOUSE FALL 2002

An improved cantilever, a working drainage system, the first brick repair and at last, a home security system.

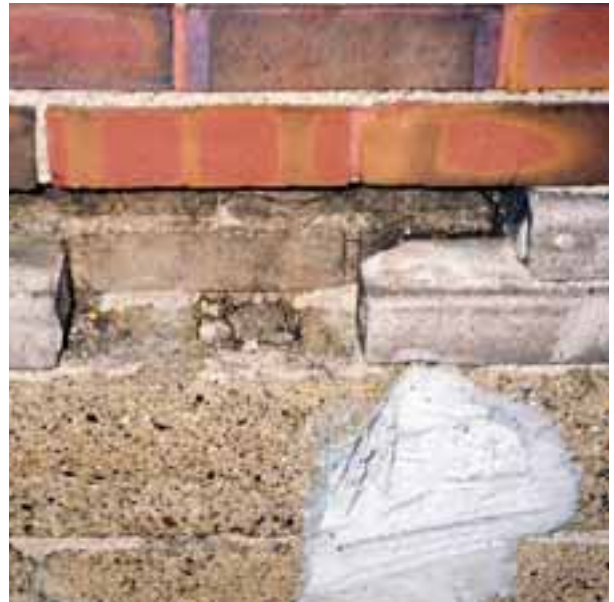
Planter box wall deterioration.

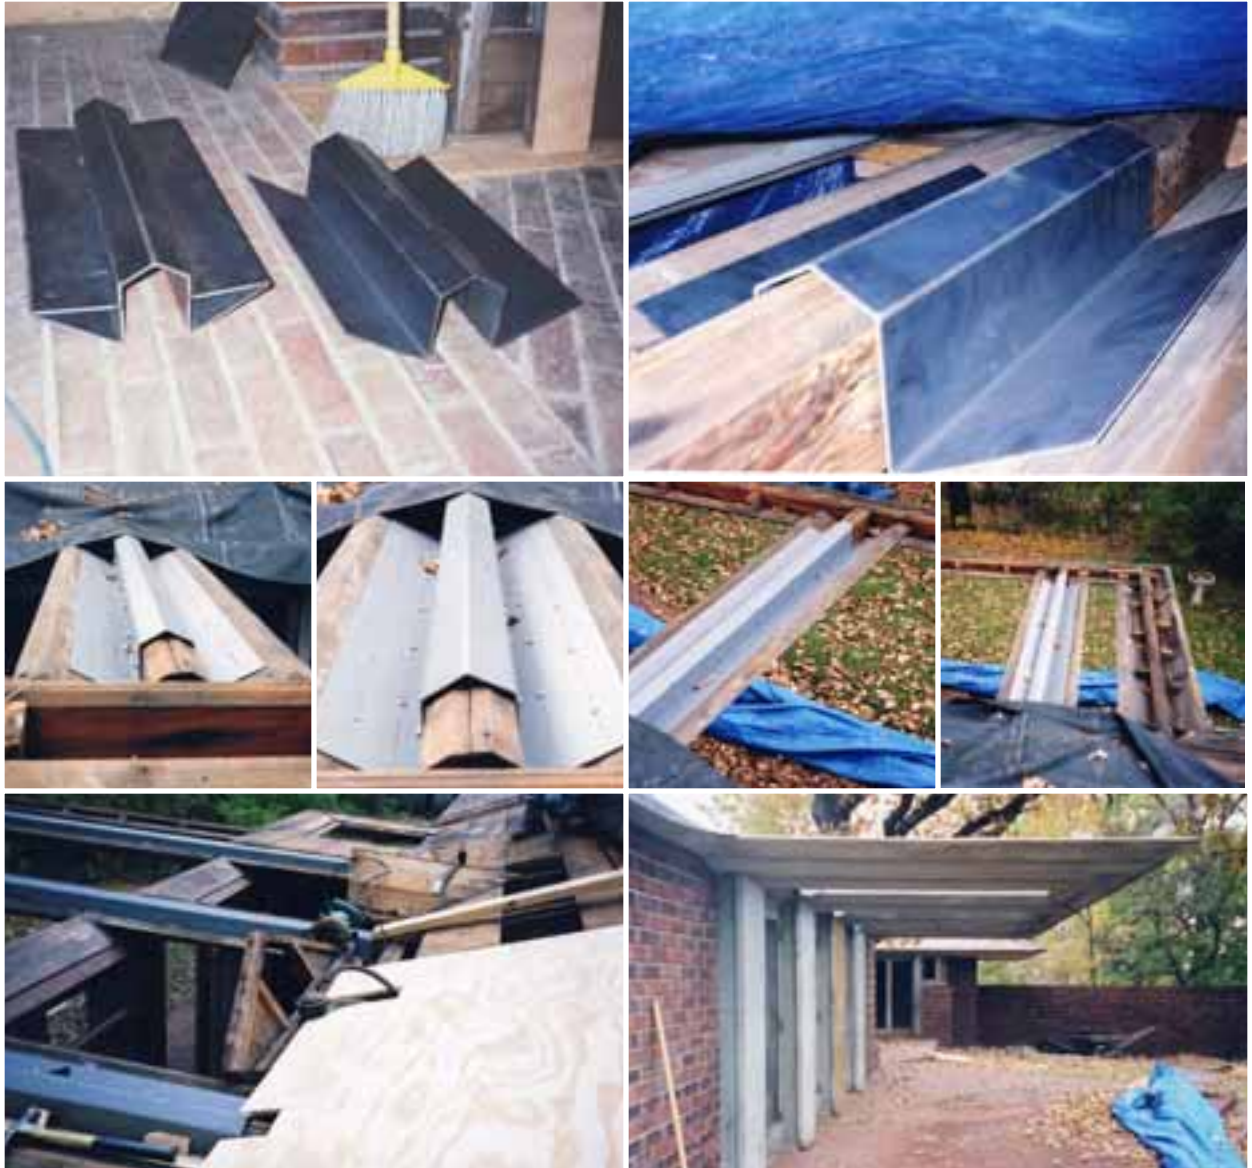
TRELLIS STEEL SUPPORTS

The trellis has an eight foot cantilever. It was constructed entirely of wood and over time naturally sagged as the wood fibers stretched. Looking at the open structure it appears that the trellis was built with a projection somewhat above level with the anticipation that gravity and

the natural flexibility of the wood might settle the whole at a point near level. After 68 years it was visually apparent that the trellis was slumping badly. Measurements proved it to be sagging by 3-1/2".

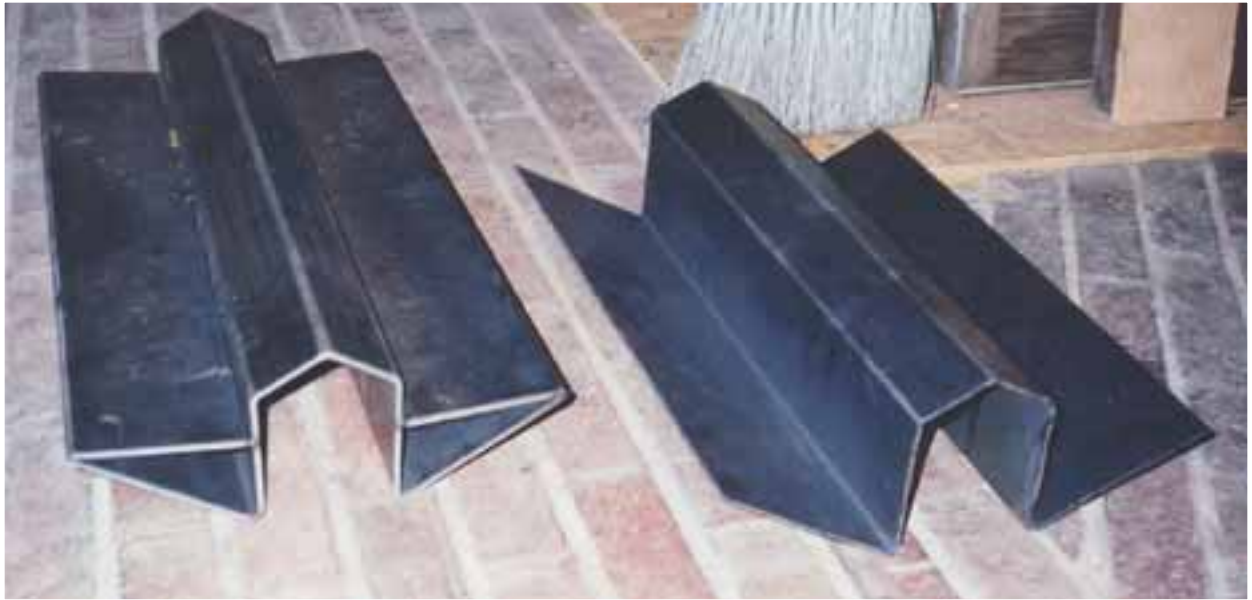
SUPPORT PROTOTYPES

On the left is a sample section of steel saddle as proposed by an engineer. The weight of his design proved excessive. The fabricators who made up the sample chuckled when told it was for a trellis. We opted for a scaled down version made of lighter gauge steel without the triangular

box sections. This design minimized weight and has proven sufficient for the degree of support we required. When the steel was bolted in place and the jacks removed there was only minor deflection and most of that was due to compression of the soft wood.

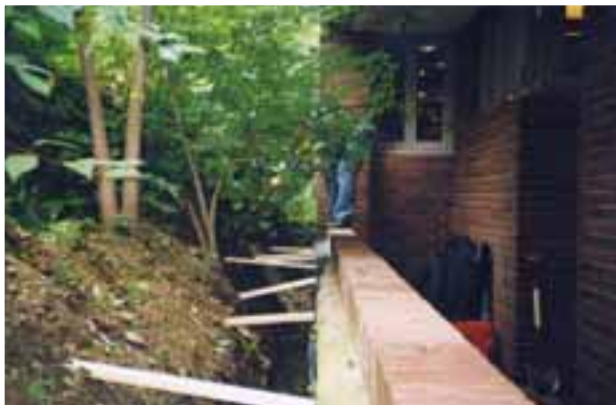
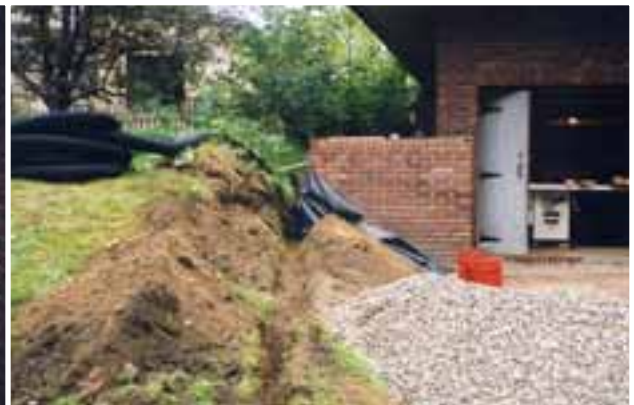
DRAINAGE SYSTEM

After removal of the fuel tank (see The Garden Wall, Volume 1, Issue 1) a drainage system was laid to funnel

some of the water shed from the roof away from the north side retaining wall.

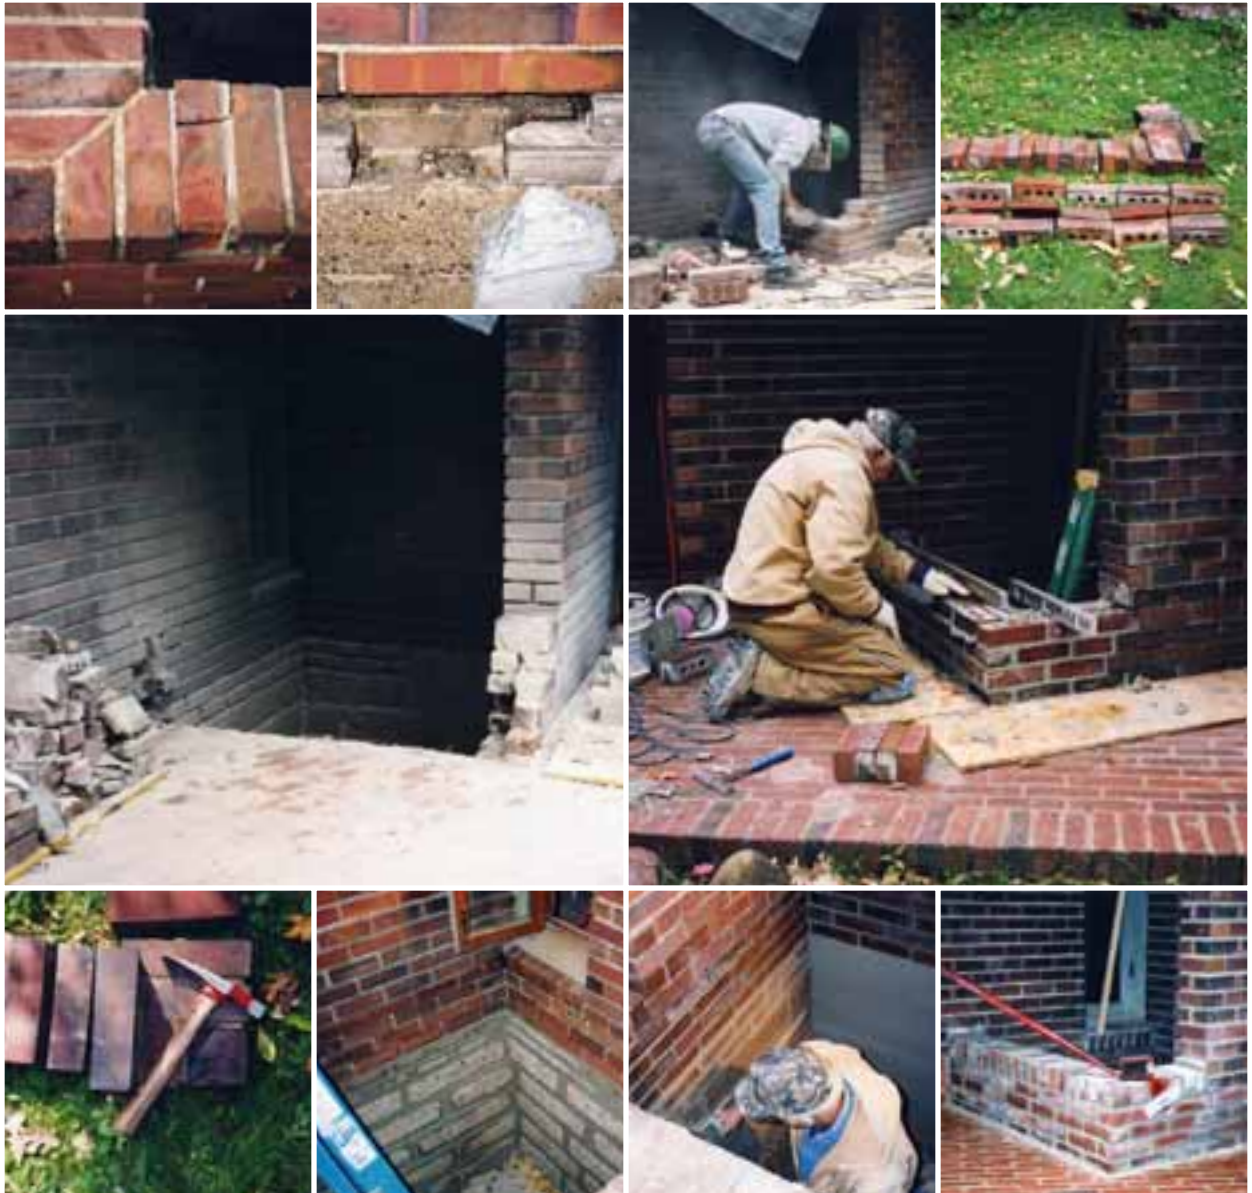
PLANTER BOX REPAIR

The planter bricks were cracked and missing, the interior bricks were even worse. Both planters leaked through the common walls into the living room radiator wells after a rainfall. They had never been waterproofed. French drains

were dug below the planter box and house footings to encourage percolation. Heavy rains often left a foot or more of water standing in the planters.

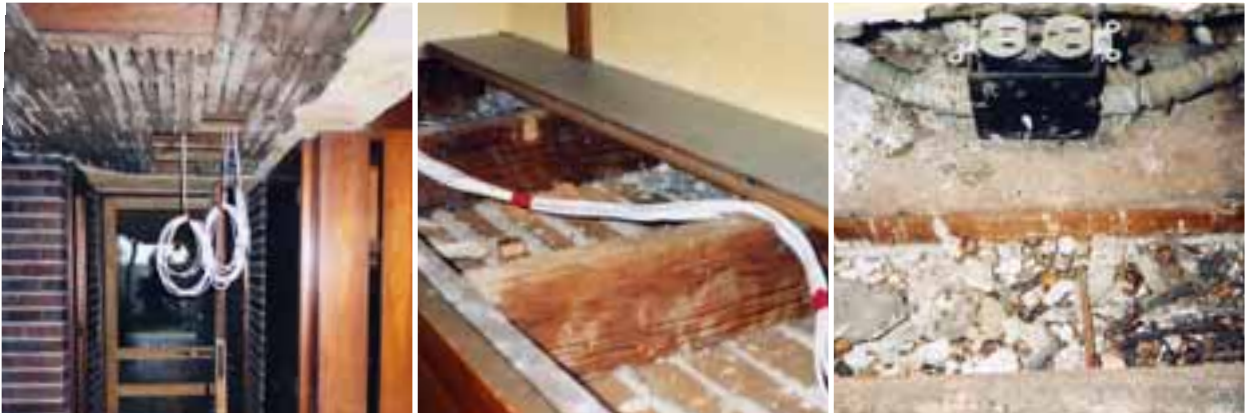
RUNNING WIRES

The water-damaged plaster that fell down in the living room in front of the french doors was turned to advantage by opening up access to a soffit that runs most of the length of the house. It became an ideal chase for security, sound system, phone and category 5 wiring. Thanks to

the open soffit and floors it was relatively easy to fish wiring for the new security system which is completely invisible and now fully operational. Most enclosed spaces in the ceiling and decks revealed caches of acorns and other evidence of past rodent habitation. 📍

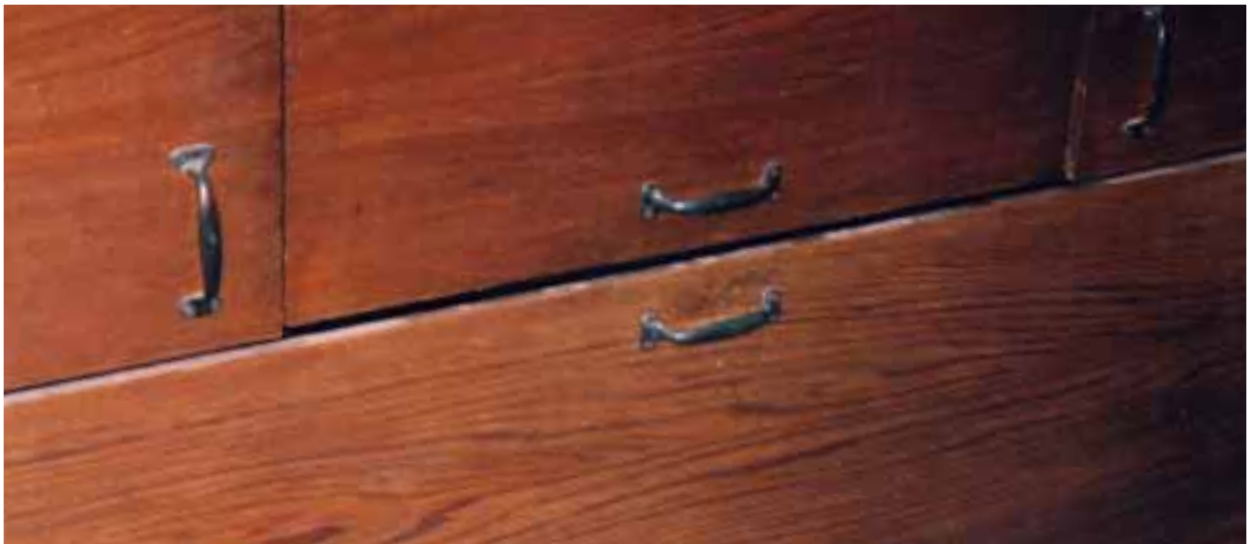
WOOD DRYING OUT

The first dry heat in years has caused the interior cypress to shrink and crack. Doors that had been swollen to the point that they seemed like the wrong door for the jamb

now swing shut with ease. Thin cabinet doors shown here, positioned directly above a gallery radiator were flat and now have warped. 📍
