# T H E   G A R D E N   W A L L

WILLEY HOUSE RESTORATION JOURNAL VOLUME 2 ■ ISSUE 1 ■ WINTER 2003 ■ ■ ■

## THE STATE OF THE HOUSE WINTER 2003

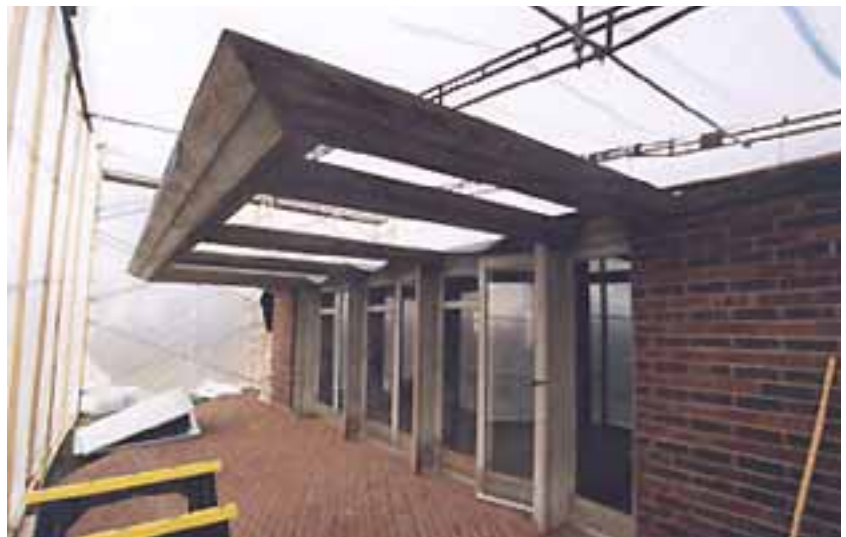
Inside the scaffold tent structure.

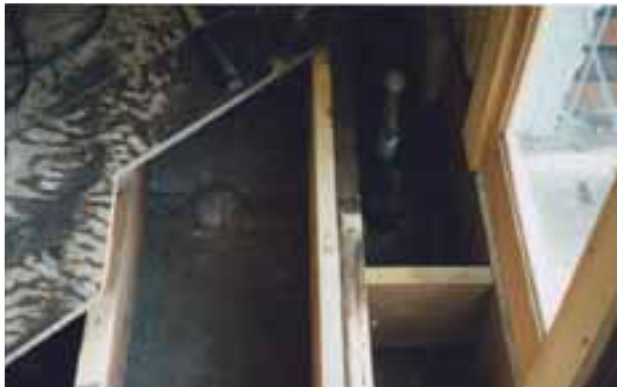
## RIM AND FLOOR JOISTS

Rim and floor joists as well as cement foundations required extensive repairs due to water entering the house over existing thresholds. Three causes were determined and are being addressed; the height and pitch of the south terrace, a splash factor that allowed water to run down and under the French doors and the thresholds themselves which were not water tight. [img]

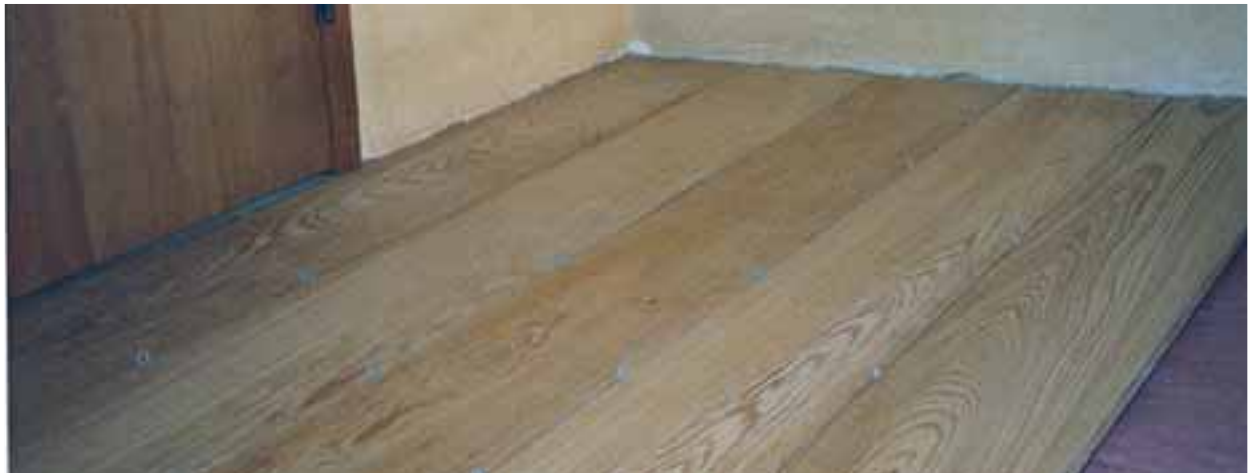
## PLANK FLOORING

Several 9" cypress floor planks needed to be replaced. The entire floor was planed so new and old flooring matched. Cypress is dimensionally unstable, shrinking and expanding

greatly from season to season. When floors were laid spacers were utilized to increase the gaps between planks so floors did not buckle when humidity reached summer levels. [img]

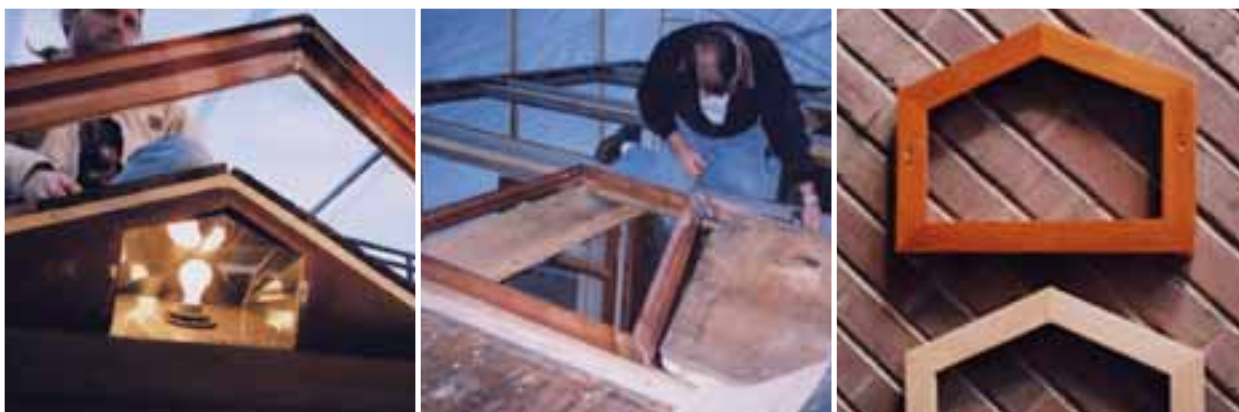
## INSTALLING SKYLIGHTS

The photo on the left shows Stafford on the roof as new skylight is being fitted. The middle photo is Steve Johnson of the Rainville-Carlson company test fitting a skylight frame.

The last photo is of the Cypress frames for recessed skylight fixtures. One frame was missing and needed to be recreated to match originals.

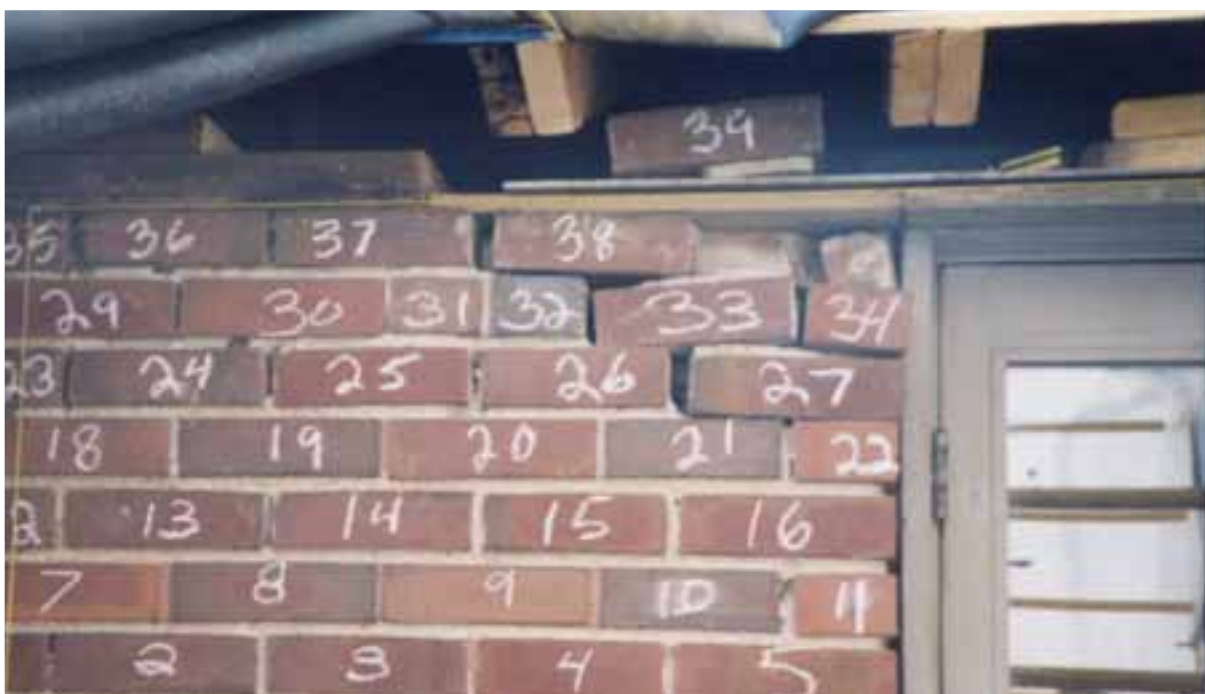
## STEEL LINTEL

Steel "L" extending over guest bedroom door opening.

Bricks were carefully numbered to be reset in new mortar.

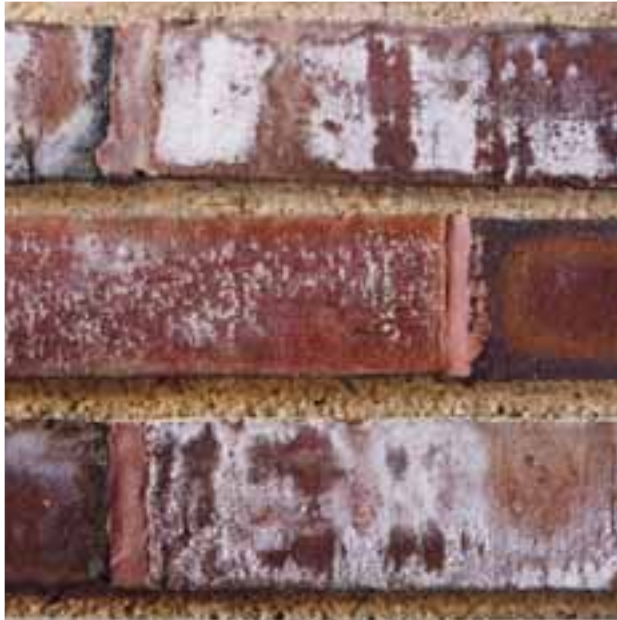
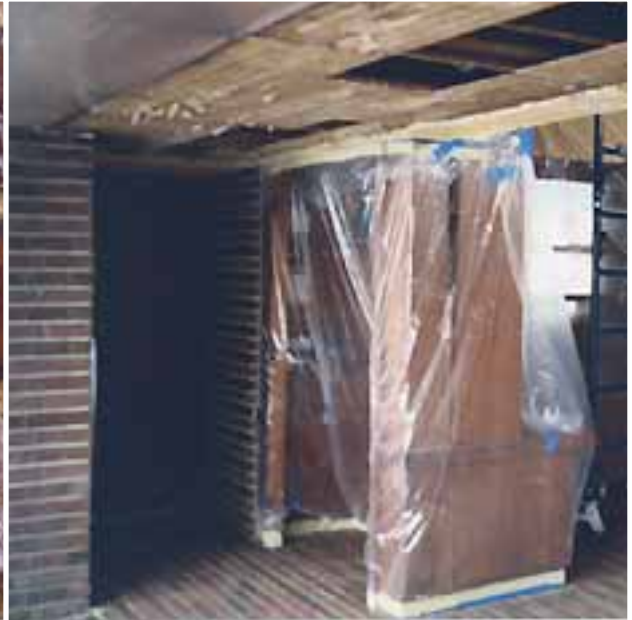
## PIT WALL

Radiator pit wall before (left) and after (right) cleaning.

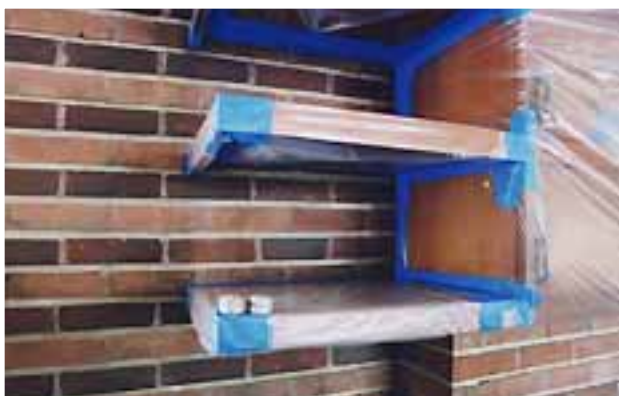
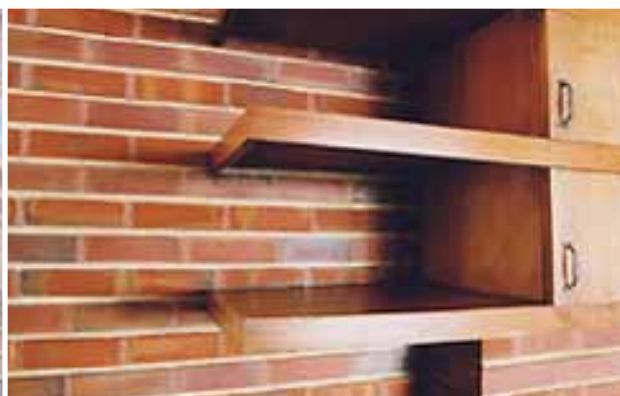
## DINING ALCOVE

Dining alcove wall before (left) and after (right) cleaning.

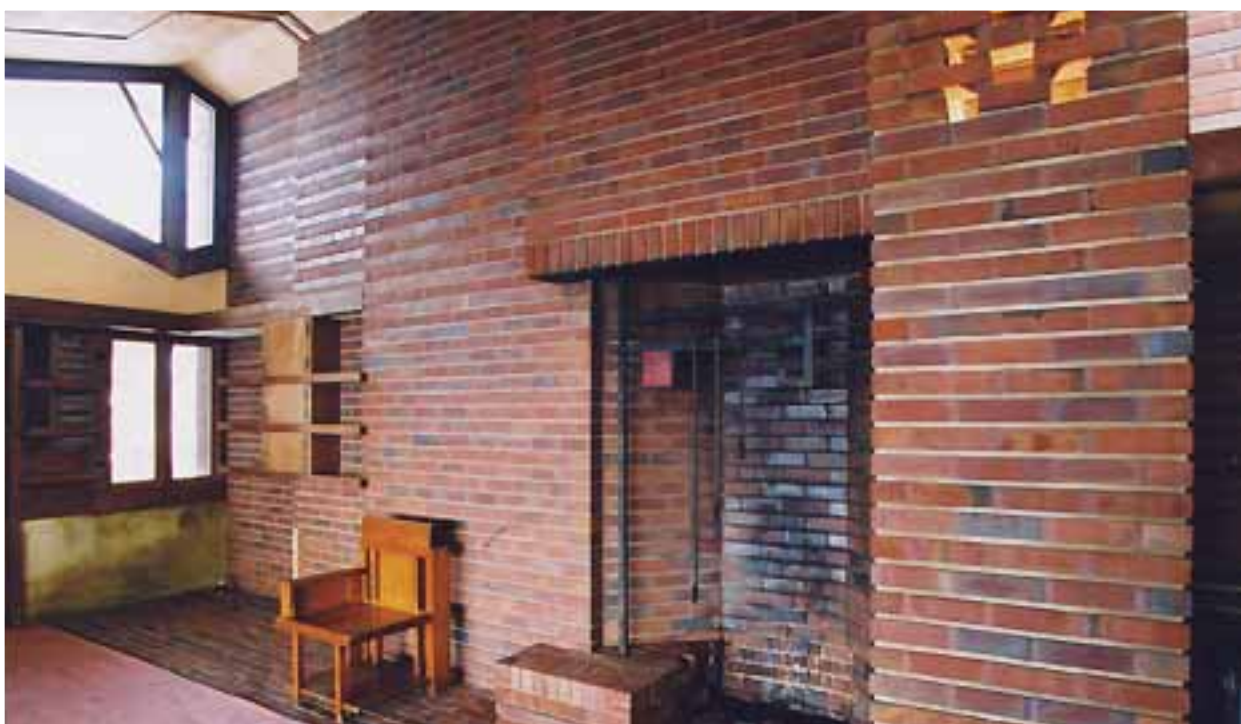
## LIVING AREA

Living area after brick cleaning. Note the alternating bands of brick next to the kite window. The striping effect of the Willey House brick seen in early photos was due

to a textural change from shiny Twin Cities Shale Brick to matte Menomonie Common Sand Mold Brick.
