WILLEY HOUSE RESTORATION JOURNAL VOLUME 2 ■ ISSUE 2 ■ SPRING 2003 ■ ■ ■

THE STATE OF THE HOUSE SPRING 2003

Exterior brick restoration, returned mobility to the fireplace arm and miscellaneous interior work waiting for warm weather.

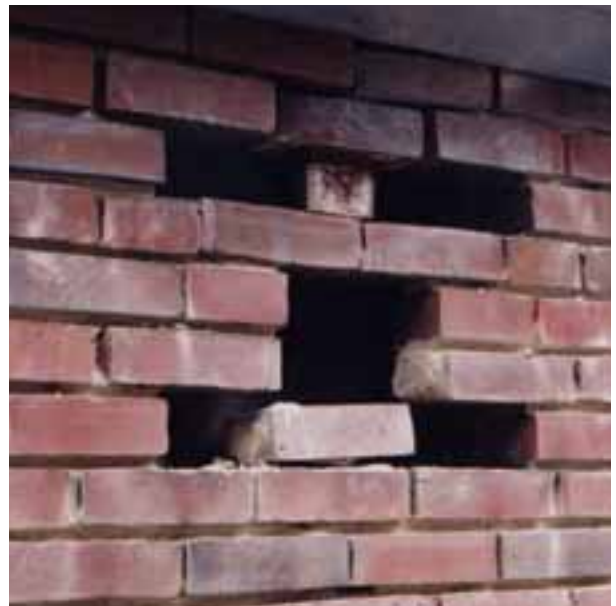
Deteriorated gallery brick screen.

The raked back joints and colored vertical head joints, an acute learning curve even for the professionals.

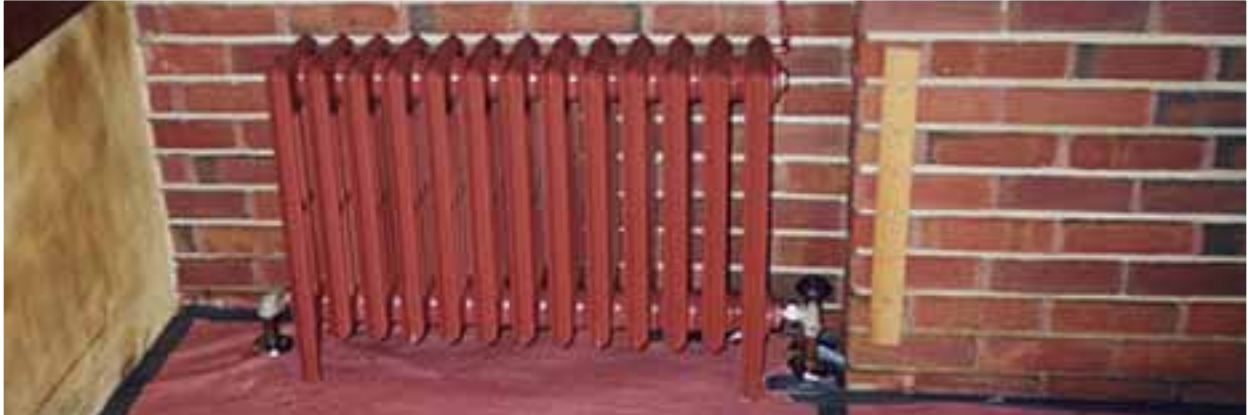
RADIATORS

Sandblasted and primed radiators were repainted to wall color and moved back into place.

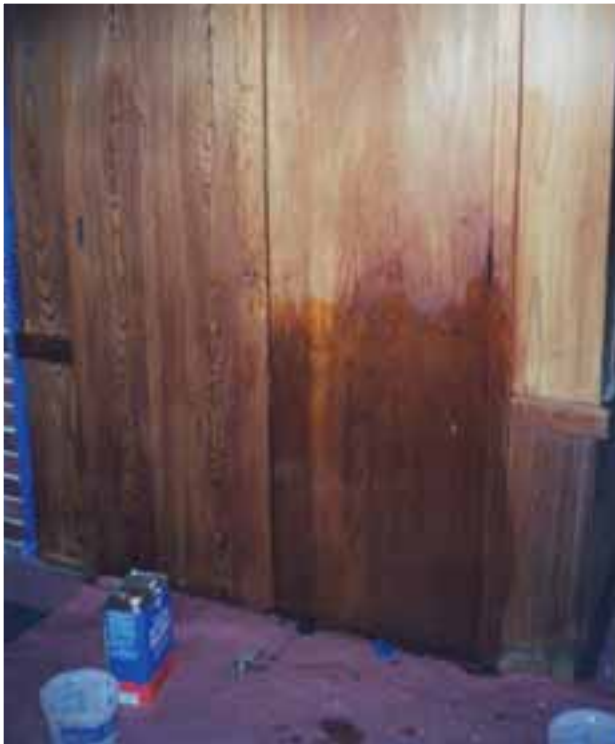
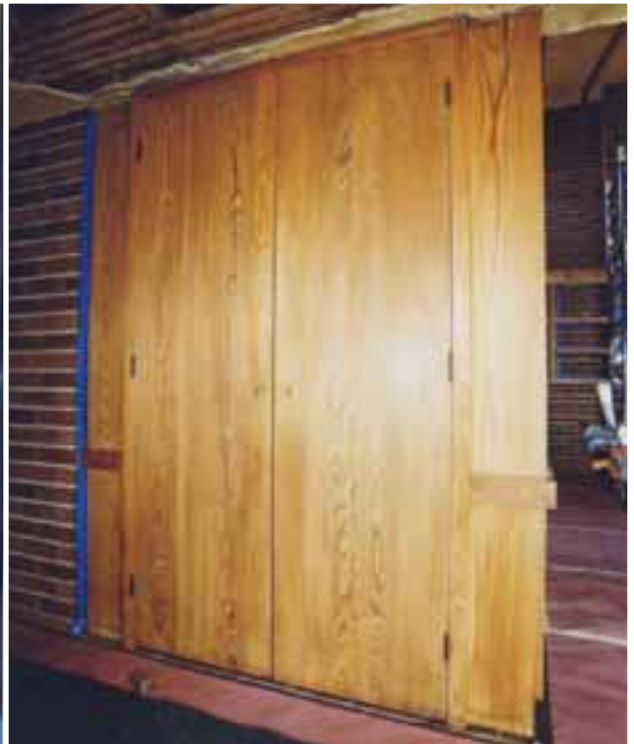
INTERIOR WOOD

Wood cleaning began in earnest, wardrobe closet during and after stripping.

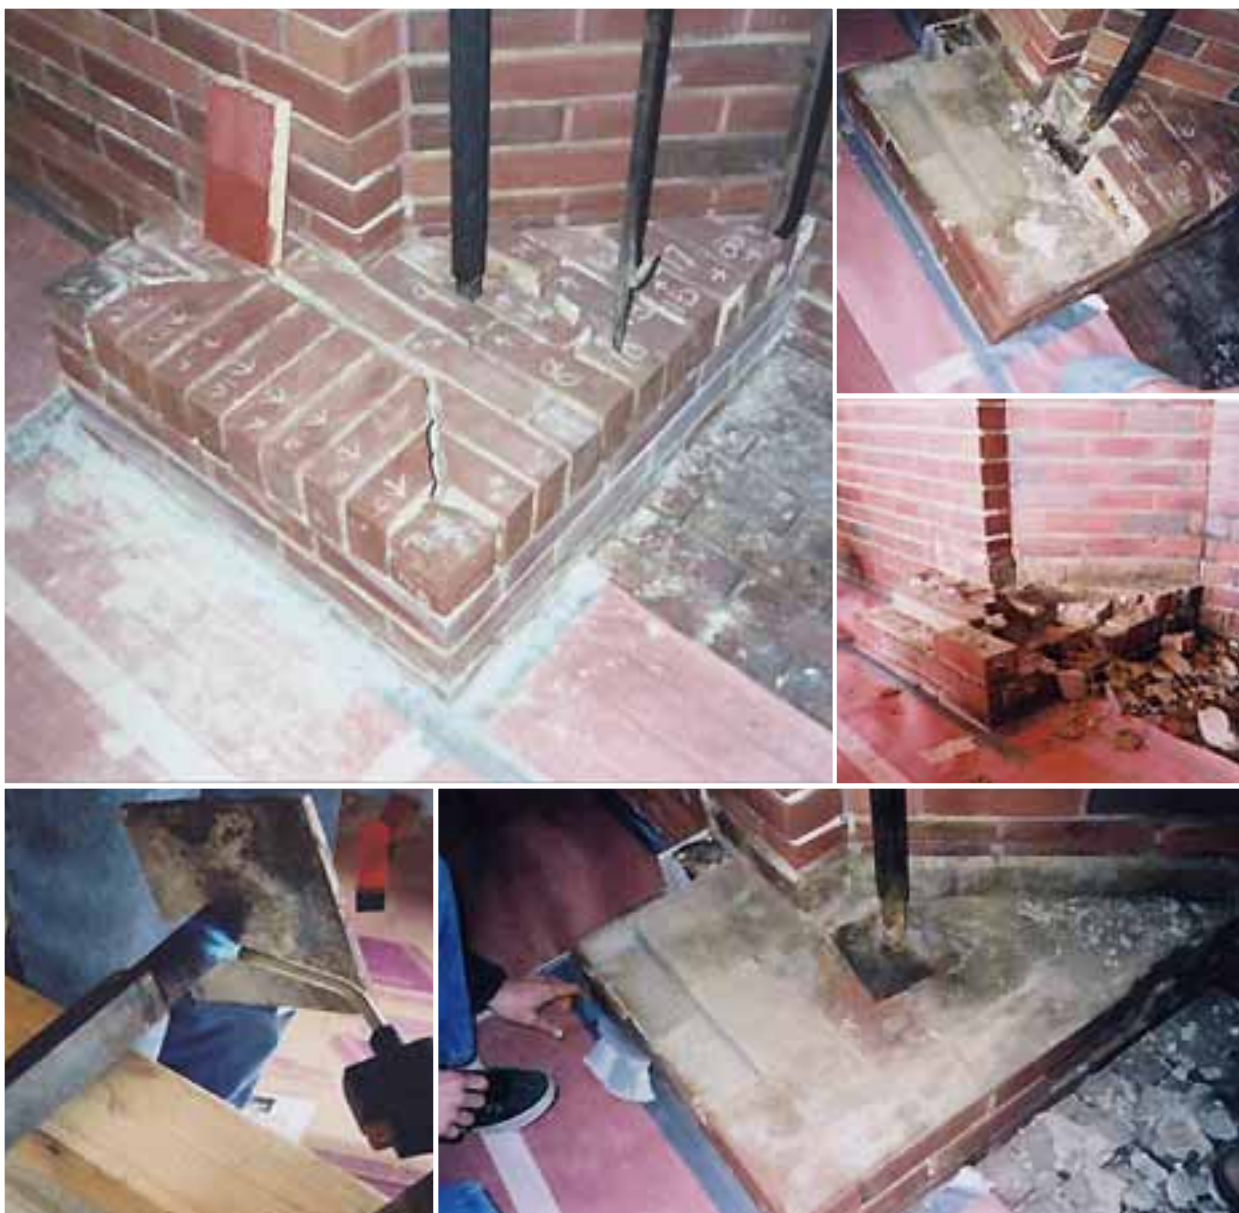
FIREPLACE CRANE AND HOB

Disassembly of the fireplace hob to free up the swinging arm. All bricks are numbered to return to original position. (photo 1). Entire top layer of brick was loose due to torquing action of the seized arm (photo 2). All loose

brick are removed (photo 3). Arm is broken free with a torch (photo 4). Freed arm is reset, bricks to be relayed over Summer (photo 5).

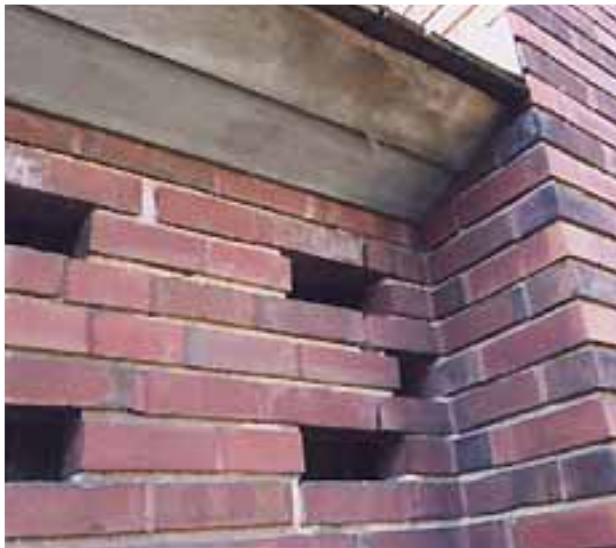
The brick is dirty and discolored, mortar is mismatched from previous repairs and the colored mortar in the head joints is faded to pink, no longer matching the brick (top left). The need for restoration is evidenced here in the missing

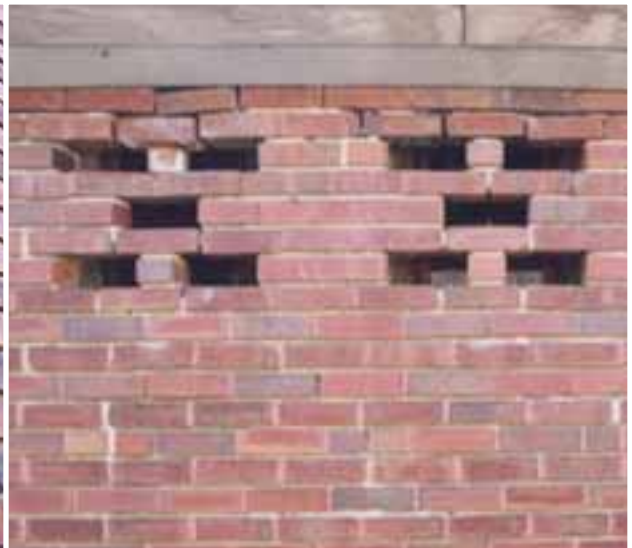
and deteriorated mortar in the gallery window screens (top right). Dirty brick (bottom left). Vertical crack in the garden wall runs top to bottom (bottom right).

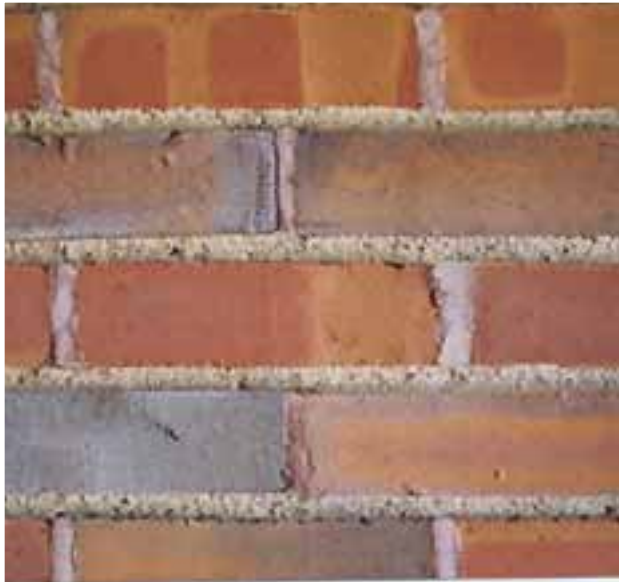
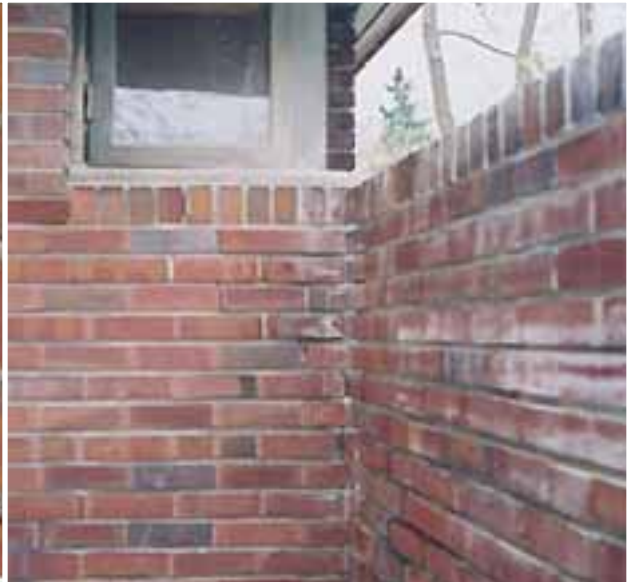
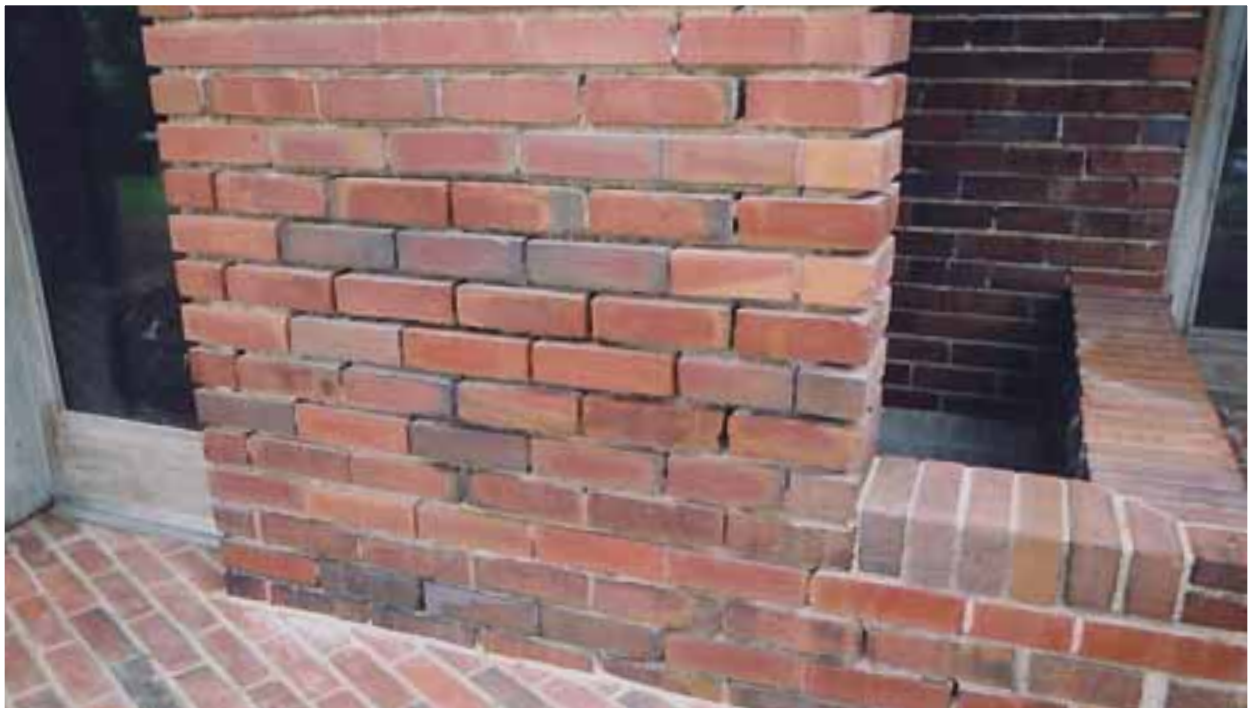
EXTERIOR BRICK CLEANING

Section of exterior brick wall after cleaning (photo 1).
Cleaning highlighted weak mortar and necessary repairs.

Photo 2 was taken at the junction of the garden wall and
master bedroom. Photo 3 is of a terrace pier/planter.
