WILLEY HOUSE RESTORATION JOURNAL VOLUME 2 ■ ISSUE 3 ■ SUMMER 2003 ■ ■ ■

THE STATE OF THE HOUSE SUMMER 2003

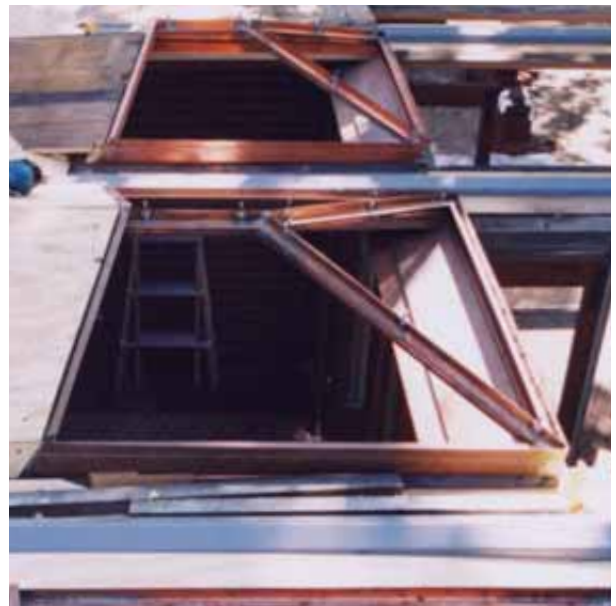
Newly installed skylight frames.

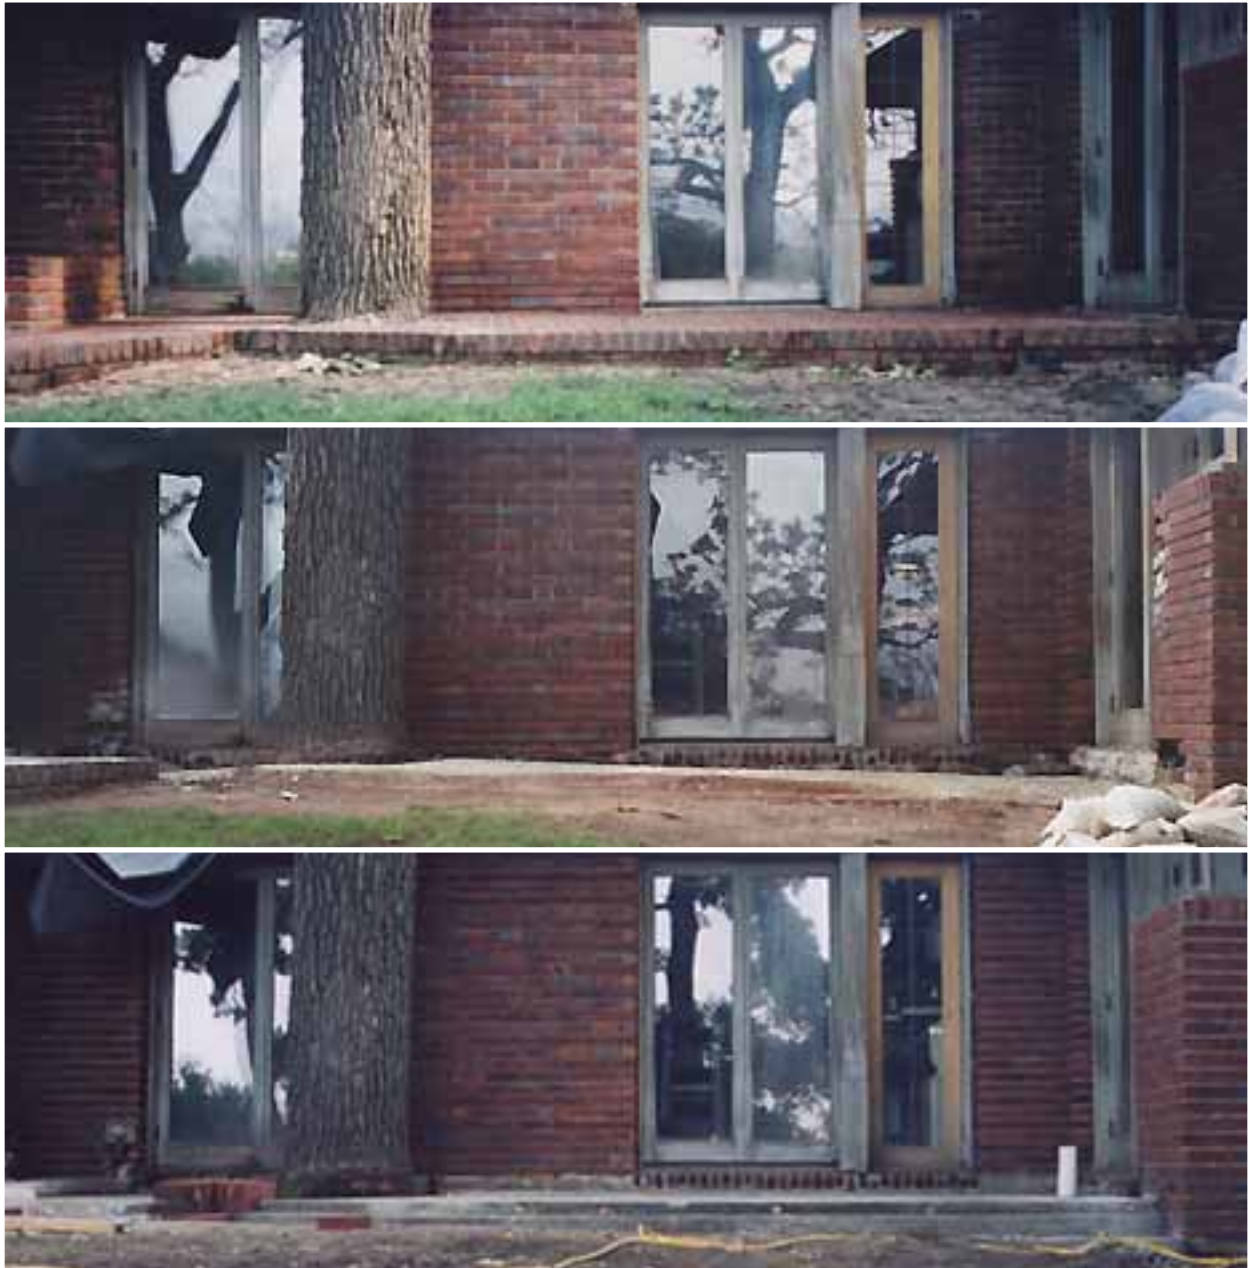
REBUILDING THE BEDROOM TERRACE

Terrace before tear out (top). Slab after tearout (middle). Note the angle of the original slab. It was probably affected by the large Burr Oak growing through the east

terrace. New slab with drainage pipe and the addition of a previously missing step to the garden (bottom).

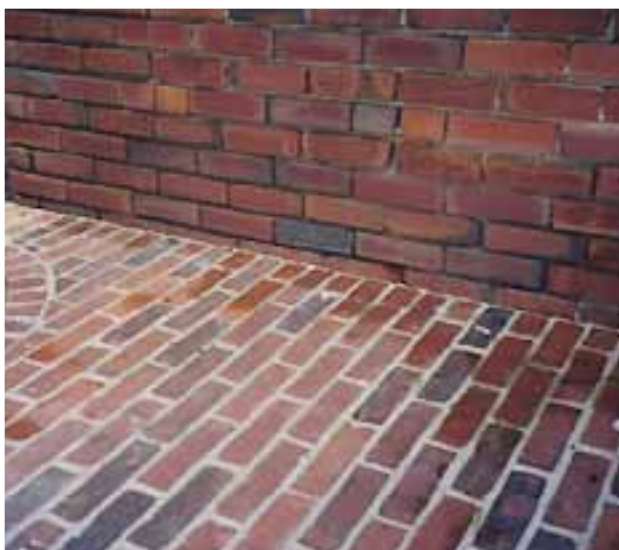
Pitch of brick terrace where terrace meets the wall.

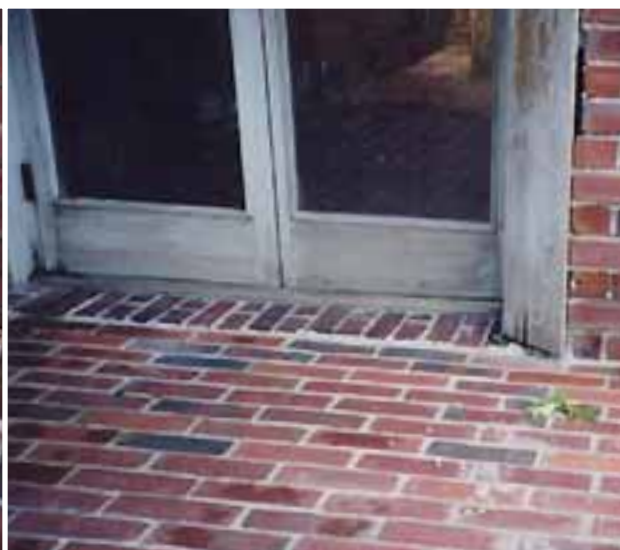
Low thresholds allowed water to enter bedrooms.

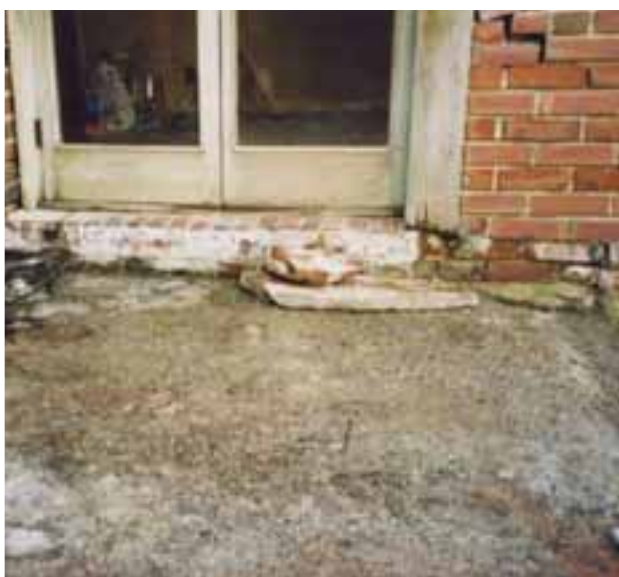
Bricks stripped off the terrace show the original slab in poor condition.

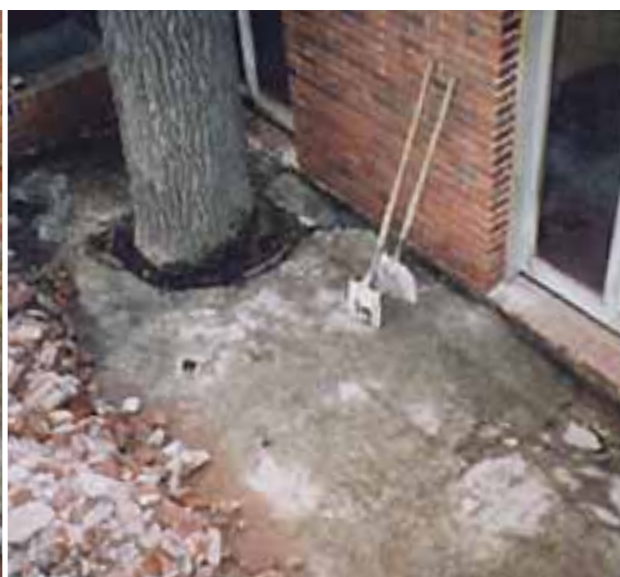
All brick removed from east terrace.

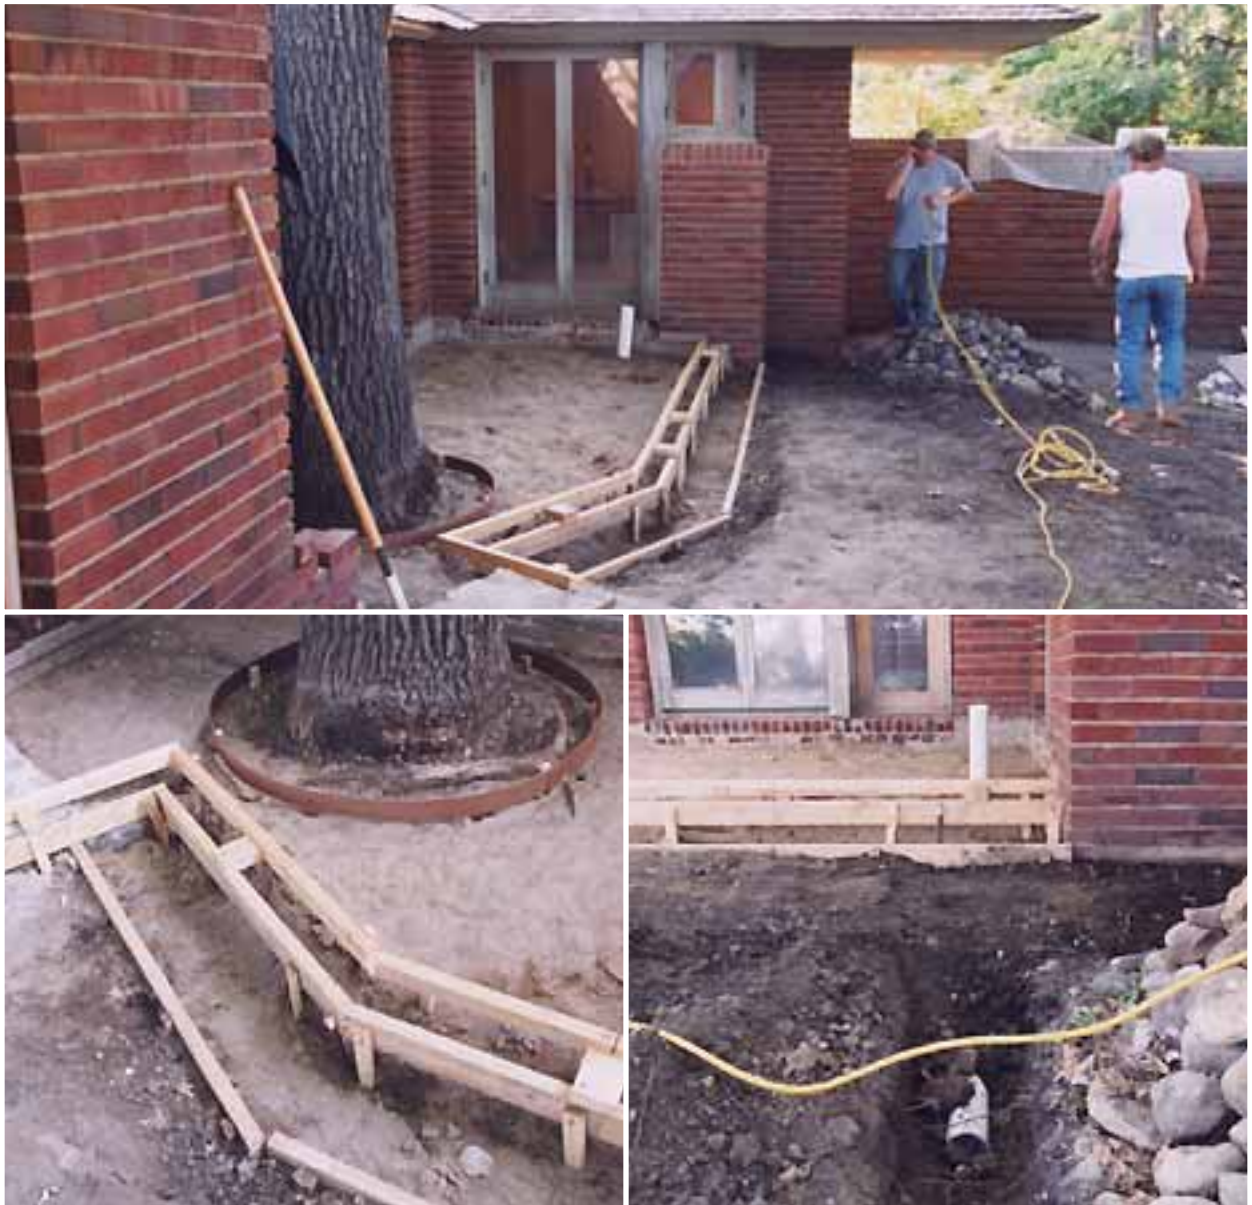
CONCRETE PREPARATION

Photos 1 and 2 show concrete formwork for the new terrace. The drain pipe is visible in photo 3.

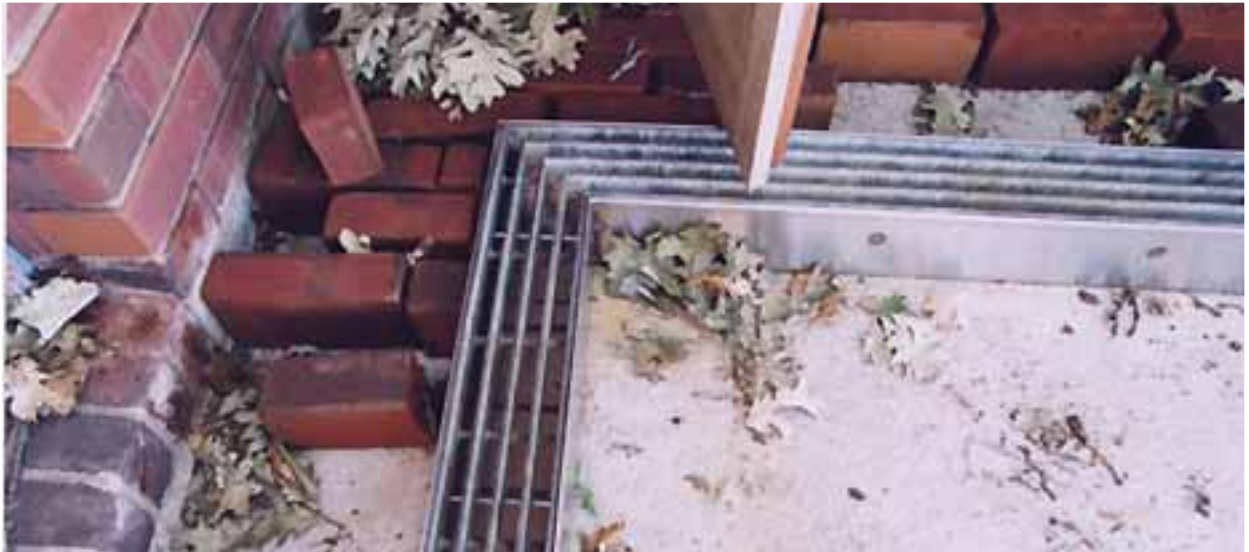
DRAIN TROUGH

Custom made stainless steel drain trough runs in front of study and bedroom doors to diffuse splatter and drain

off standing water.

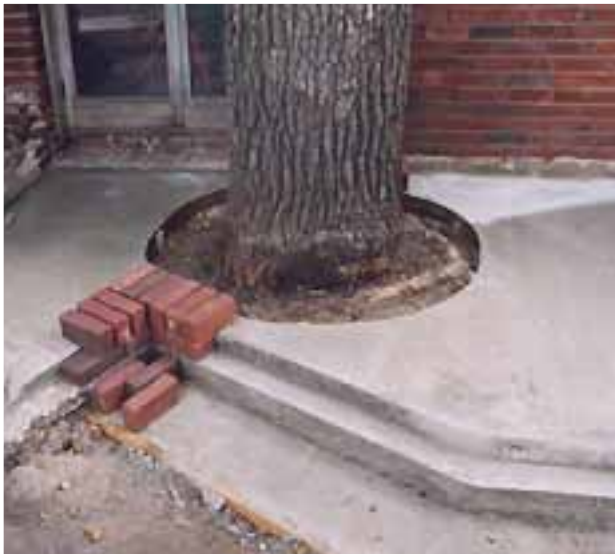
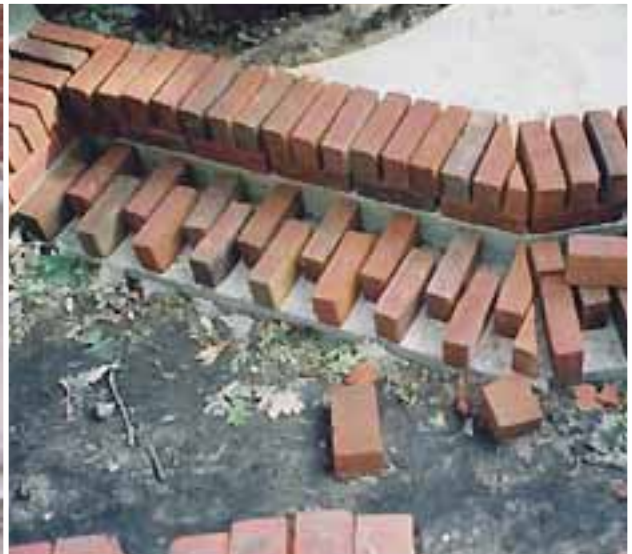
POURED SLAB

Step details.

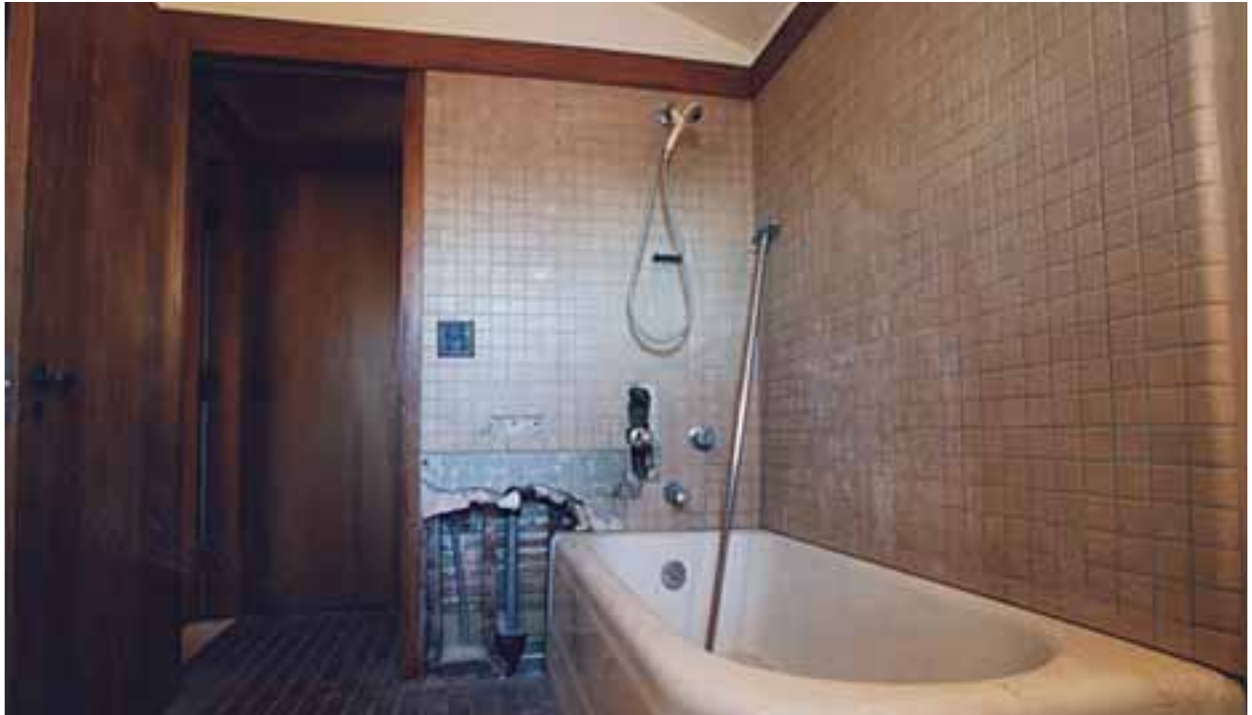
Bathroom pre-demo shows 1970's vintage tile.

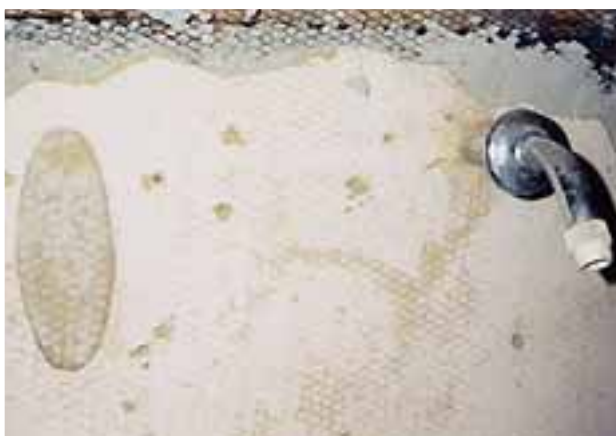
The shower in this bathroom was not believed to be original. However, the original cement plaster wall under the tile shows the ghost of the shower rod plate.

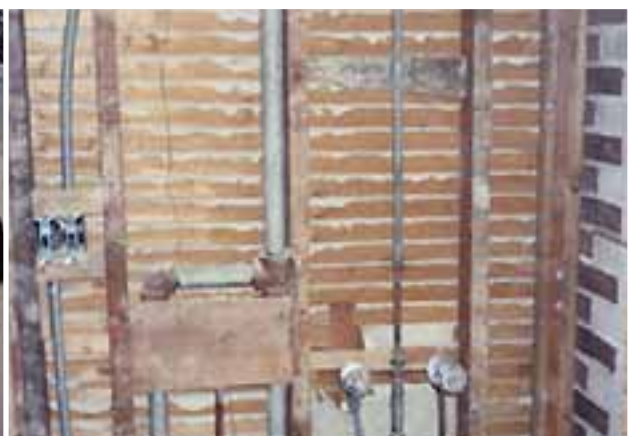
Plumbing for the shower head was held in place by a wooden brace that appears to be made from a piece of construction scrap.

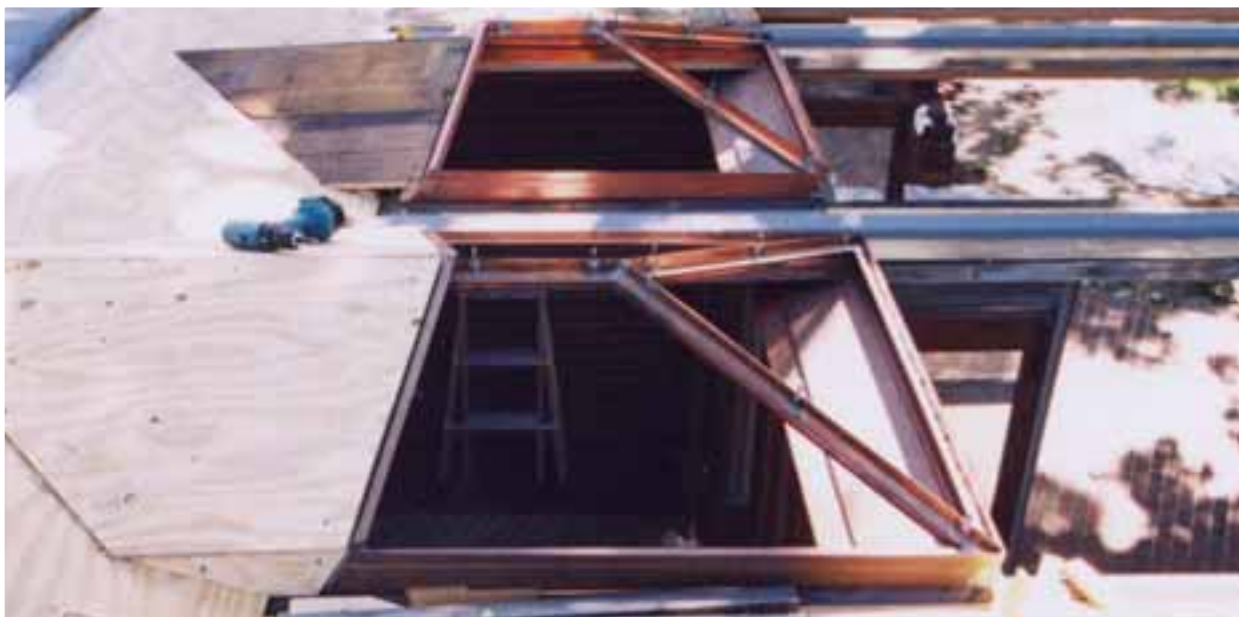
NEW SKYLIGHTS

Wood crickets are built up to the height of the new skylights.

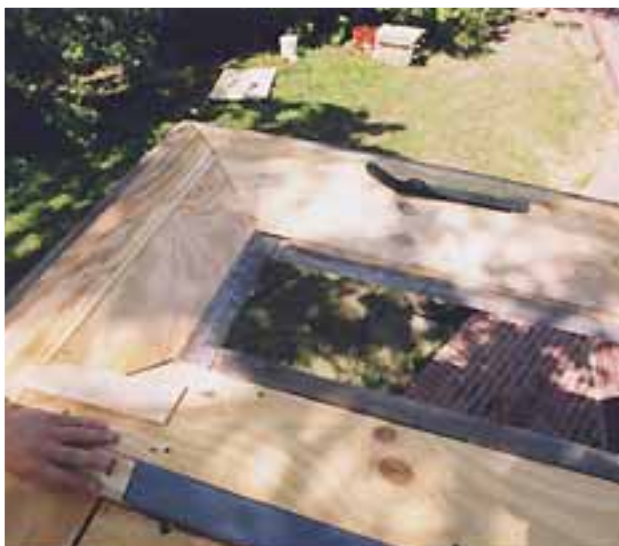
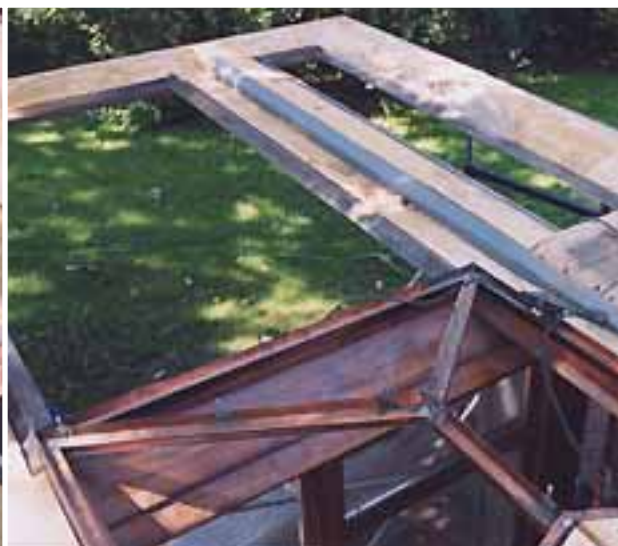
Completion of the plywood underlayment on the trellis.
