WILLEY HOUSE RESTORATION JOURNAL VOLUME 3 ■ ISSUE 1 ■ WINTER 2003-04 ■ ■ ■

THE STATE OF THE HOUSE WINTER 2003 - 04

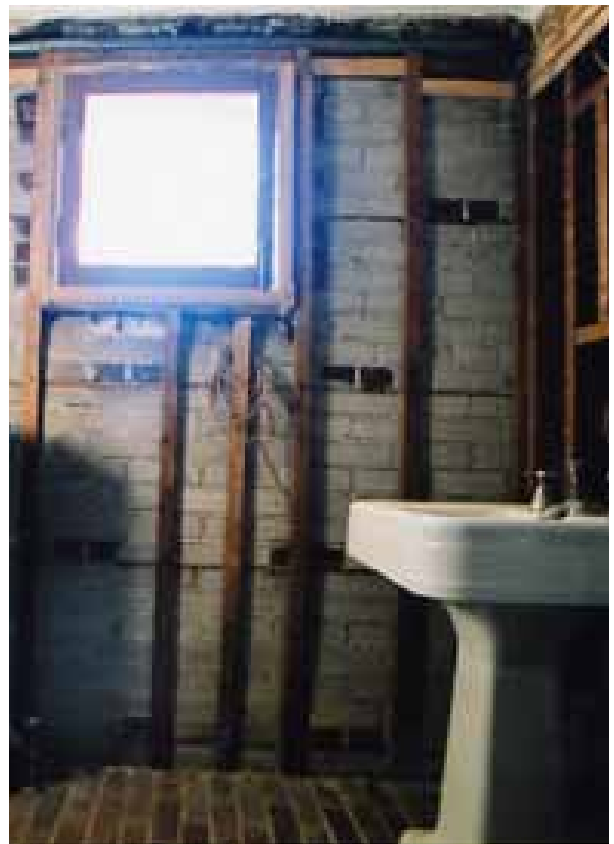
East bathroom wall. Notice the use of cement brick hidden inside the wall, punctuated by red tie bricks.

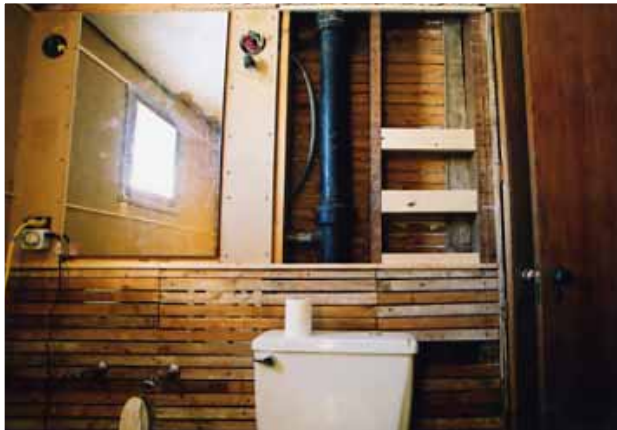
South bathroom wall stripped of plaster.

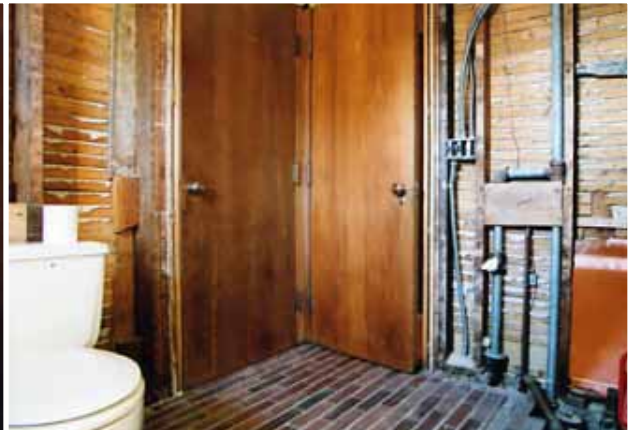
West bathroom wall. Note plumbing for small sink next to tub on the right side of the photo.

sink was cracked and missing a drain seal and wall bracket and had been placed in an awkward spot to begin with. New plumbing for it was run before the decision to abort was made so it can be installed at some future point if determined worthwhile.

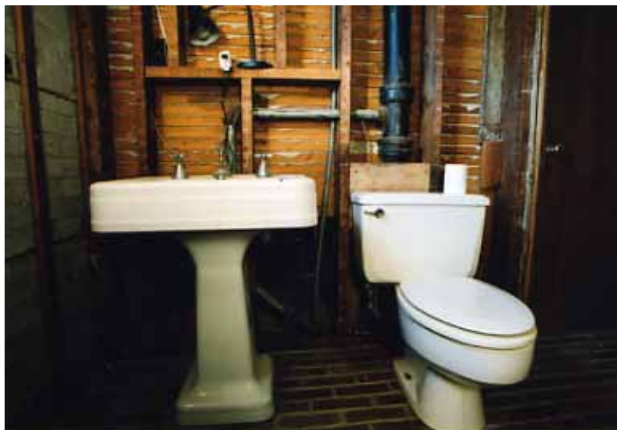
Original sink and replacement stool.

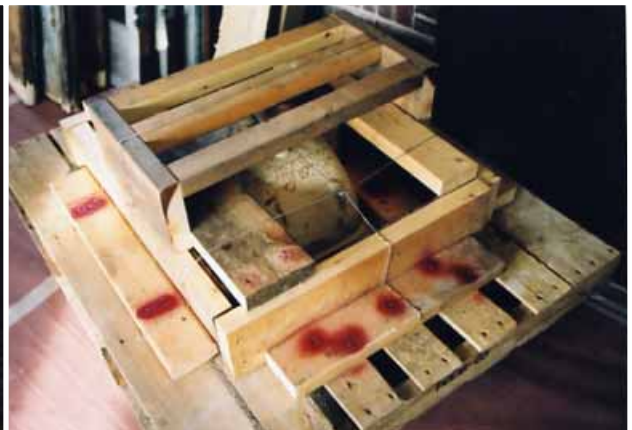
Sink top crated to send off for recoating with porcelain. It is made of cast iron but the porcelain was chipped and worn through. The Bathtub, in a similar condition and was sent to be reporelained also.

As winter turns to spring a re-porcelained tub is safely back in place, a vintage replacement Crane pedestal sink has been secured and all the bath hardware restored or replaced with matching vintage Crane parts.

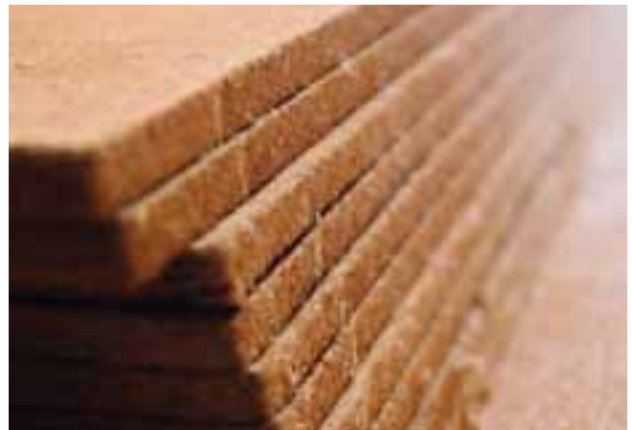
A match to the original fiberboard used in the house. The original was called "Insulite" and was donated by the manufacturer.

Stafford located some ceiling banding strips in the garage, that they are a complete and matched set that fit directly into place on the bathroom ceiling. A match to the original "Insulite" fiberboard insulation was found and installed. Access panels were added behind the sink and tub. New plaster with integrated raw sienna tint and a sienna tinted cement shower surround are being applied as this is being written. 📷

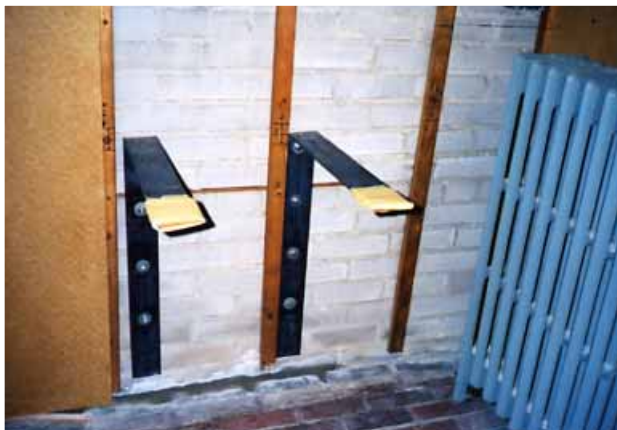
Steel support brackets for the cantilevered vanity table.

Wright's cantilevered vanity, radiator cover and seat are being built along with the addition of a wrap-around mirror inspired by the Taliesin guest room bath to open up the cramped space and create the illusion of spaciousness.

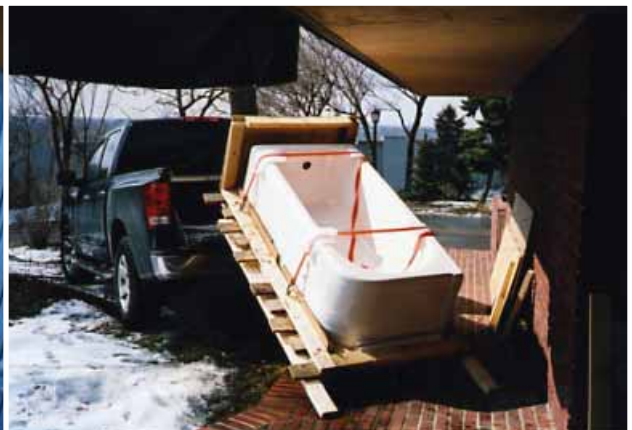
The return of the restored bathtub.

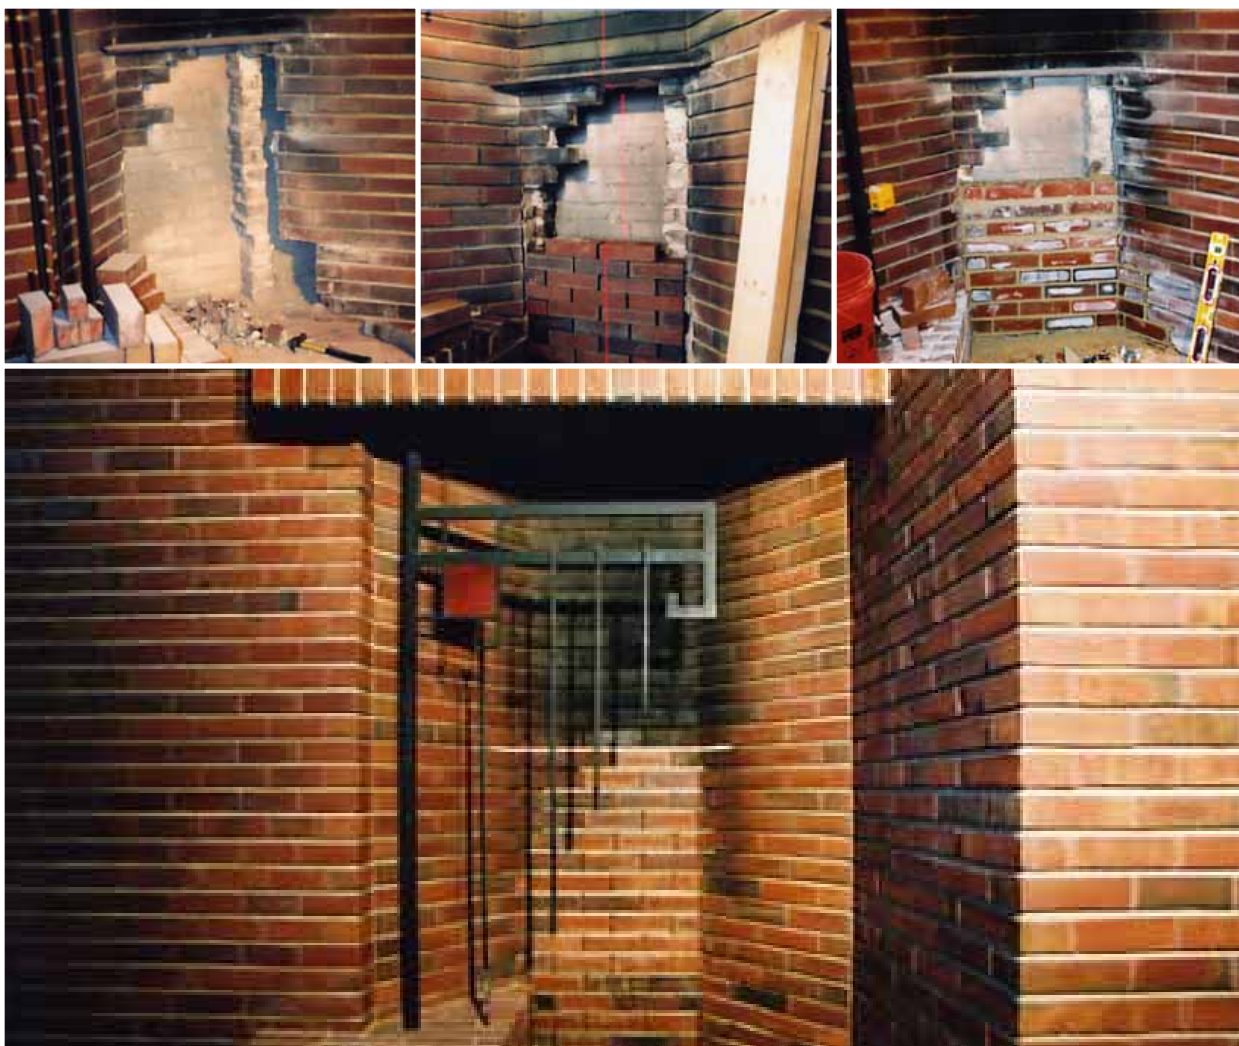
Spawled and broken bricks in the fireplace were removed. Custom-made replacement bricks were cut to size and placed for fit. Custom brick being mortared into place. The fireplace with new brick in place. The joints have yet to be tinted to match the smoke stained originals.

New brick was custom made for the fireplace backing and floor. The old spawled and broken brick was removed and the new laid. All mortar joints were pointed and matched to the originals. The fireplace irons designed to pivot had been seized in position for at least 30 years. When questioned, Russell and Jane Burris the second

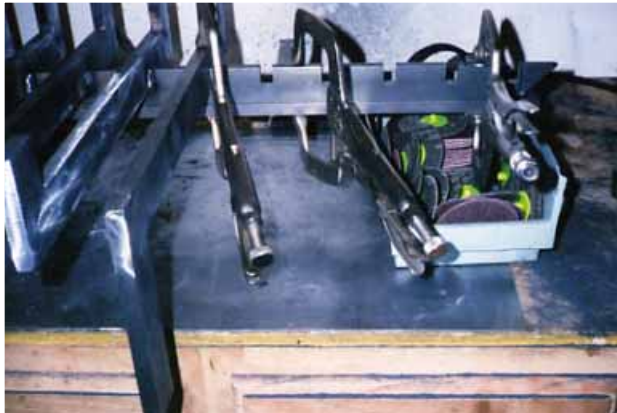
Grate being built by Joshua.

A steel fire grate designed in the grammar of the house was built. Josh cut the 1/2 inch steel on a CNC mill and welded it with body clamps and a square in his garage. The grate continues the musical rhythms of the irons and

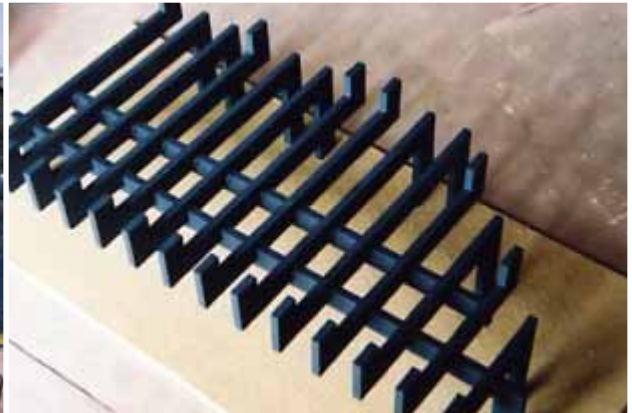
The completed grate (detail)
