WILLEY HOUSE RESTORATION JOURNAL VOLUME 3 ■ ISSUE 3 ■ SUMMER 2004 ■ ■ ■

THE STATE OF THE HOUSE SUMMER 2004

A return to the roof, structural repairs, and modern insulation.

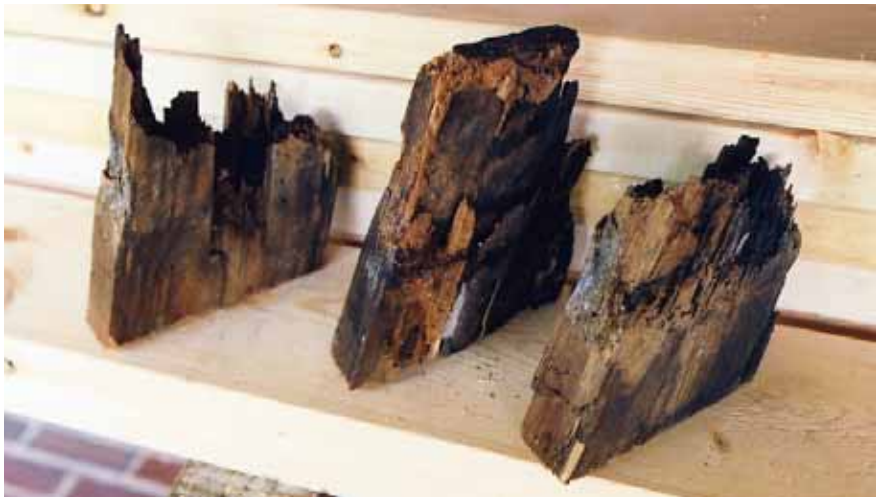
Rotted rafter ends were cut off.

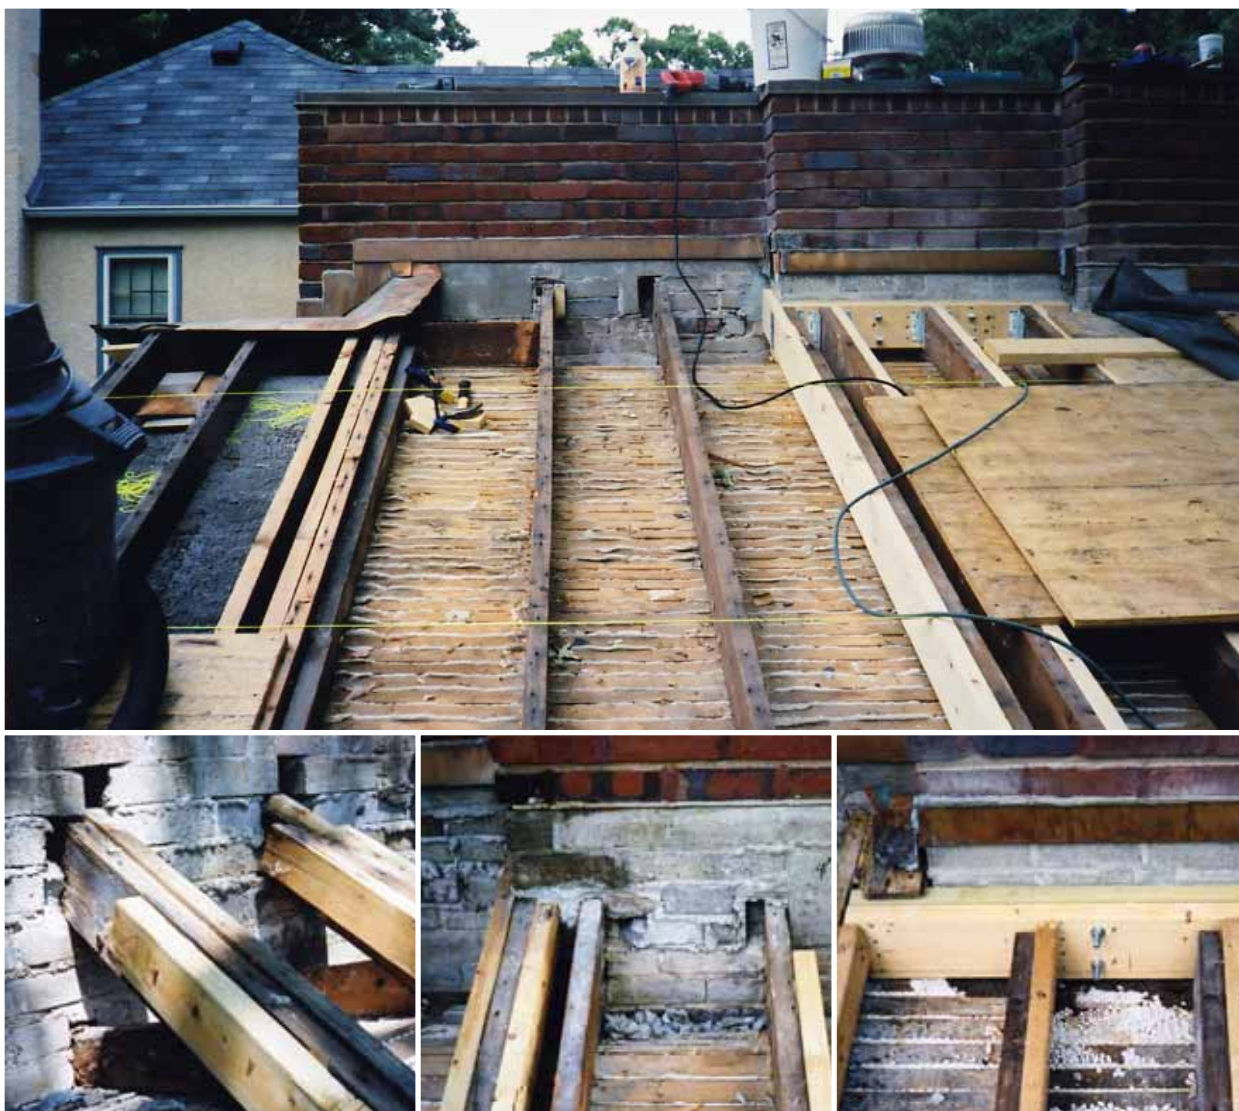
Most of the water problems in the house centered around the chimney mass and the area where the roof tied into the chimney. A copper chimney cap was put on during the first year of restoration. That device prevented the continual seepage into the chimney mass and subsequent moisture leaching through the interior brick. It also stopped water from running down the face of the exterior chimney brick and behind the flashing. The next major leak occurred where the rafters had rotted and slumped at the point they tied into the chimney. The rotted ends of the old rafters were cut off. The chimney was patched and new ledger boards bolted onto the brick mass. The fallen rafters were jacked back up to

Top: the roof as it appeared below the chimney mass when fully exposed. Notice the condition of rafters to the left vs. the repaired rafters to the right. Bottom left and middle: earlier roof repairs; bottom right: final roof repair.

proper position and tied into place. Damaged and weak rafters were sistered together with new ones and securely bolted. The living room ceiling required patching at the chimney after rafter repairs were made.

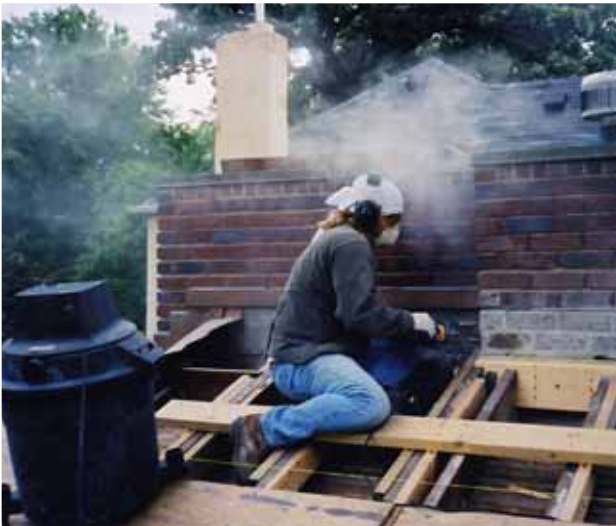
Excess mortar from an earlier chimney repair had to be ground out.

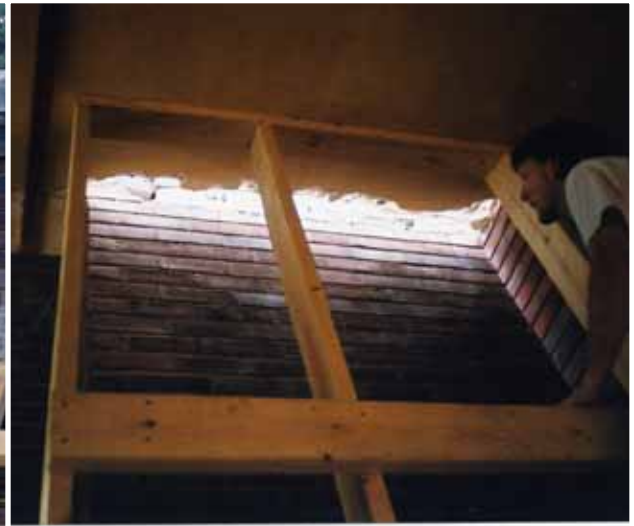
The living room roof and ceiling sagged approximately two inches on the west side. It was jacked up before repair.

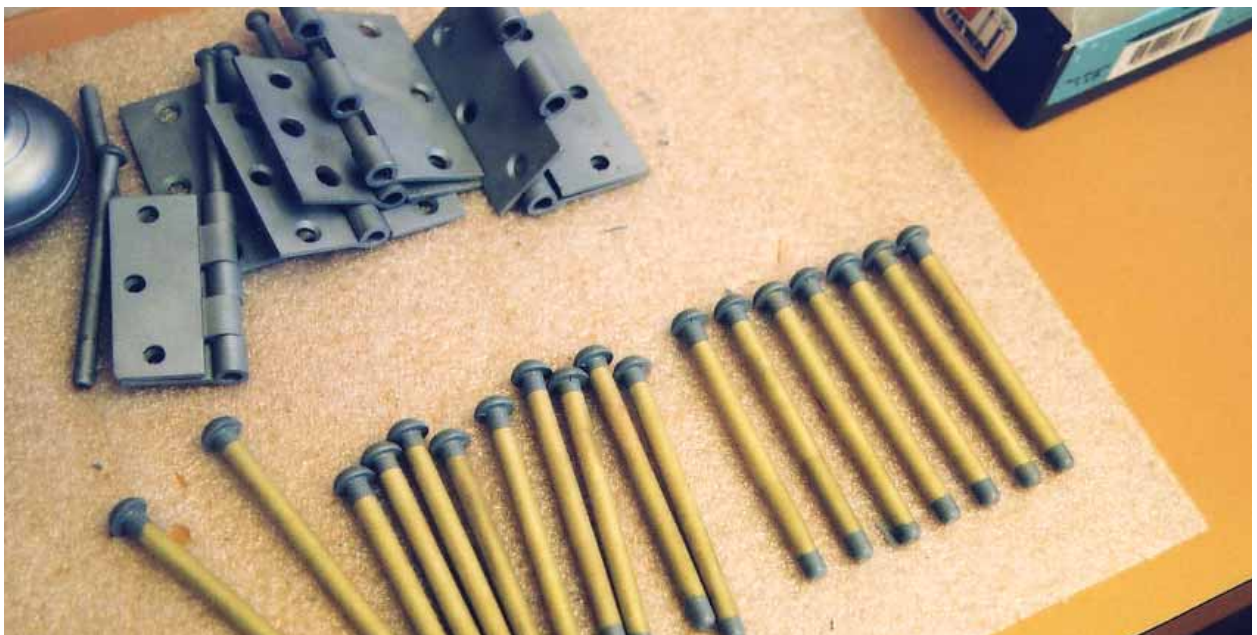
The loose pin hinges on all of the French doors were painted grey. The 70 year old paint failed and the hinges rusted. Before the new doors arrived all of the hinges

were systematically removed, sandblasted down to bare metal and powder coated grey to match the stain of the doors.

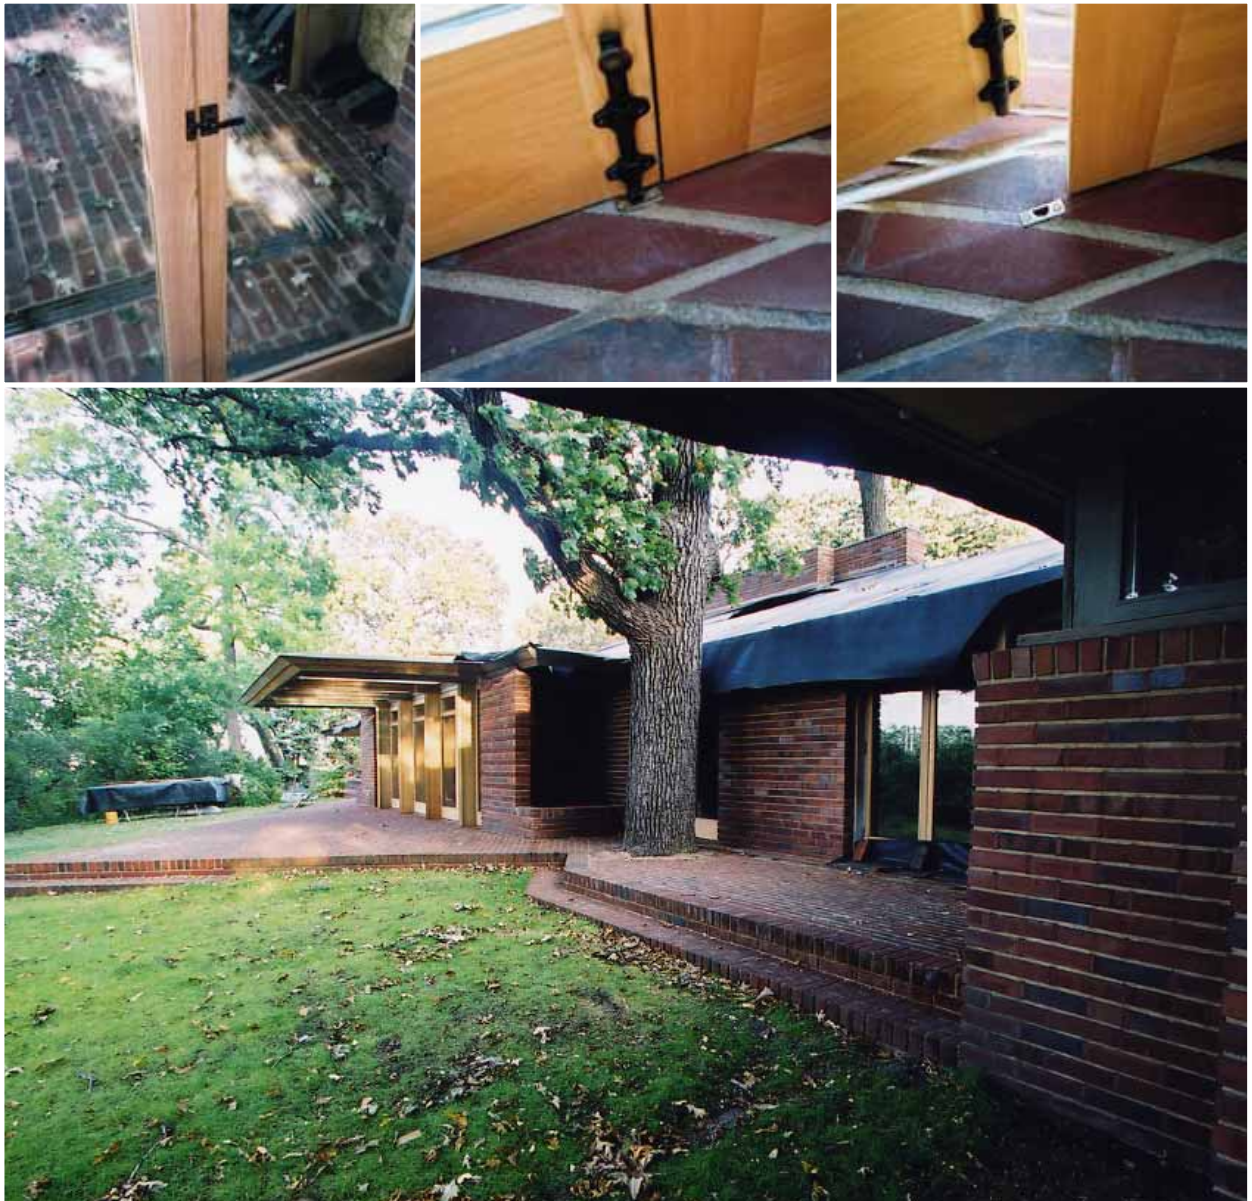
Top left: drainage system seen through the new master bedroom doors; top middle and right: thrust bolts lock into new thresholds; bottom: the house exterior begins to take shape.
