WILLEY HOUSE RESTORATION JOURNAL VOLUME 4 ■ ISSUE 1 ■ WINTER 2004-05 ■ ■ ■

THE STATE OF THE HOUSE WINTER 2004 - 05

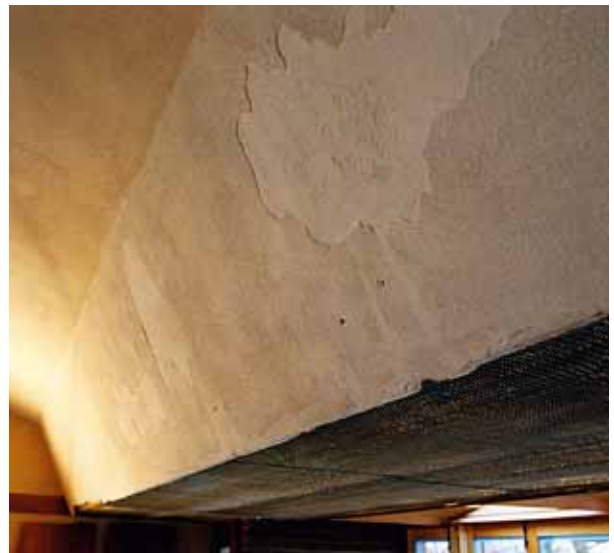
The cathedral ceiling rises from 6' 8" to 13'. A persistent leak over the years near the chimney mass cracked and weakened the plaster. Roof repairs done last summer have cleared the way for final plaster repair and a fresh skim-coat. To prepare for this the ceiling bands or marking strips were carefully measured, removed and labeled. Many were already marked from earlier removals. A stain preventative paint was applied to the damaged plaster prior to patching.

Loose plaster is scraped away. Kilz stain preventative paint is applied before plaster is repaired and skim-coated.

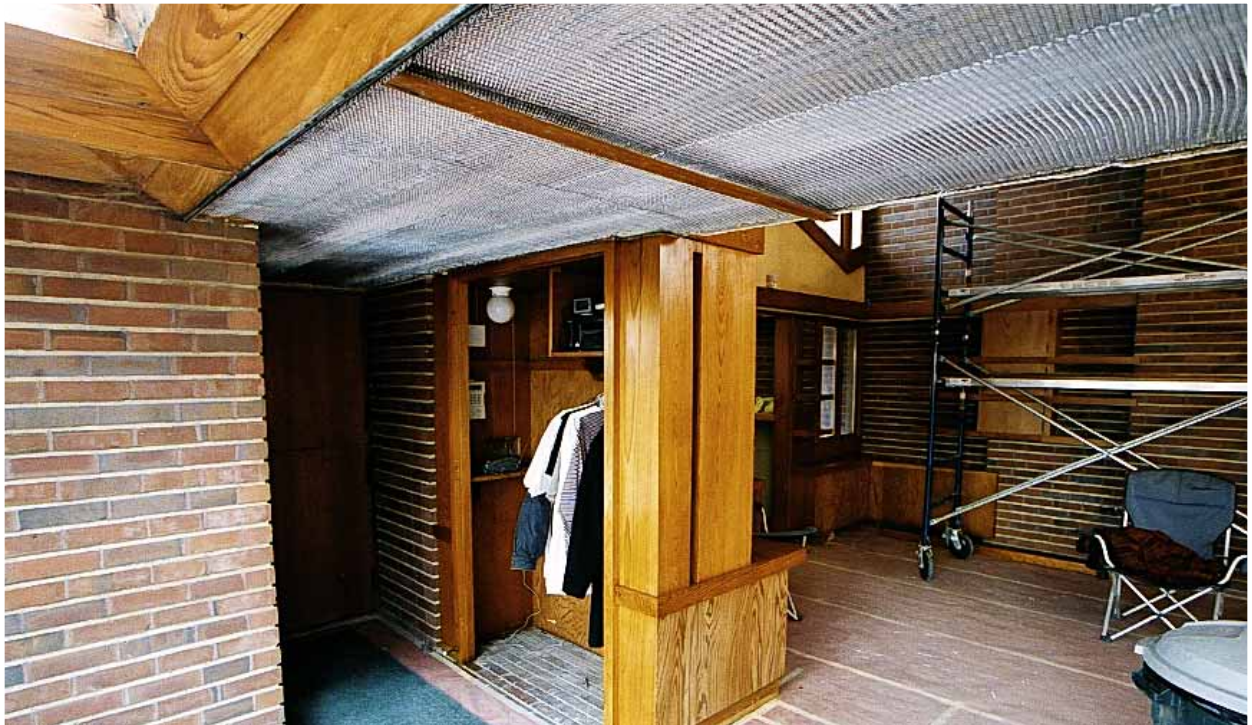
A single banding strip is laid over metal plaster lath to calculate final plaster thickness.

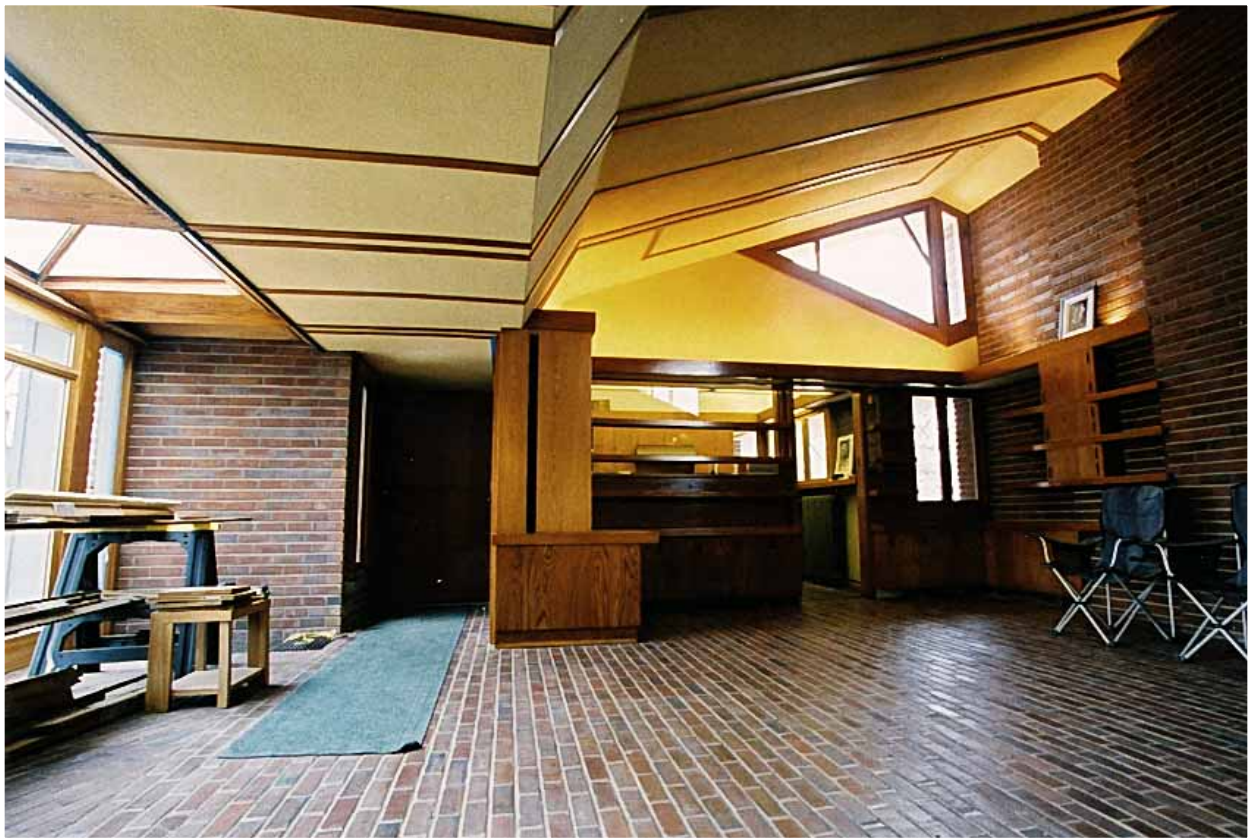
Living room lighting scheme, recessed into decks.

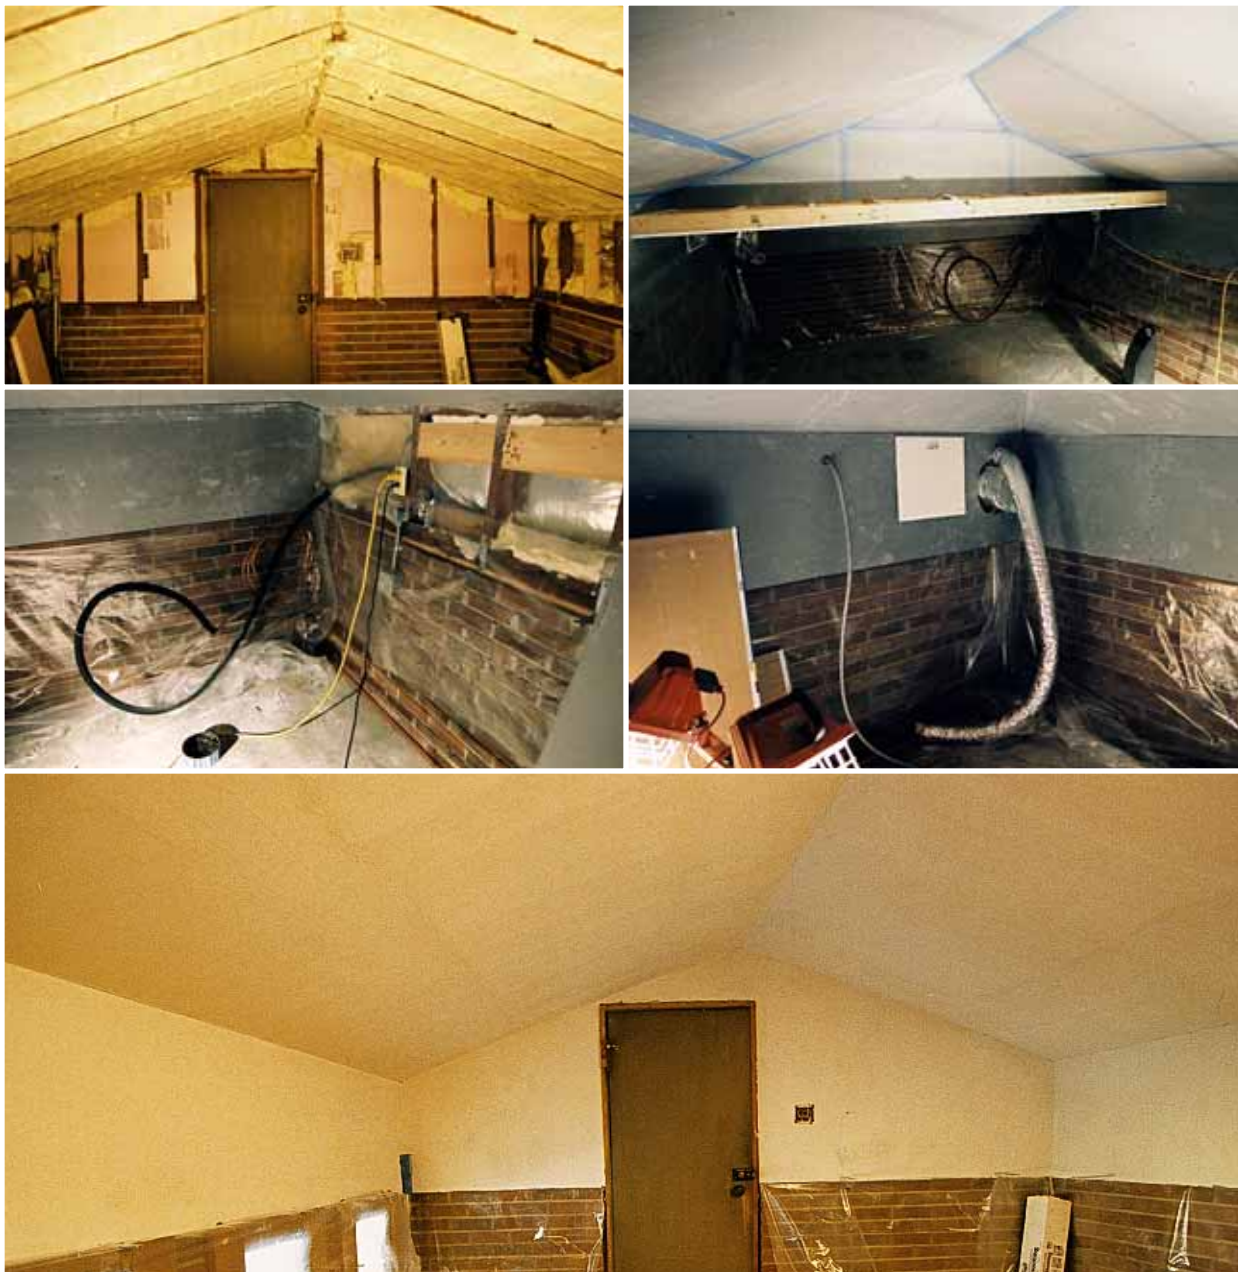
Top L: The unfinished ceiling of the storage room is insulated. Top R: Blue board up as a base for skim-coat. Soffit deck in position. Middle L and R: Ductwork and mechanicals are in place for the air handling unit. Bottom: Finished plaster.

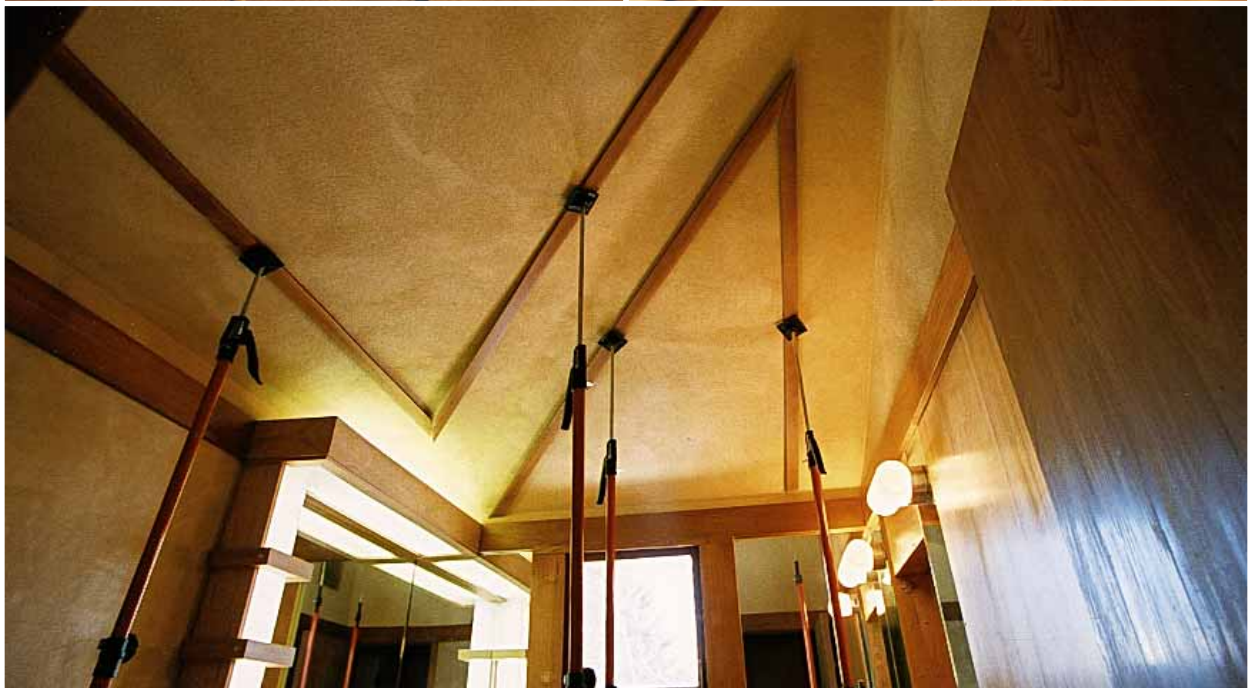
Ceiling marking strips braced into position.

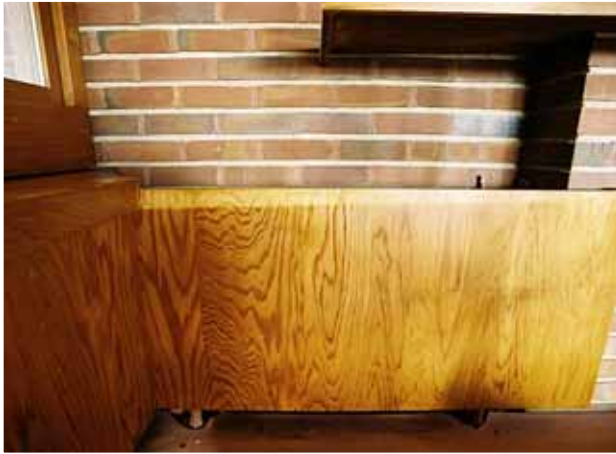
Ghost showing position of top on radiator cover in dining alcove.

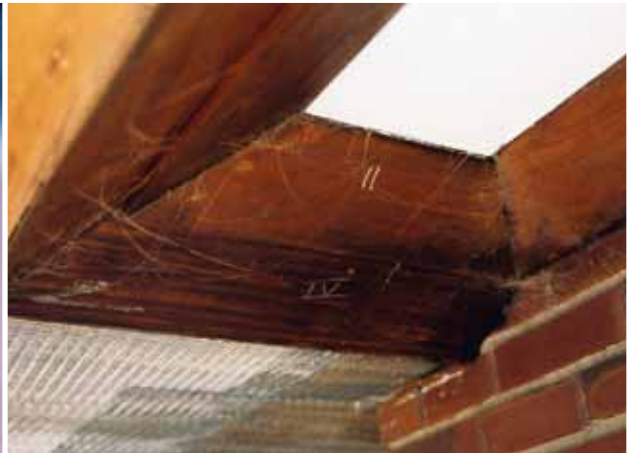
Most wood needed only to be cleaned with alcohol, shellacked and waxed. However, to match new wood to old in situations where the original was beyond redemption, such as below the living room skylights, some original wood needed to be stripped bare and lightly sanded to reach a medium tone that could somewhat be matched to.

An untouched section of trim below the skylights shows ultimate cocoa brown of cypress exposed to direct sunlight.

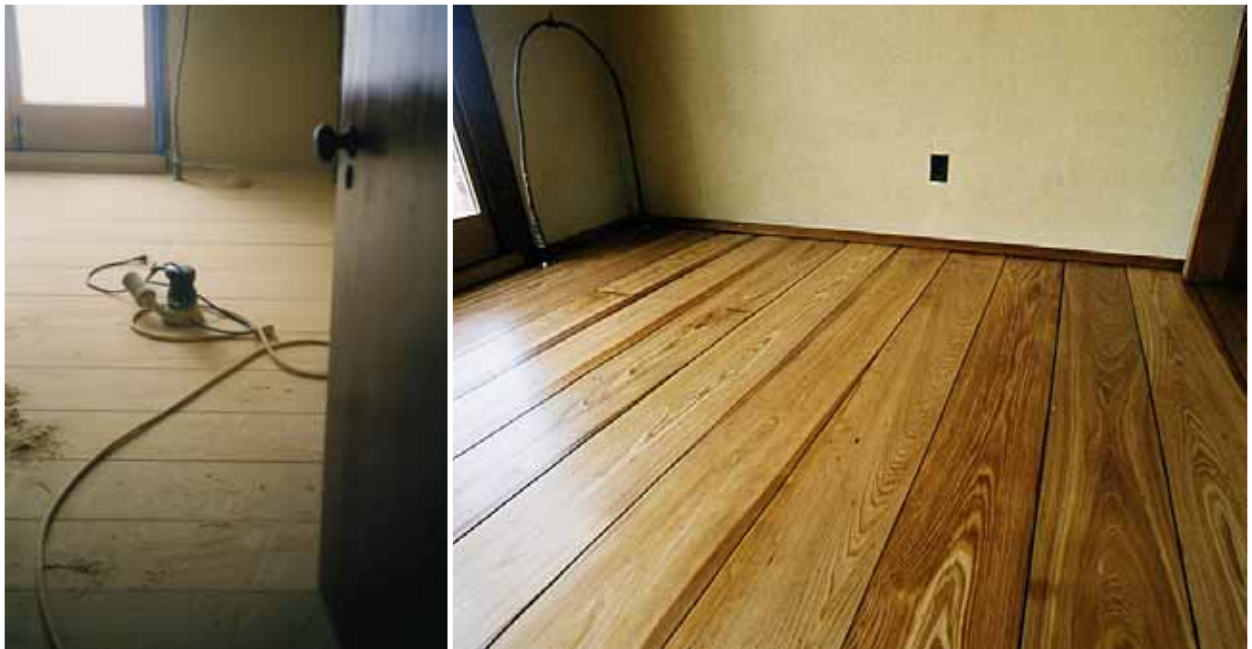
Nailing the ceiling bands and base shoe back in place has given the rooms a feeling of finish to them. Although built-ins and furniture are yet to be constructed, it is evident that real progress has been made. The only two wooden floors in the house, the bedrooms, are both made of 9" wide cypress planks. They had been planed down and protected with rosin paper for the past couple of years. This winter the floors were hand sanded and finished. Good riddance to the rosin paper. 📍

Hand sanding the cypress plank floors.
