WILLEY HOUSE RESTORATION JOURNAL VOLUME 3 ■ ISSUE 2 ■ SPRING 2004 ■ ■ ■

THE STATE OF THE HOUSE SPRING 2004

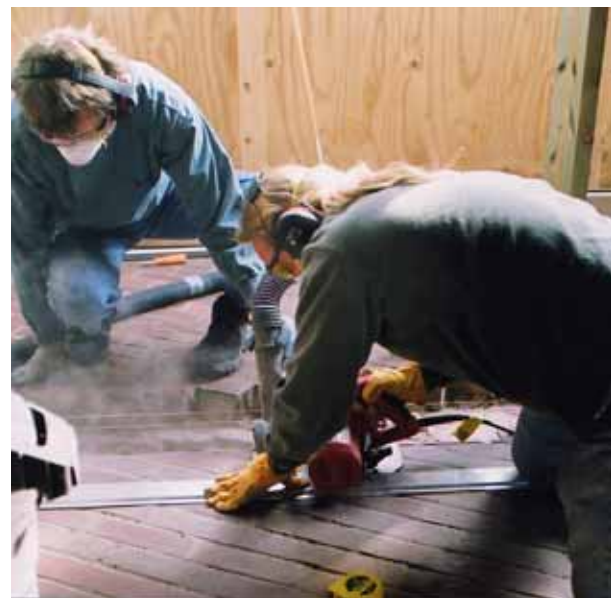
Cutting the living room brick floor to accommodate the new threshold.

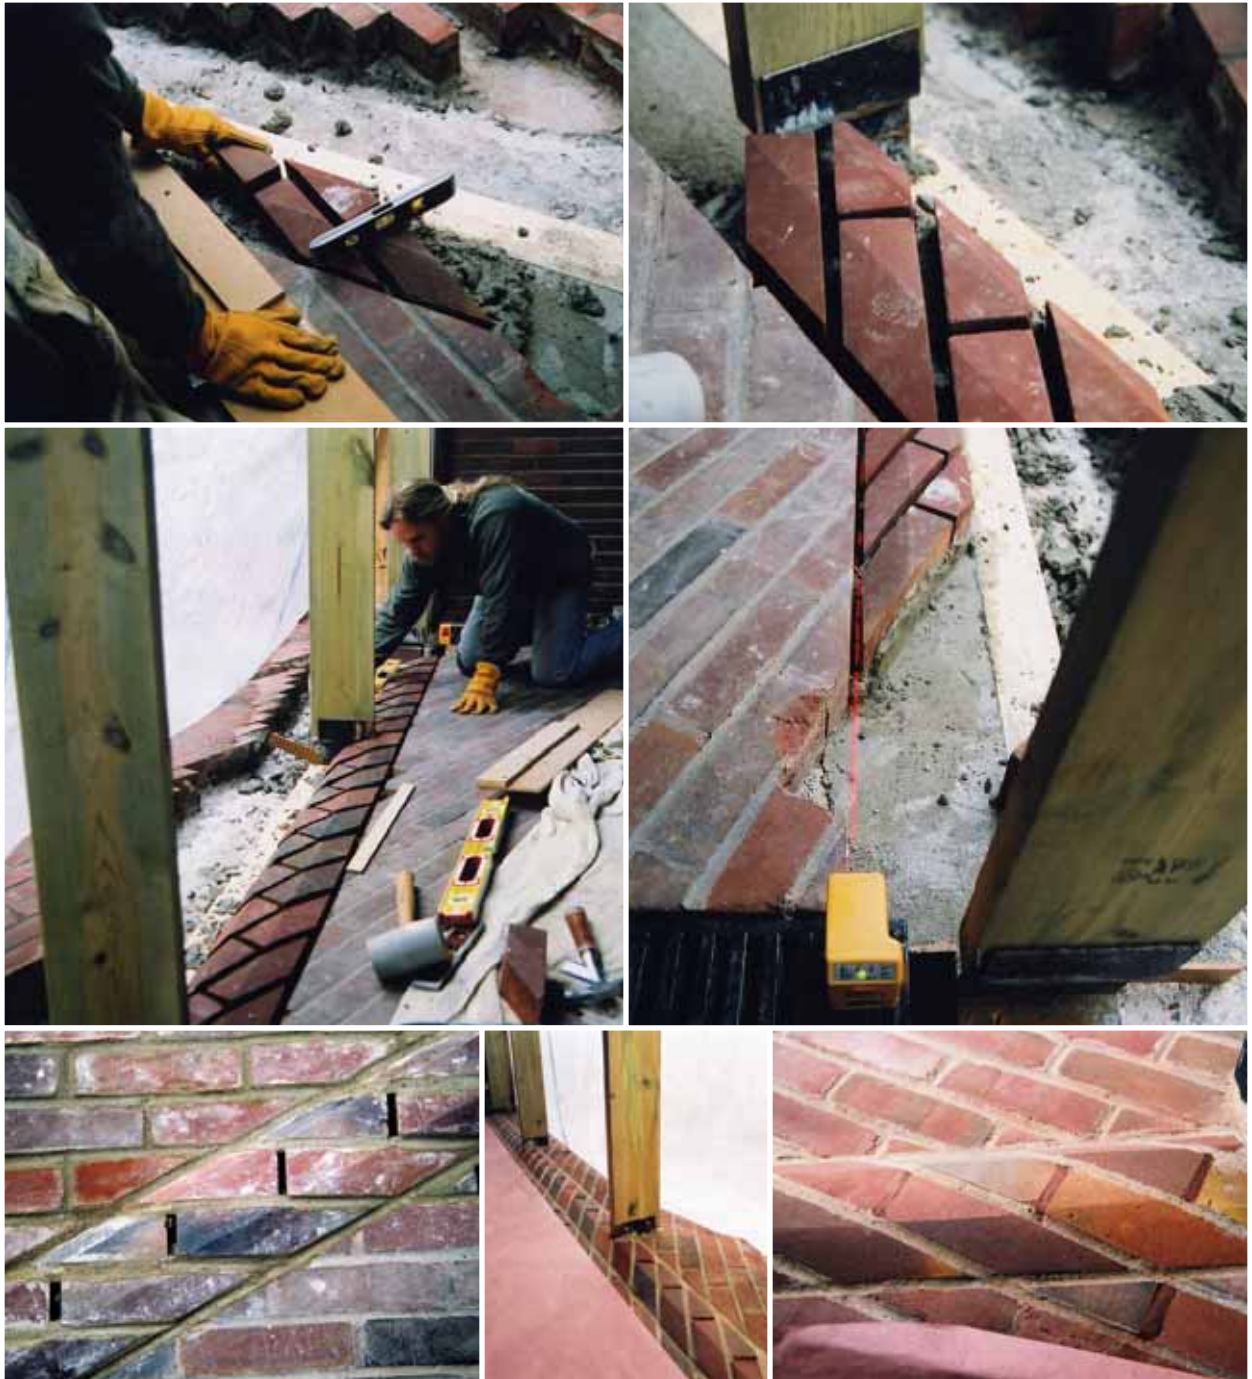
Setting the living room brick threshold. Bricks must be level, plumb and in alignment with the grout lines on the existing floor.

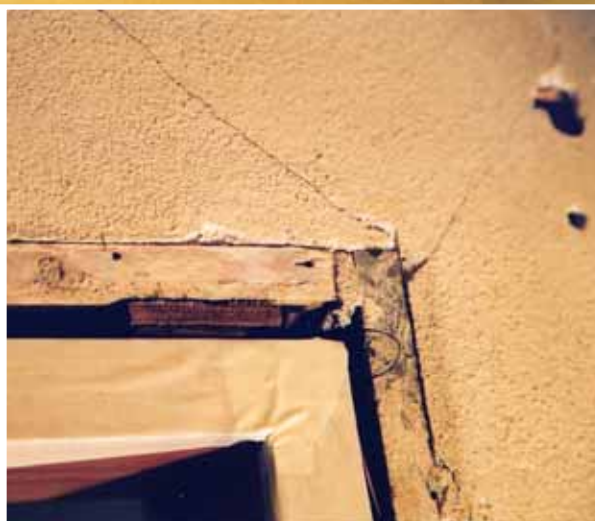
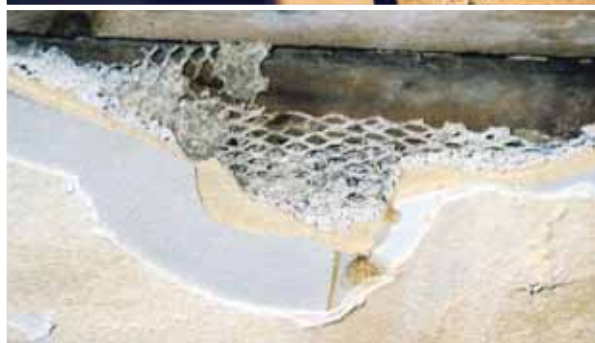
Top: patch of original plaster in the master bedroom closet; middle: original colored plaster on door framing; bottom: layers of plaster showing previous repairs and original color coat.

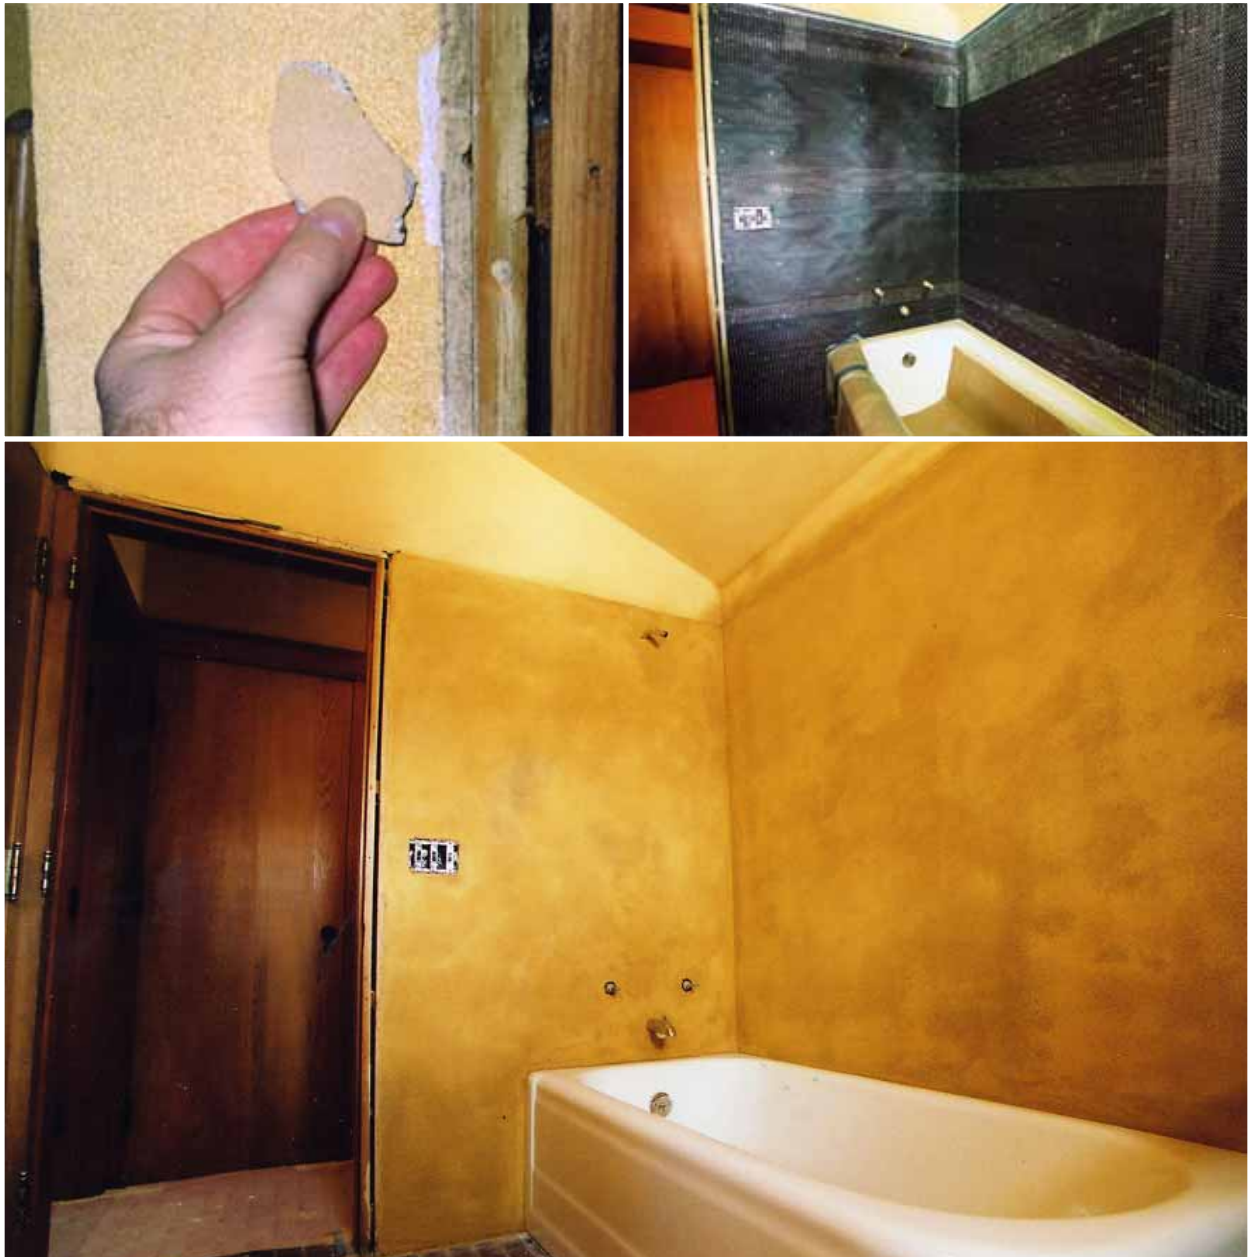
The shower surround is made from a colored cement plaster. The original was a match to the exterior cement soffits. The restored surround is made with integrated

pigment but is smooth for practical reasons. It was executed by a craftsman who fabricates cement sinks and countertops.

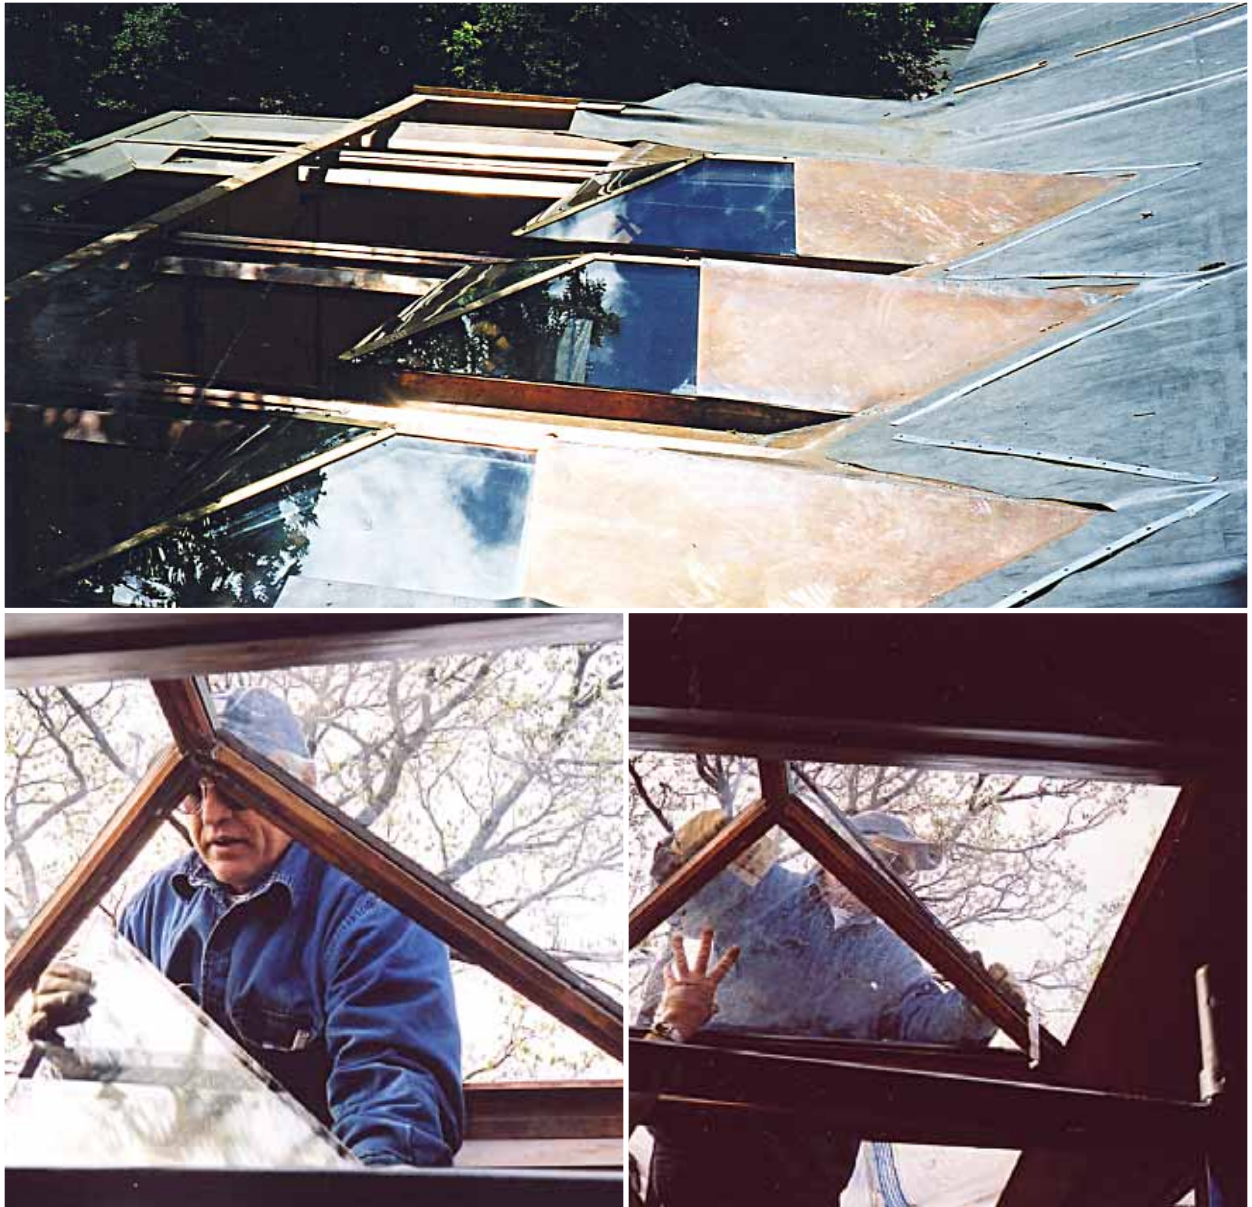
Glass was fabricated for the new skylights. The quality of fabrication did not meet our standards and so the glass is being remade. Seeing light once again

through the skylights is amazing, even through the temporarily imperfect glass.

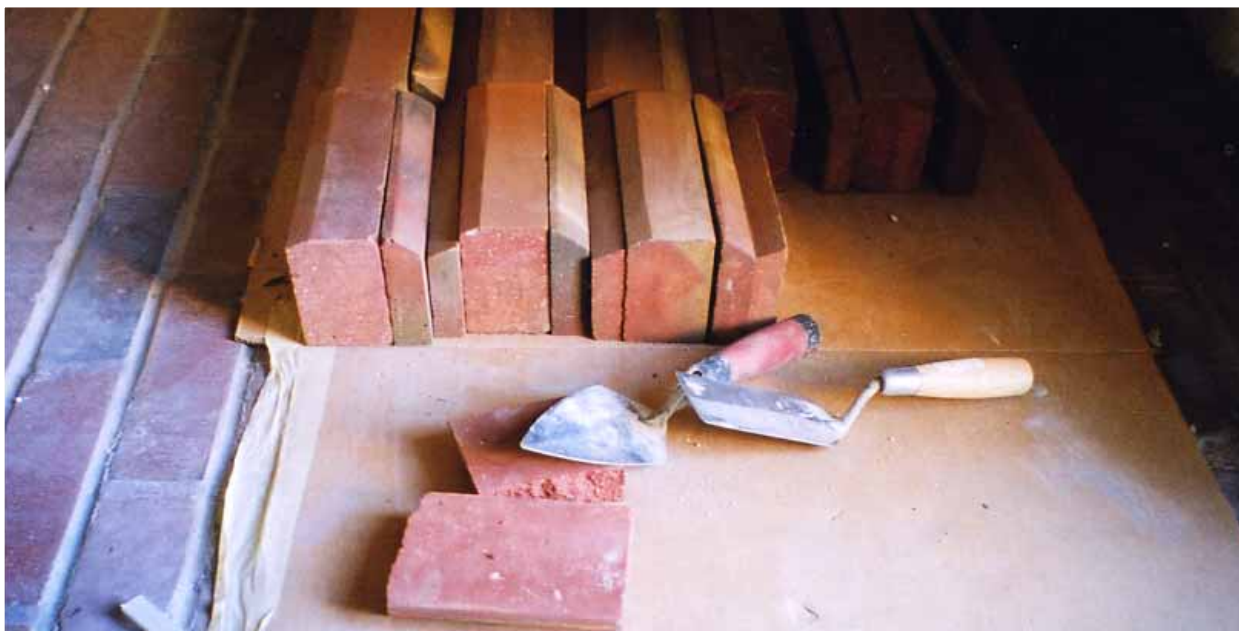
Newly fabricated threshold bricks arrive and are set in place.

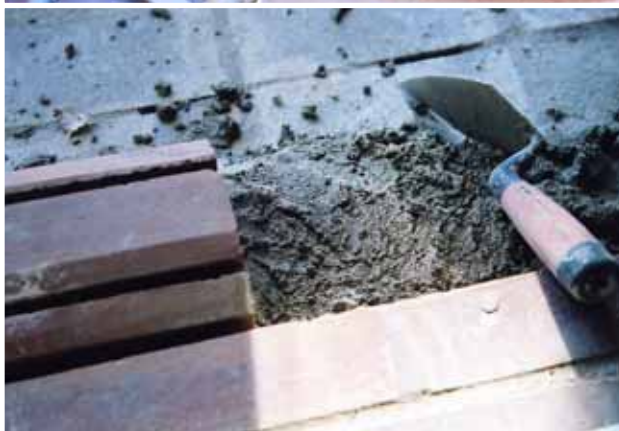
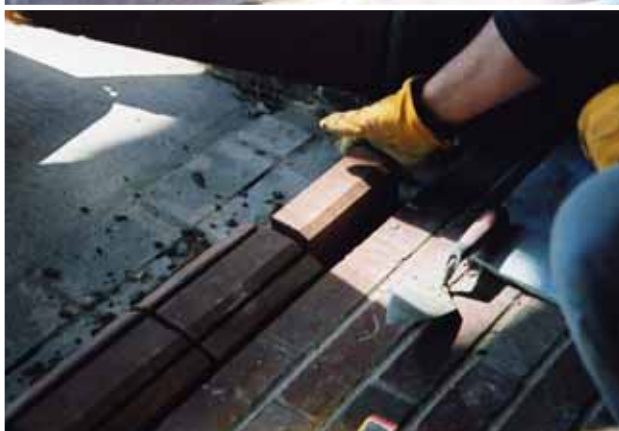
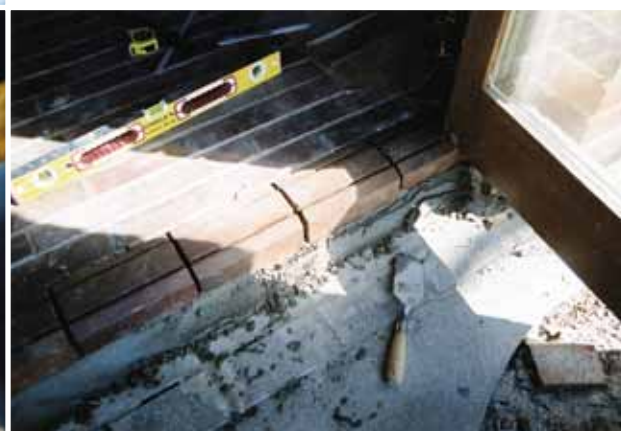
The study floors run in a straight longitudinal fashion, as opposed to the diagonal of the living room floor. The threshold bricks are therefore a different design from those in the living room. Each brick is made in three parts.
