WILLEY HOUSE RESTORATION JOURNAL VOLUME 2 ■ ISSUE 4 ■ FALL 2003 ■ ■ ■

THE STATE OF THE HOUSE FALL 2003

Metal cladding on the trellis as intended by Wright, roof repairs phase one, casting original door pulls, and a further education in the black art of brick making.

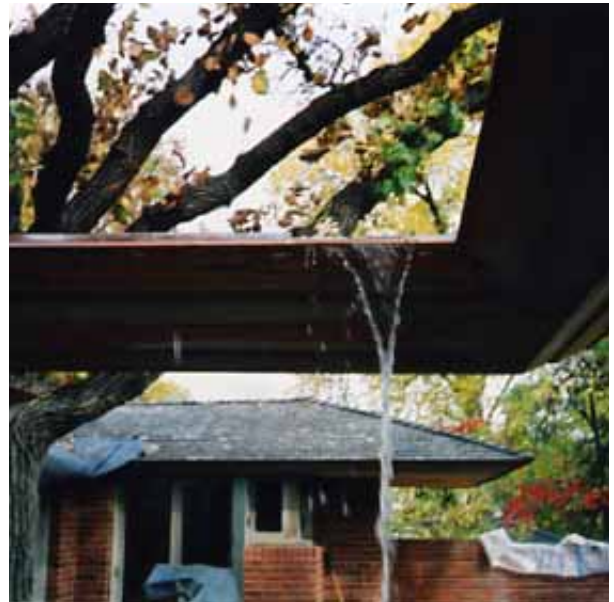
Water test of the integral gutter system.

In an episode of correspondence between Nancy Willey and her architect, Wright suggested that the new detail for the trellis be used in place of his earlier drawings. In a Western Union Telegram of September 15, 1934 he wrote "TRELLIS WRONG STOP WAIT FOR CORRECTION". On September 18th he sent a new drawing he referred to as "Detail for the working of the trellis as a gutter" "The trellis will carry rainwater from the living room roof away from the doors as originally intended." On September 20th again he mentions the gutter system "The gutter plan of the trellis takes care of the water so the thresholds below can remain as they are. This is no change but merely the correct interpretation of the details originally made." The original trellis was apparently well under way or already completed. Near the end of her wits and undoubtedly her budget, Nancy Willey did not make the change. Until this fall, the cantilevered trellis never had the integrated gutter that Wright belatedly intended. When bolstering the slumping trellis we made

allowance for the addition of his wonderful and we hope, functional gutter detail. Though it added considerable complexity to the metal fabrication the gutter system has at last been beautifully executed by the Rainville-Carlson company and seems to be up to the task of rerouting the torrent that flows down from the shed roof during a rainstorm.

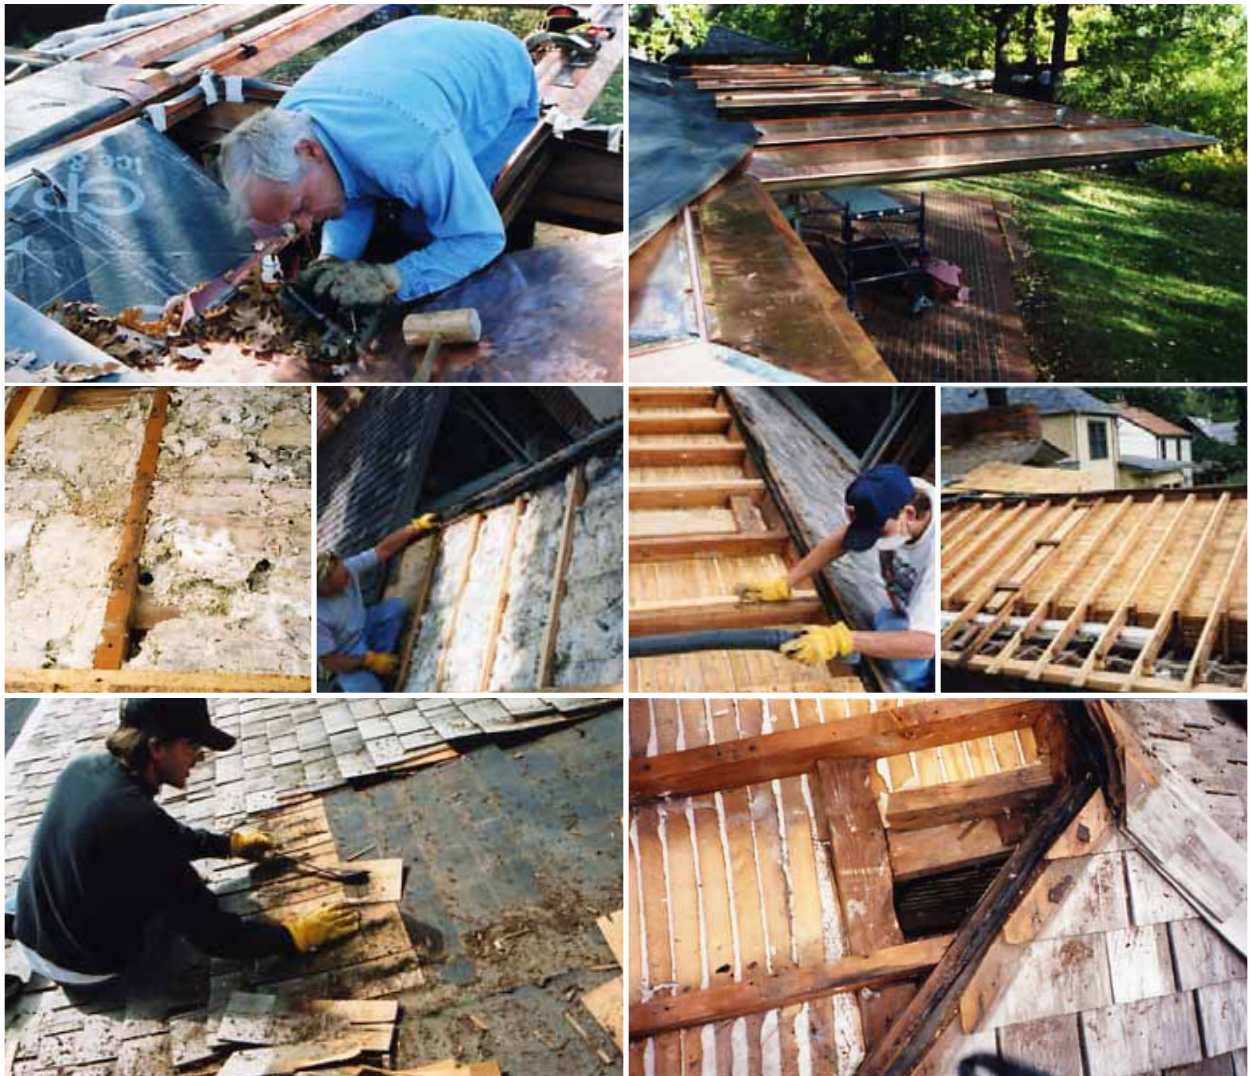
A craftsman solders the lapped joints on the sheet copper between the skylights. New copper cladding on the trellis. Evidence of rodents and water permeation in the Rock Wool batting. Original Rock Wool loosely packed between rafters. After removal of old Rock Wool batts the cavities are vacuumed out. Exposed roof structure showing new rafters. Joshua stripping cedar shakes off the roof. Roof hip above bedroom/bathroom closets.

Section by section while the weather held out, the roof was stripped of its cedar shakes and sheathing. Batts of Rock Wool insulation were removed, spaces vacuumed out and bad rafters replaced one by one. The roof proceeded as far as the living room before threat of snow forced Stafford and Joshua to cloak the house in rubber

roofing for the winter. In spring time work will commence where it left off. The roof will be insulated with an environmentally friendly expanding foam insulation and a new shake roof will be put down complete with the original braided hip detail.

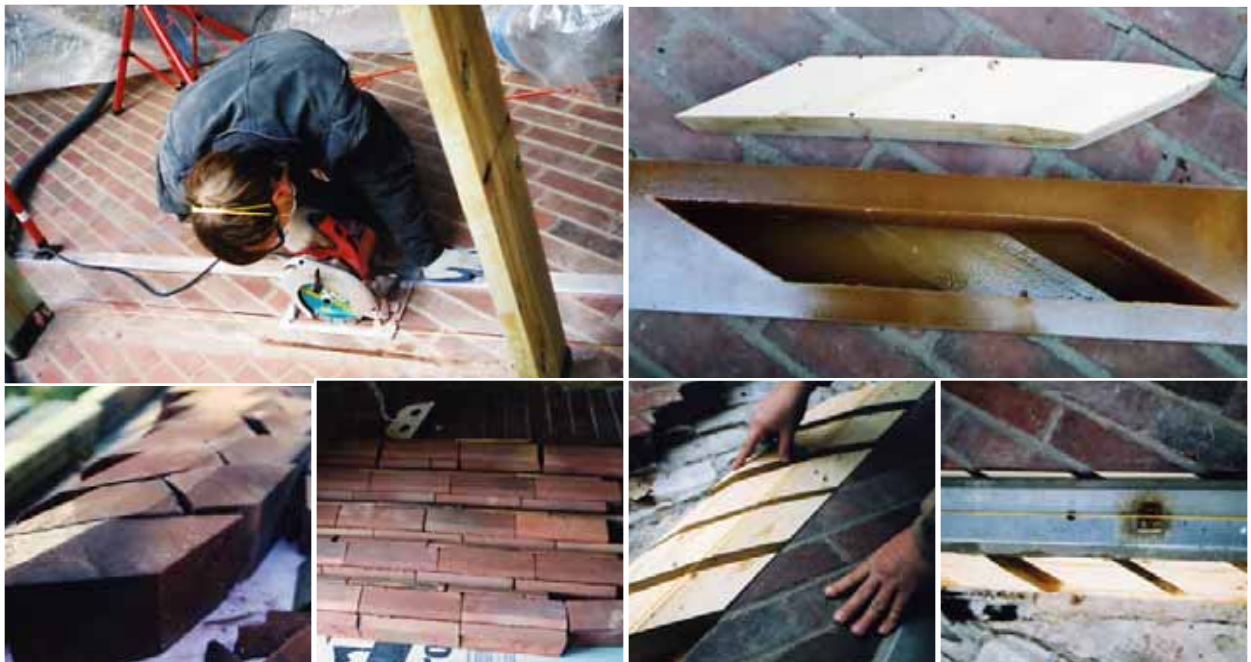
Cutting the area around the living room French doors to accommodate the custom threshold-shaped brick. Latex mold and wooden mock-up threshold brick sent to Stone Art to test bricks before shipping due to critical tolerances. First attempt at the threshold brick. Kiln shrinkage and a slight angle discrepancy made the brick unacceptable for use. Study threshold brick runs the length of house, matching interior floor and exterior terrace. Wooden mock-up of the improved living room brick threshold.

The brick restoration stopped short of completion last summer for lack of appropriate bricks. The Willey House uses two types, three if you count the modern terrace brick. The house originally was built with alternating courses of sand mold brick from Memomonie, Wisconsin and a harder Twin Cities shale brick that had a sheen to it. The effect of the alternating brick created a series of horizontal bands running the length of the house, at once subtle and striking. Neither brick has been manufactured for decades. However a good salvage source was found at last for the sand mold bricks. The local bricks continue to allude us. Modern brick is referred to as "modular" size and measures 7 5/8" in length. The original brick that comprises the Willey house was approximately 8" long. The 8" size is found today only in pavers. Thus, there is a reasonable facsimile that works fine and is easily

replaceable for the terrace bricks. Custom brick tests have been made for us in Tennessee but the process seems to be more of an art than a science. Turn around times are long and results vary in degree of success. In all fairness, a vast number of variables account for the impossibly rich variations in regional brick. Not the least of these is the clay itself, add to that the means in which the brick was formed either molded or extruded, the kiln, how the bricks are stacked, firing method and temperature, reduction firings, and additives or glazes. Consider then, that bricks shrink when drying and again while being fired. Lynda Evans of Stone Art was commissioned to create custom brick matches for the fireplace, living room and study thresholds and the top of the garden wall. Watch for the results in future issues of the journal.
