# T H E   G A R D E N   W A L L

WILLEY HOUSE RESTORATION JOURNAL VOLUME 3 ■ ISSUE 4 ■ FALL 2004 ■ ■ ■

## THE STATE OF THE HOUSE FALL 2004

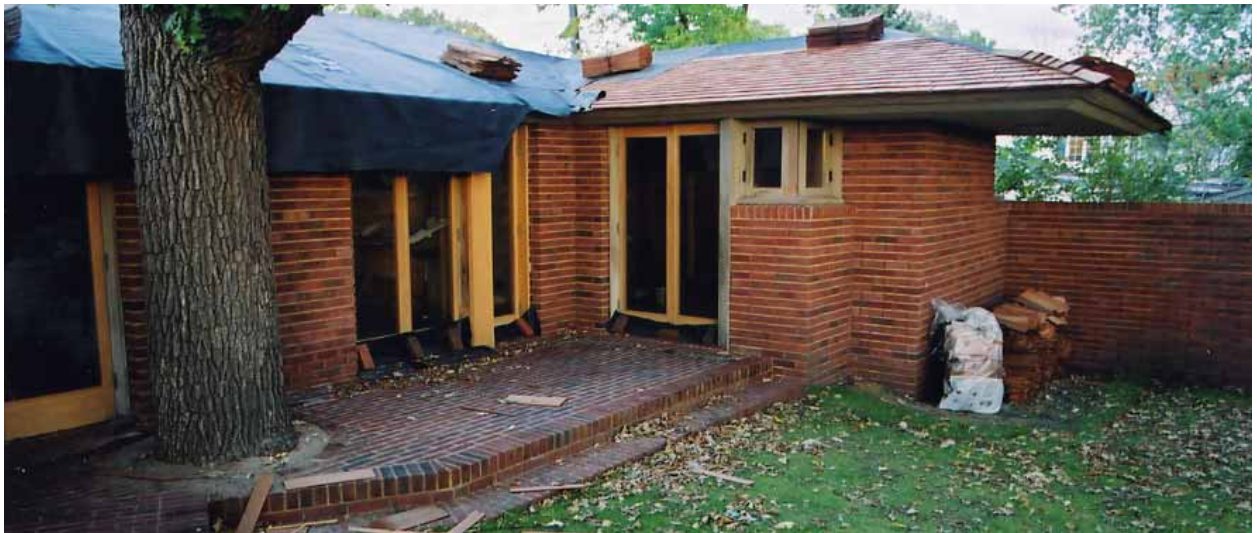
Shingles applied to the master bedroom roof.

**R**oofing over the garage and master bedroom has been completed with fragrant new cedar shingles. Special pains were taken to use only the widest shingles in the bundles and lay them in precisely straight courses. Cedar Breather was installed beneath the new shingles to prolong their life span. And at long last, the

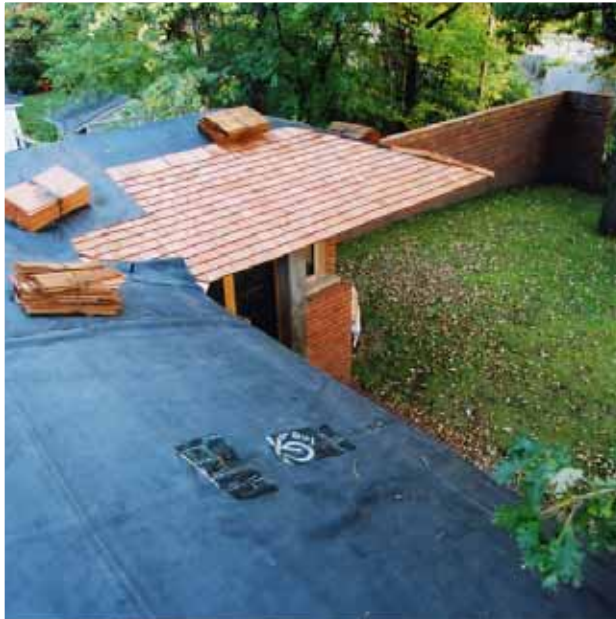
A copper valley above the master bedroom.

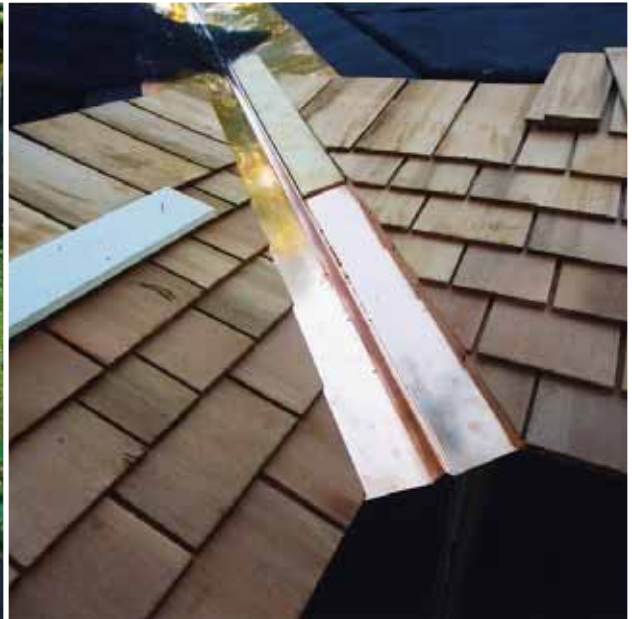
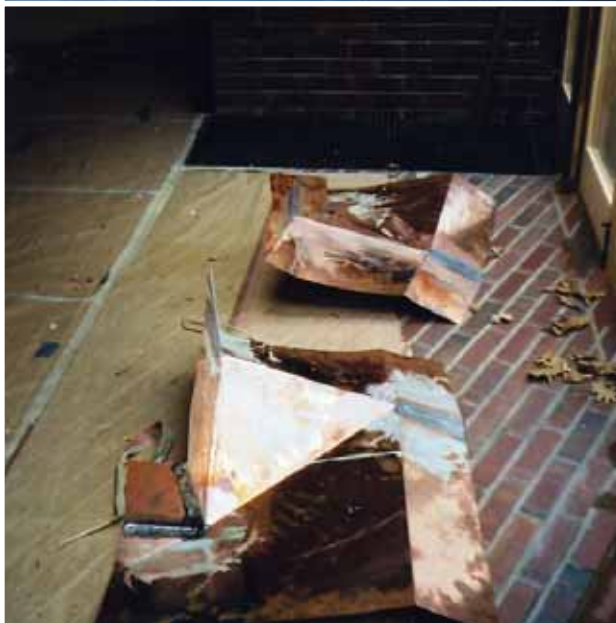
Complicated copper flashings that abut the chimney mass.

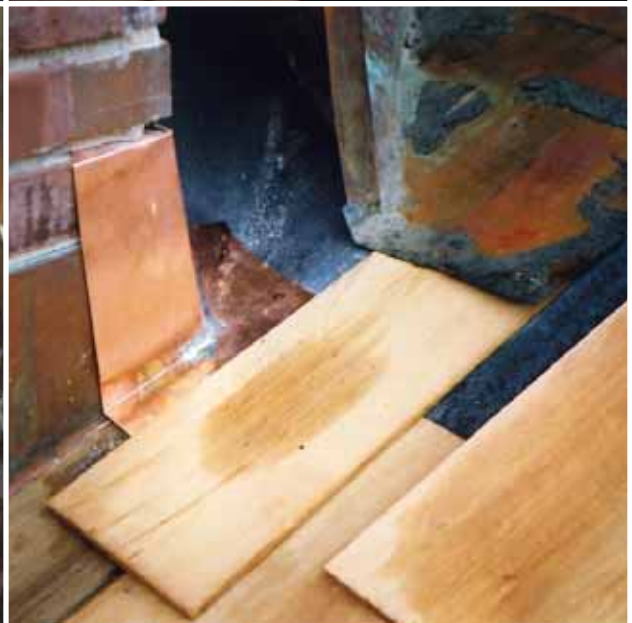
Shingling up to the copper chimney flashing.

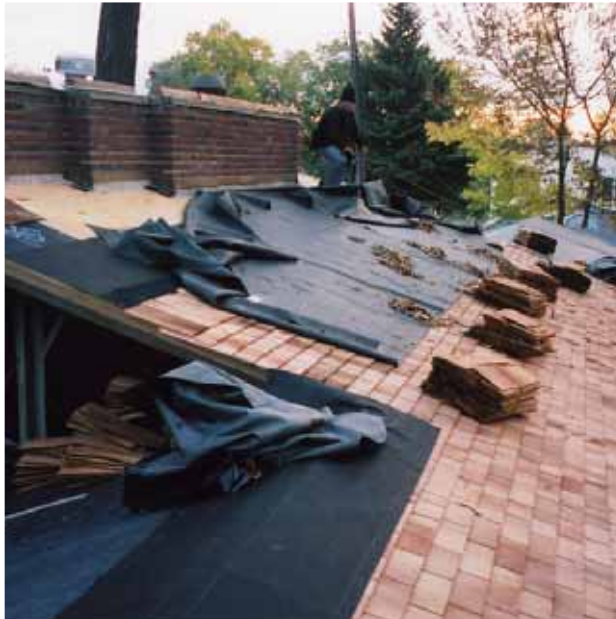
Water shield at roof edge and below kite window.

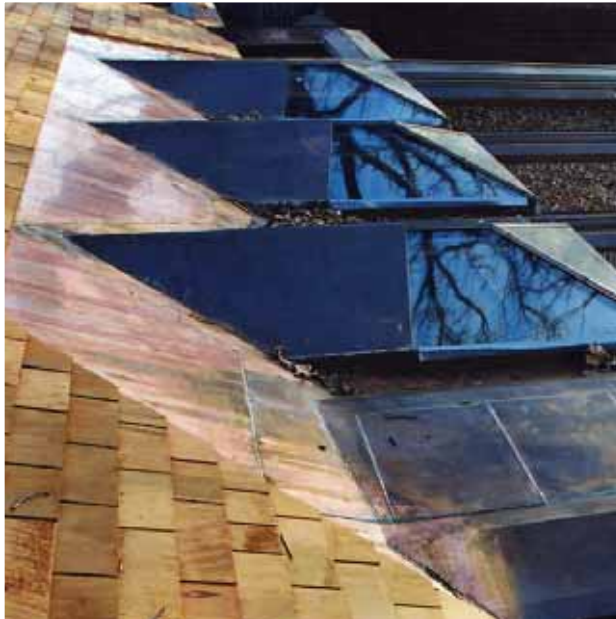
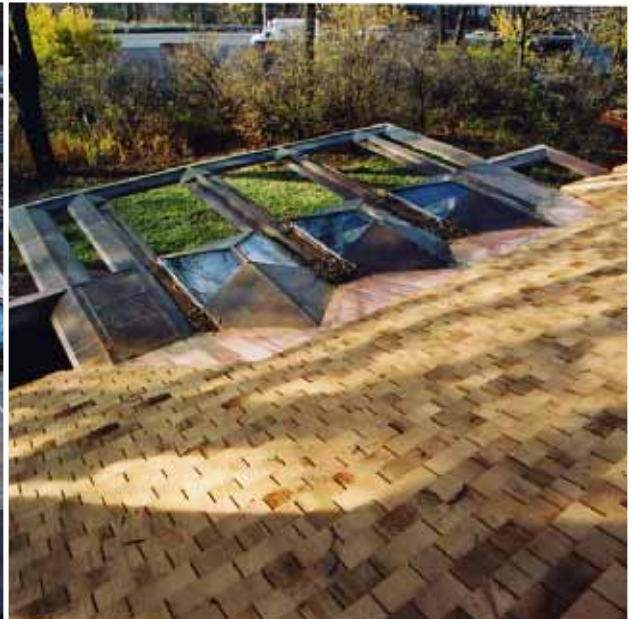
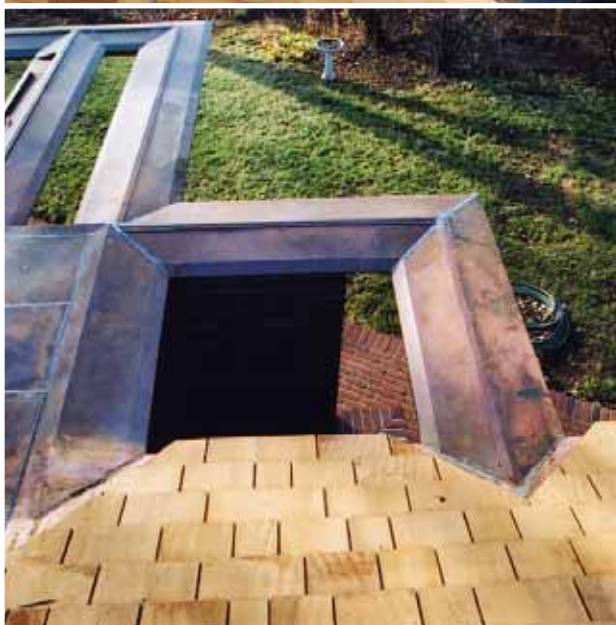
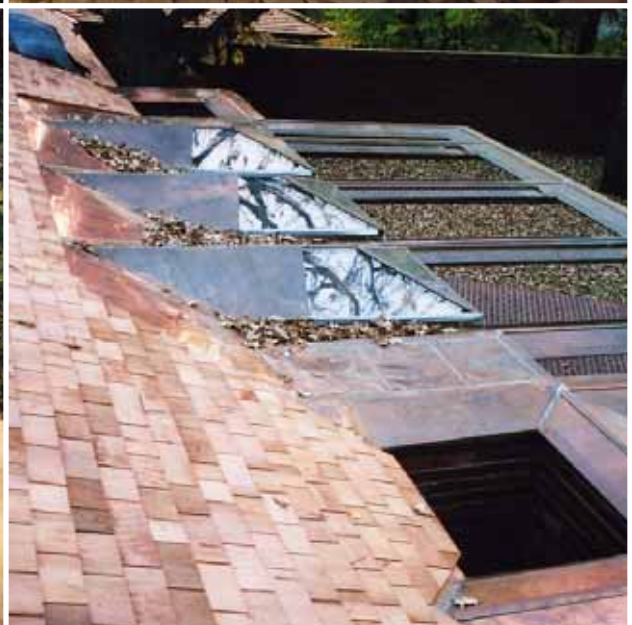
Shingles above trellis and planter.

Shingles at trellis.

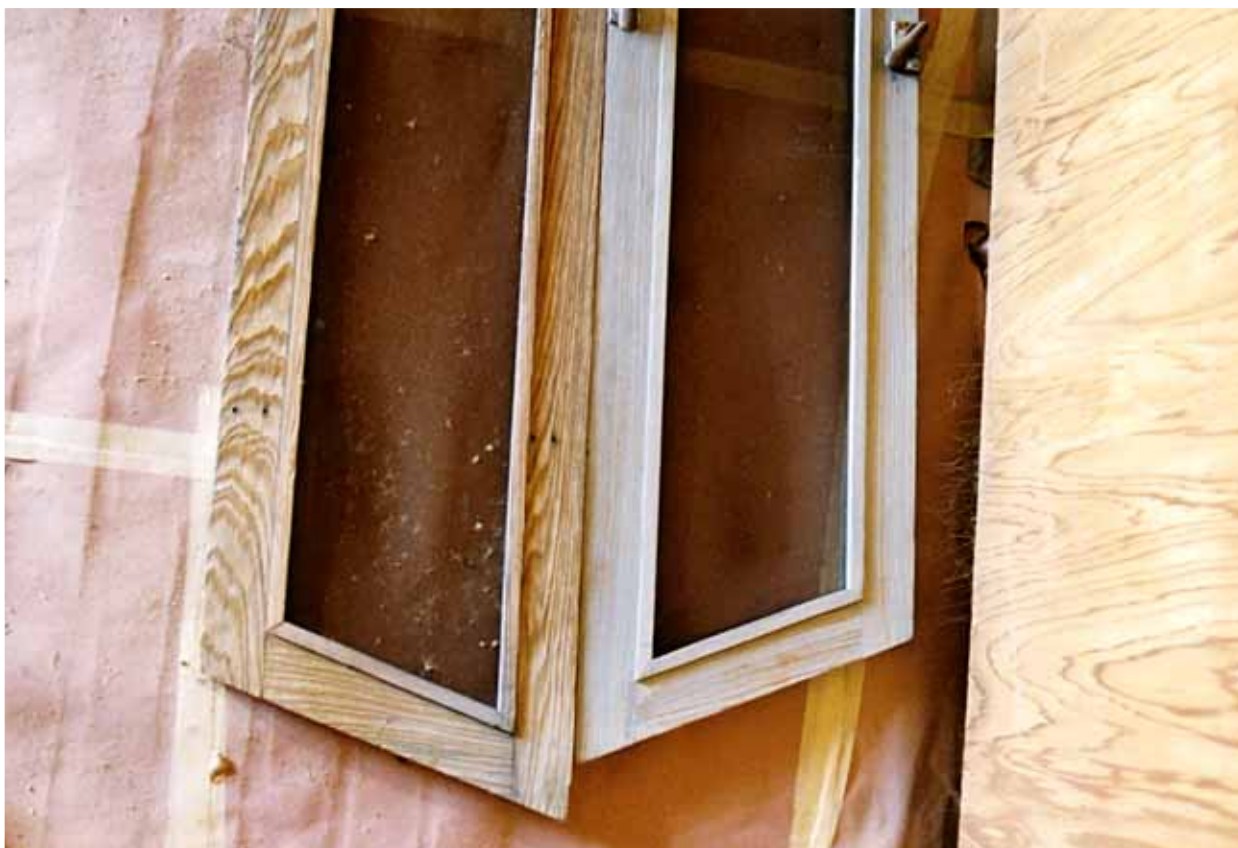
Exemplars of a hand-made house. Had the window screens not been removed for restoration and laid side by side, we never would have noticed the difference in dimensions. The screens, built for the kite windows on the east and west sides of the living room, are not even close in size as seen above and right.

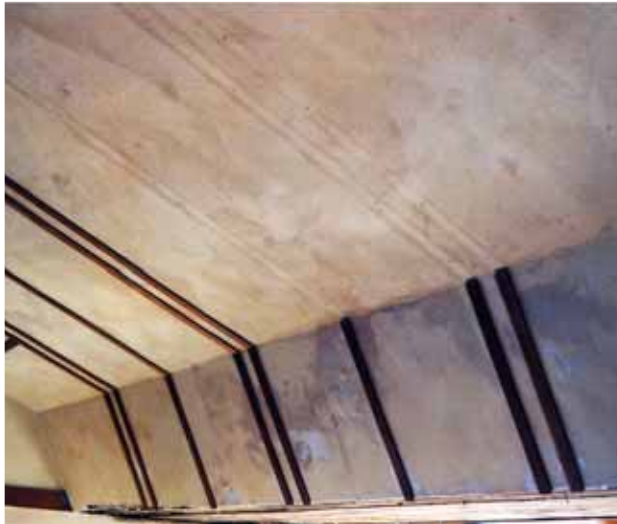
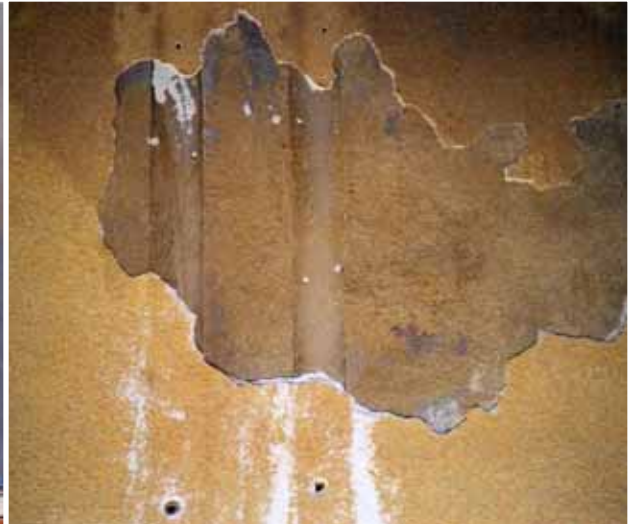
Ghosts of ceiling stripes on original plaster show band position from 1934.

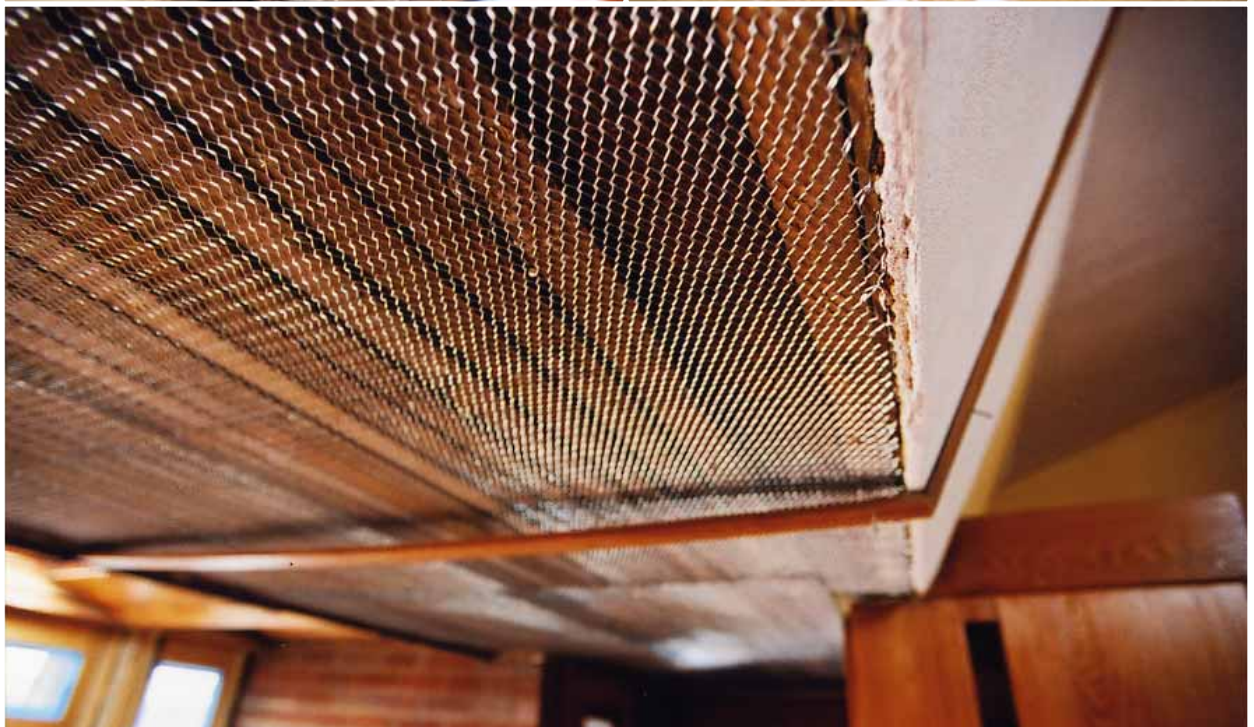
Plaster prep for living room ceiling repairs. This image shows calculation of plaster depth at entrance way ceiling so that bands fit back in place.

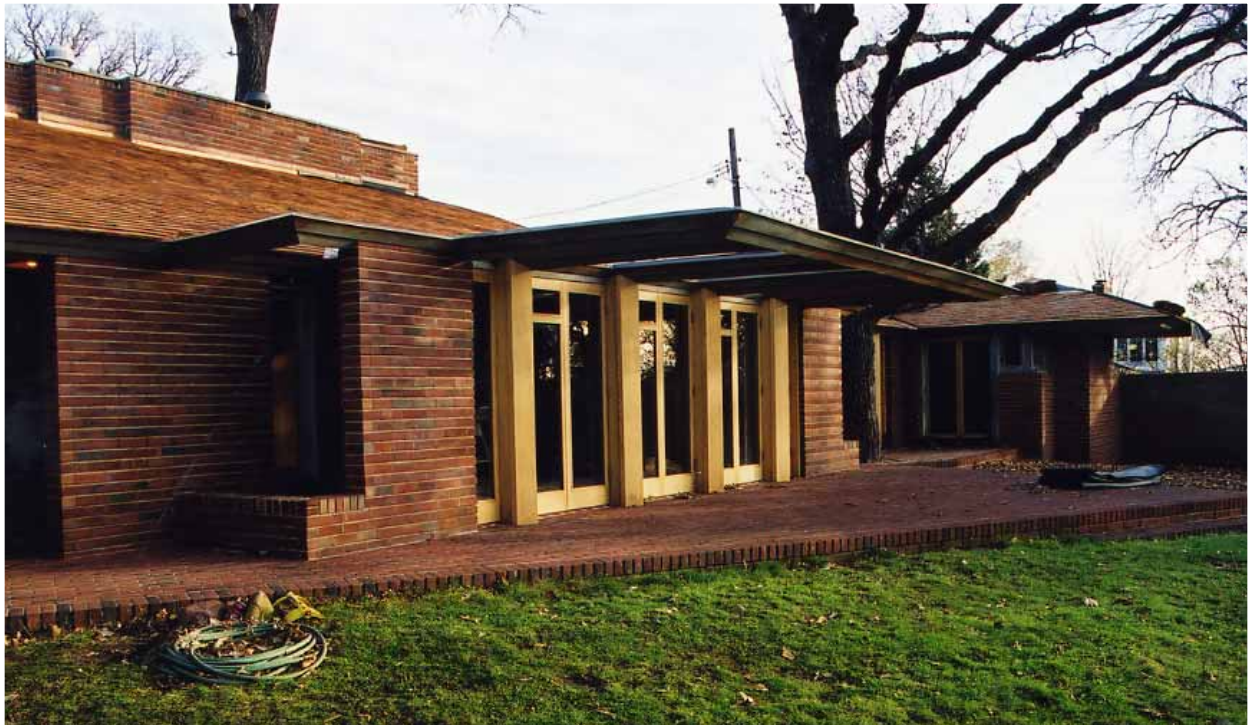
New doors in place before finishing. The natural warm hue made us reluctant to stain the wood, but we understood that it needed to be done. Once the roof changes

to a mature silver gray, the stained doors will look appropriate. For one brief moment, they were golden.

Cabots light grey stain was applied, both transparent and solid were used in a 50/50 mix, to achieve the original effect. As sad as it was to cover the pristine natural wood of new doors, sanded fascia and trellis, the fresh coat of stain brings the somber palette in line with Wright's explicit instructions. 📐

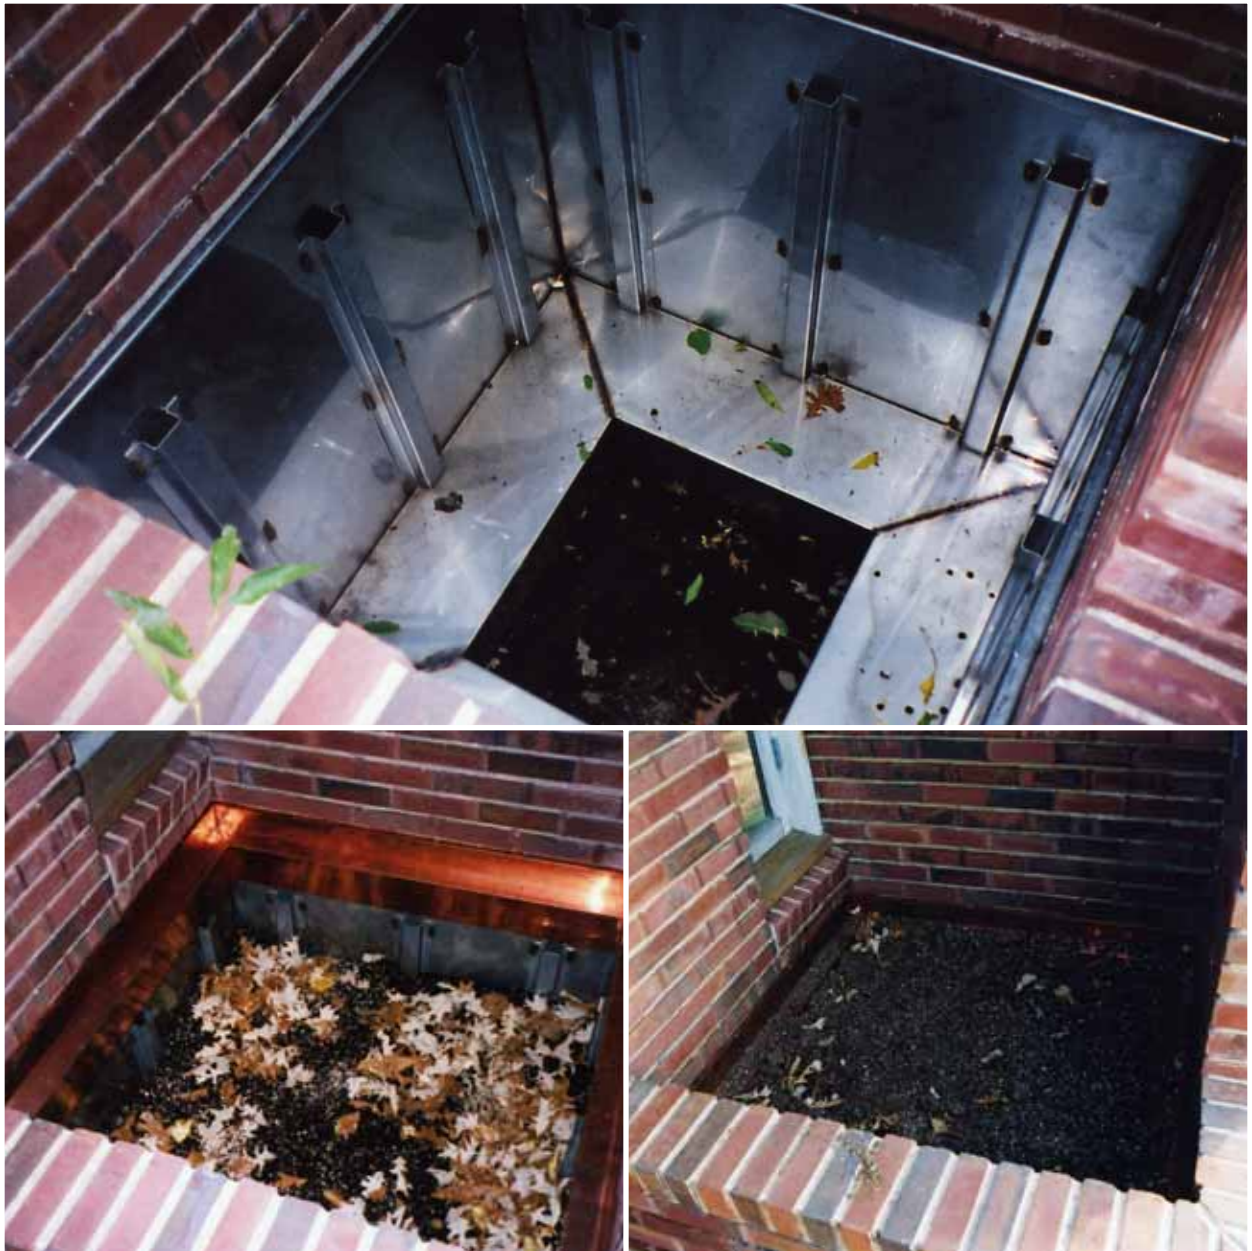
Long leaking water into the living room radiator pits, the planter boxes were dug out, rebuilt and skim coated in cement. This fall the two planters received stainless steel liners, copper flashing and artificial soil (peat moss, perlite, vermiculite). They are now ready for planting next spring. 🍁
