T H E G A R D E N W A L L

WILLEY HOUSE RESTORATION JOURNAL VOLUME 4 ■ ISSUE 2 ■ SPRING 2005 ■ ■ ■

THE STATE OF THE HOUSE SPRING 2005

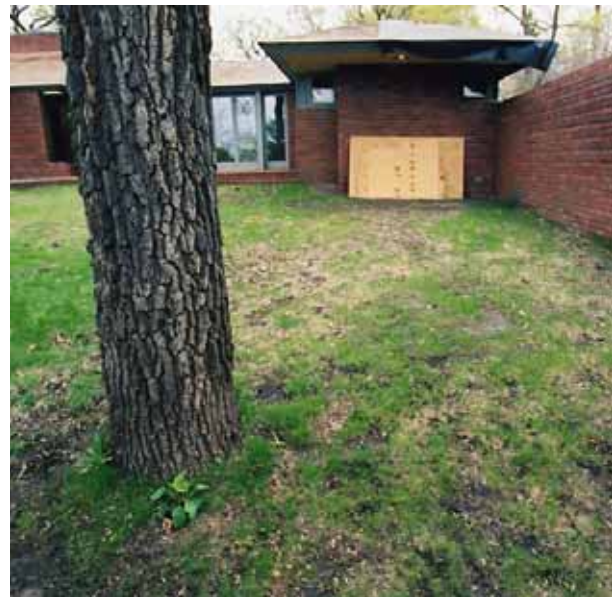
The garden prior to the path.

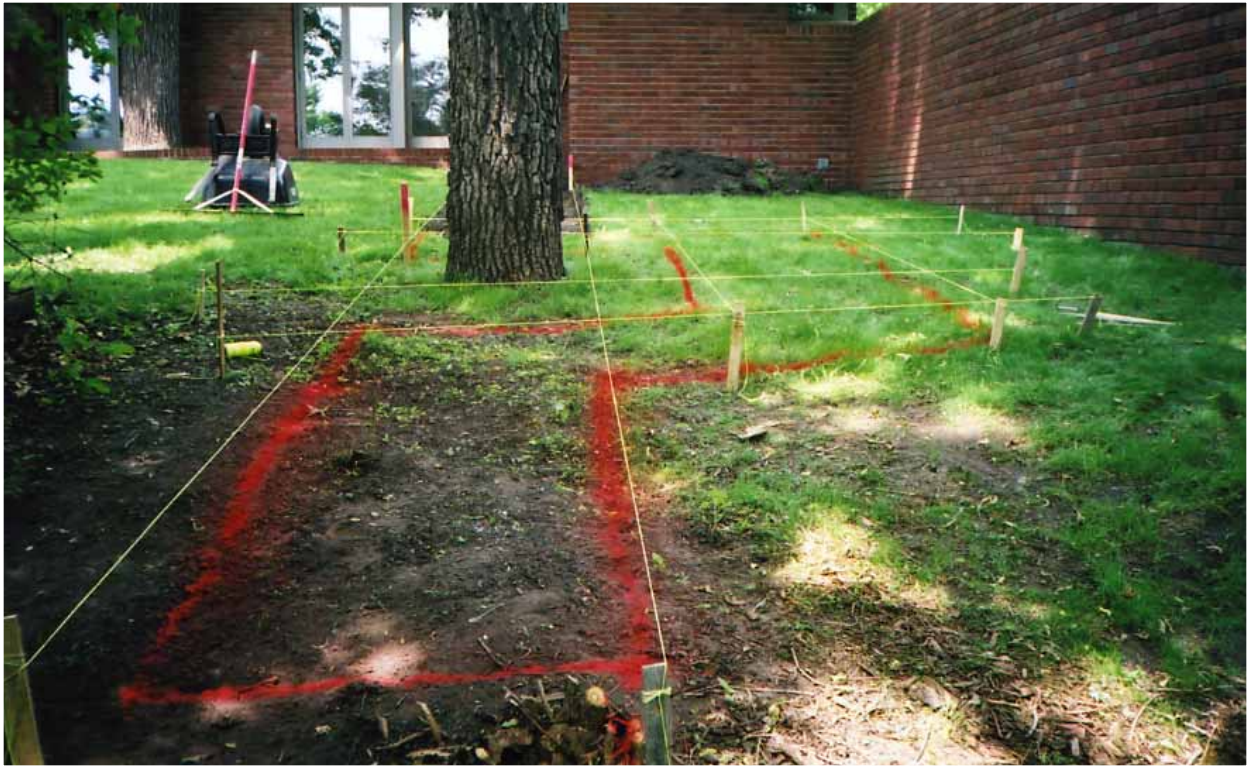
Staked out lines define the path.

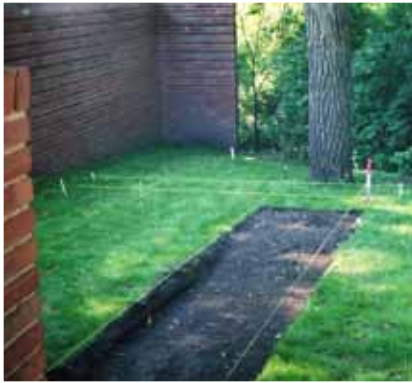
Sod being removed from the staked area.

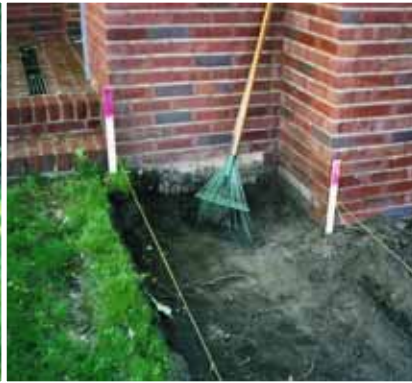
Master bedroom terrace.

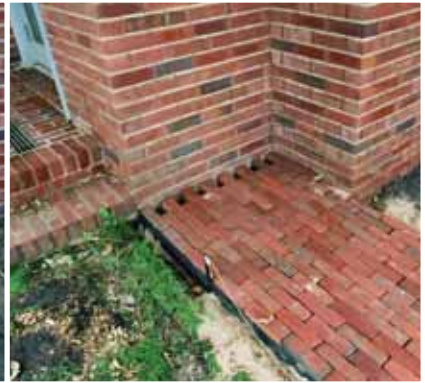
Master bedroom terrace after bricks laid in place.

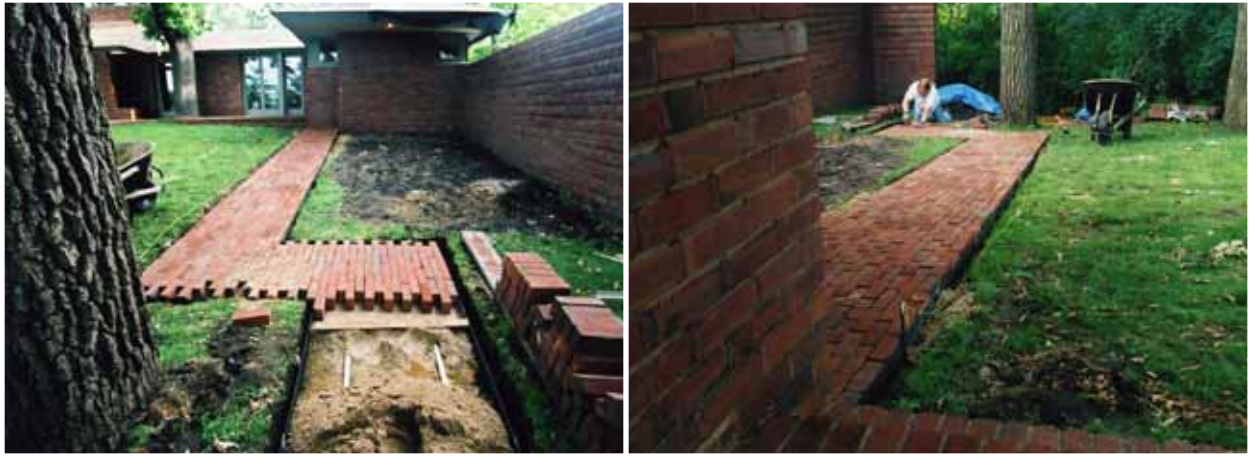
Making the turn around the oak.

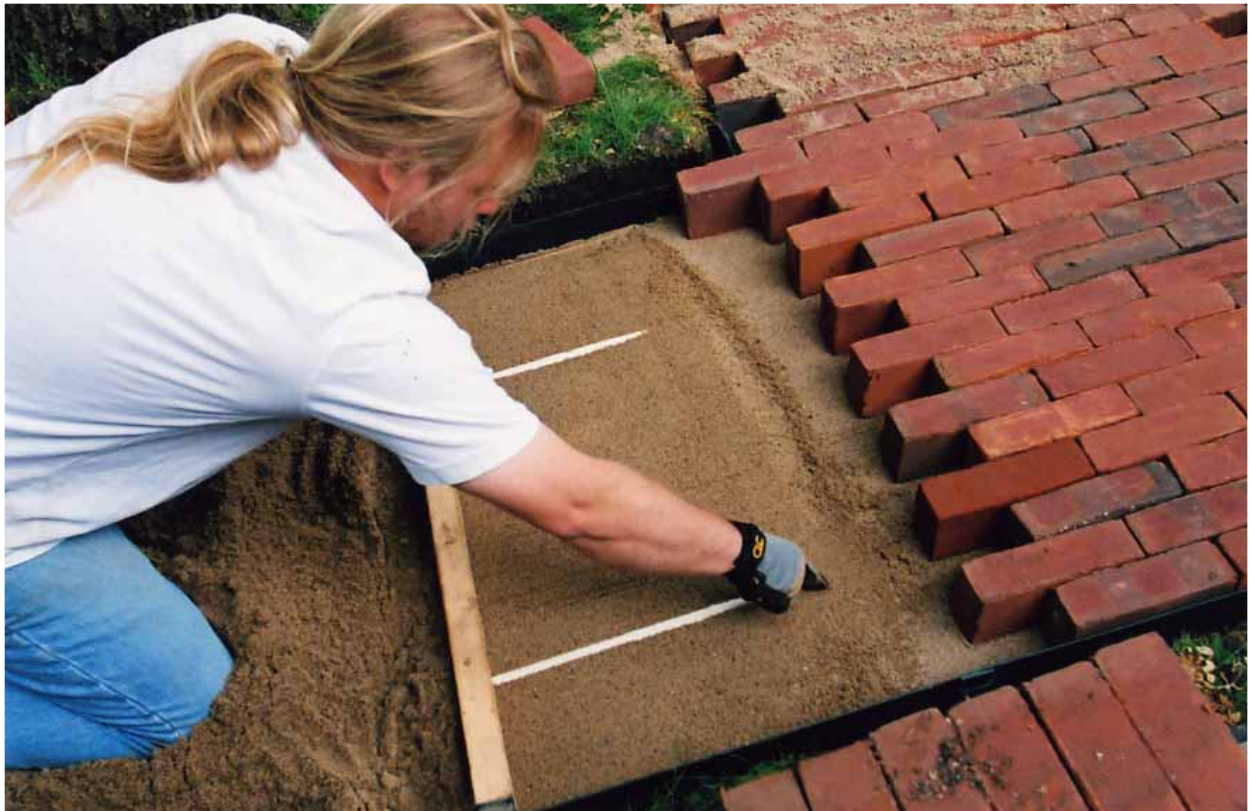
Sharp masonry sand being screed flat and level.

The bricks used match the terrace bricks. However they are laid on edge in a bed of sand rather than on a cement slab. The path follows the sloping grade of the site to the end of the wall where it ends. The garden space is now beautifully defined even before planting of any sort has begun. 🏠

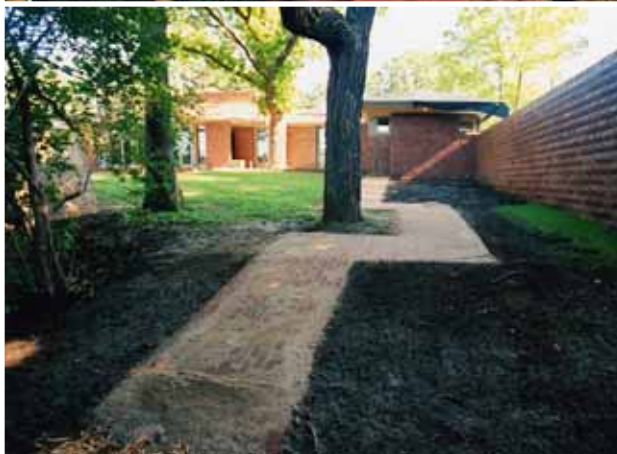
Finished path with sand swept into the joints.

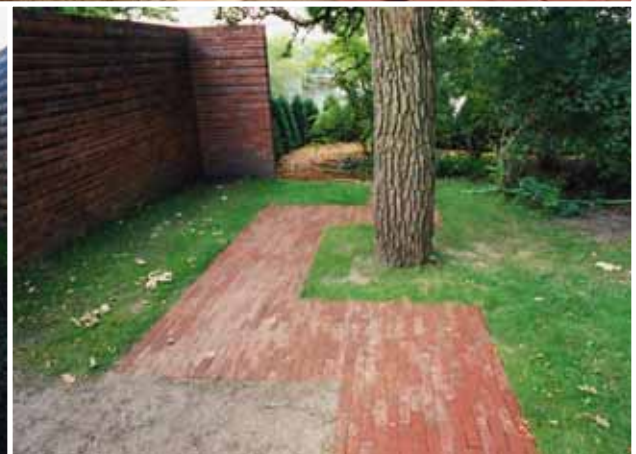
Path projecting out from bedroom terrace.

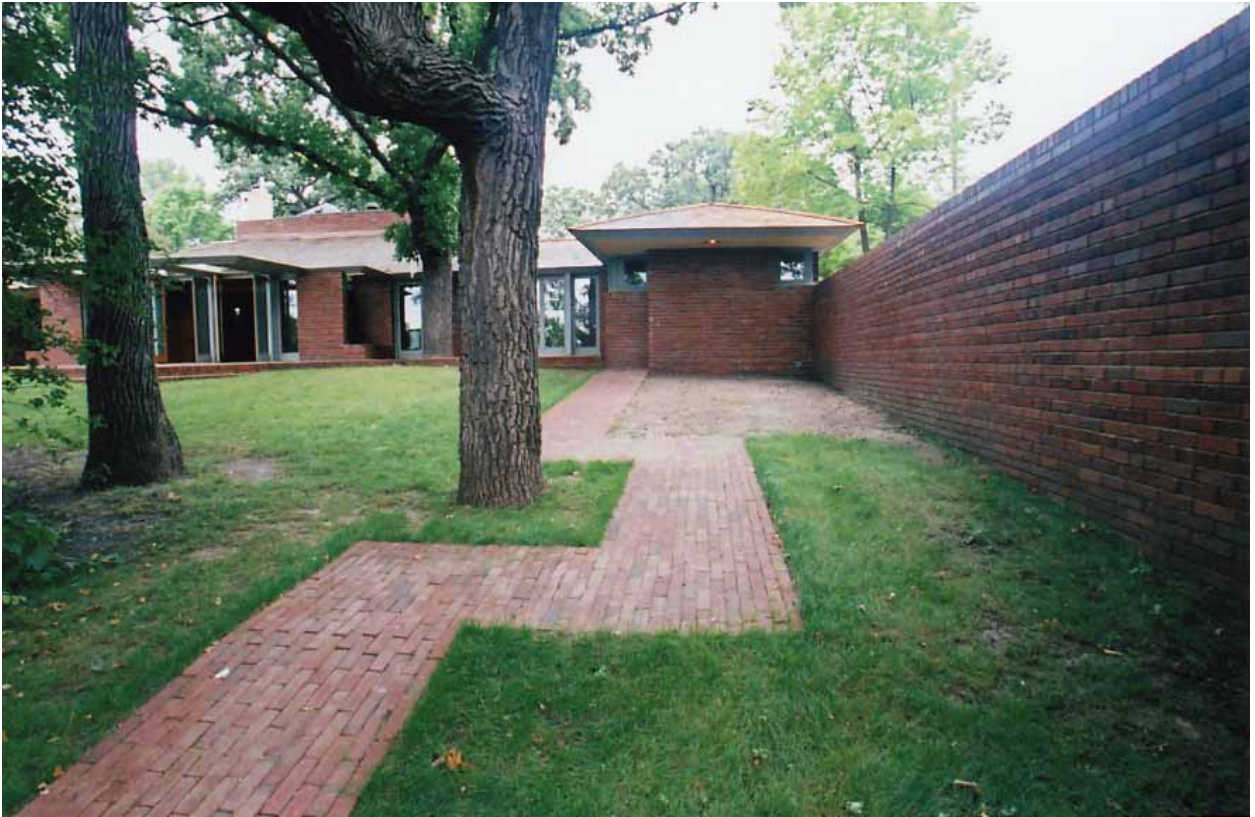
Path circles the oak tree.

Mr. Wright's house plan defined a brick walking path that paralleled the garden wall. The path separated the main garden plot from a smaller strip of plantings and the lawn. The walk in plan, ran straight into the foliage at the termination of the wall. The drawing however did not take into account any of the existing trees on the site. One of the largest Burr Oaks grows dead center on the projection of the path. It wasn't going anywhere for the next hundred years so we elected to run around the tree rather than dead end at its roots.

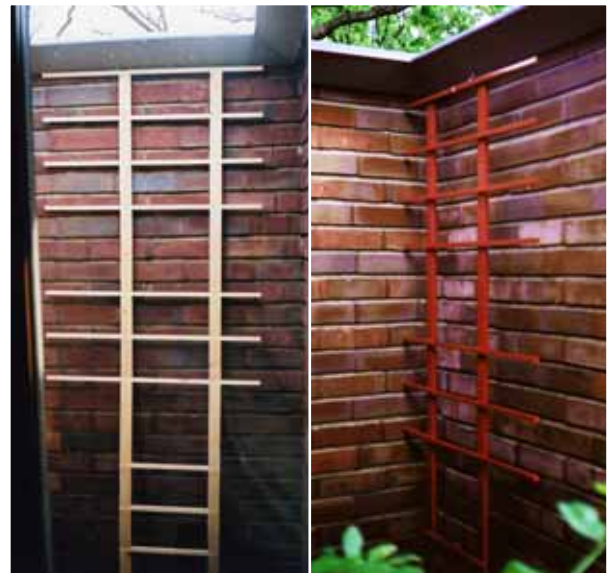
Mock-up in place (left). Steel trellis powder-coated Cherokee Red (right).

A small ladder trellis was designed for each planter to assist the new vines up to roof level. A wooden prototype was first constructed and approved before Josh committed the final forms to powder-coated steel. 📸

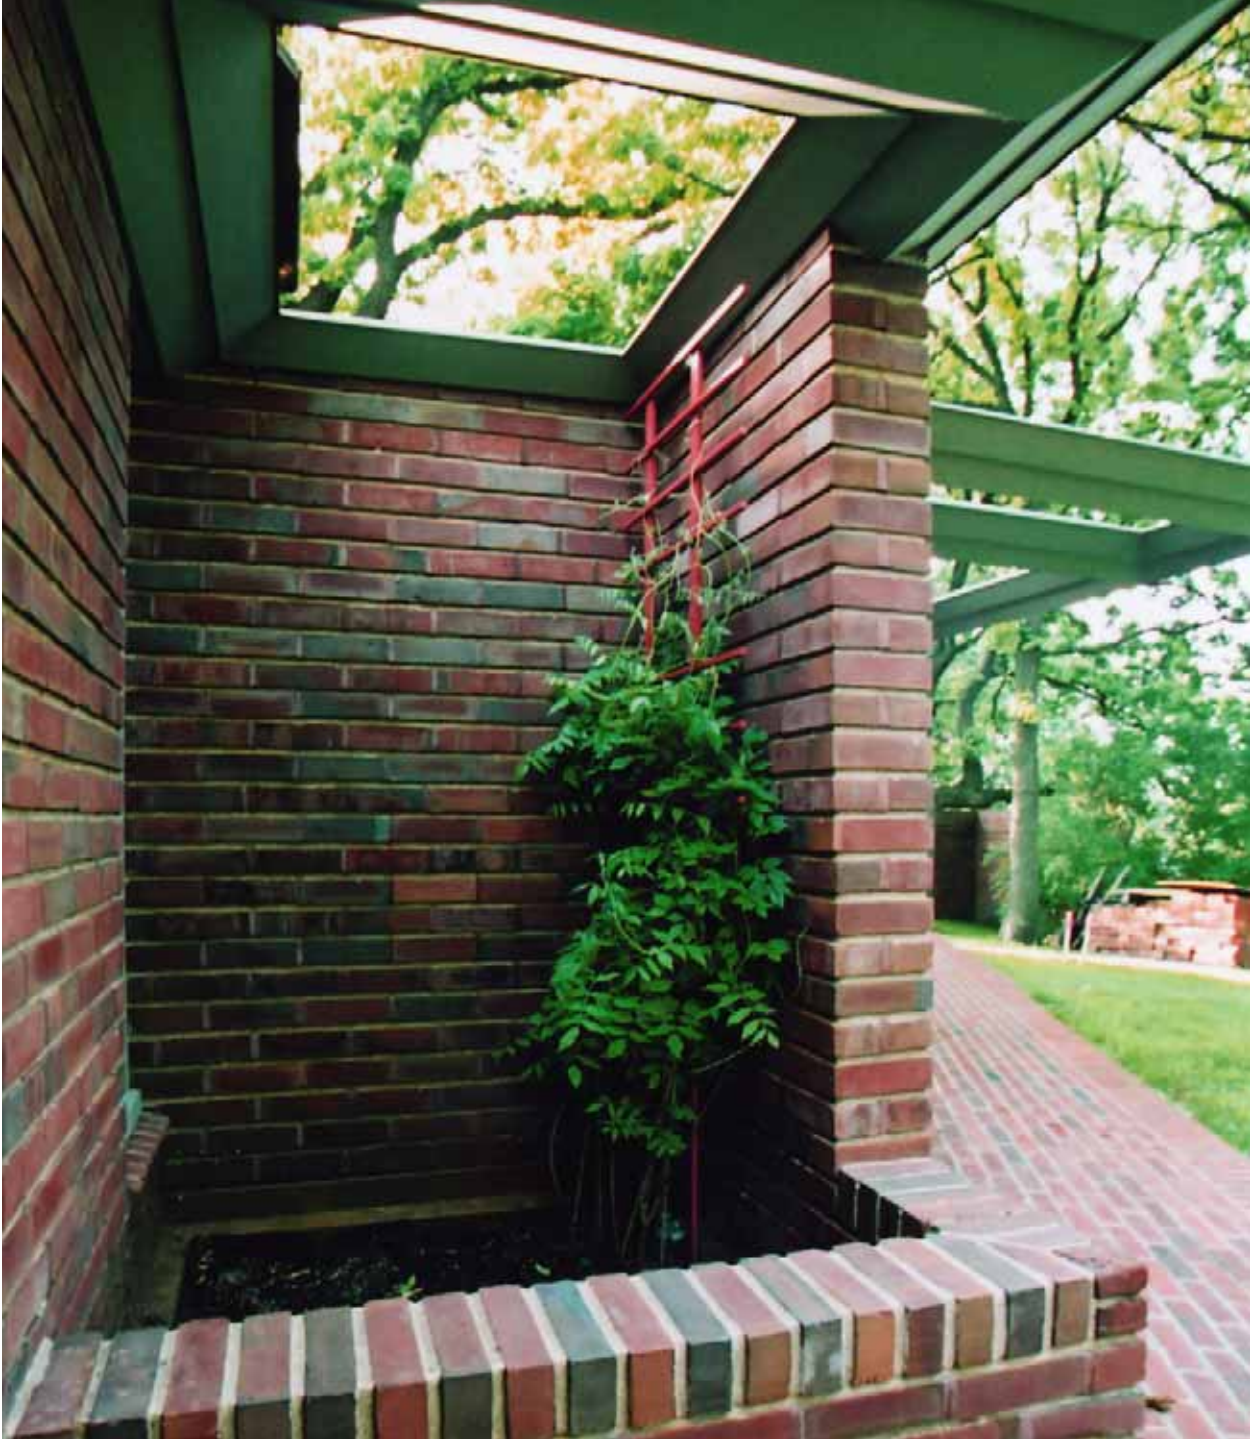
Wisteria vines growing up the new trellis.

The zone 3 hardy varieties we have selected are Aunt Dee and Blue Moon, both pale blue in hue. This time around the vines will be trained to grow only on the outer fringe of the trellis so they do not interfere with rain water drainage.

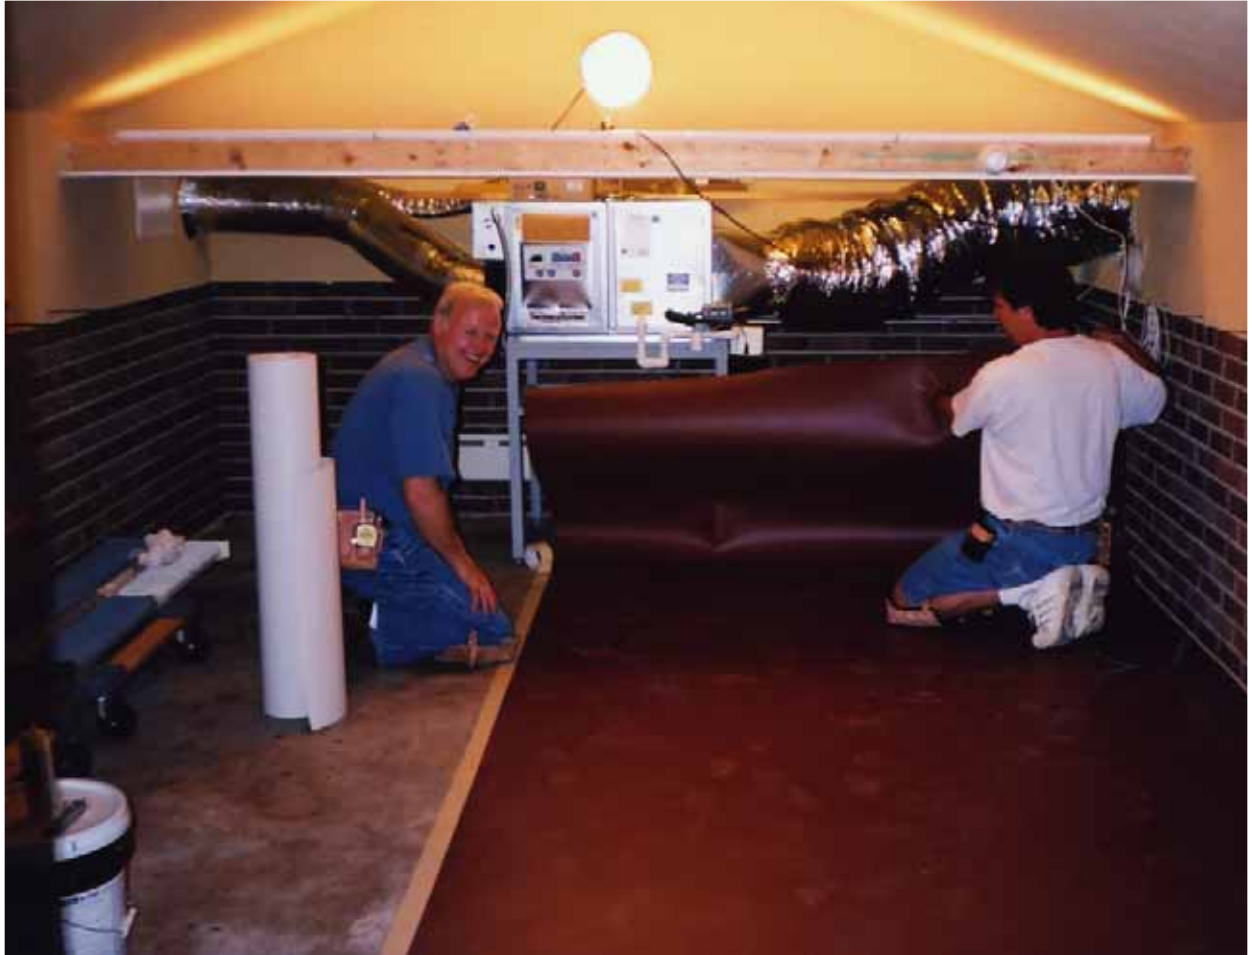
Battleship linoleum being laid in the storage room

Wright was not yet referring to the color as Cherokee Red but the linoleum flooring is most certainly a variant of that elusive color. A very nearly lost source of battleship linoleum was rediscovered this spring. Armstrong sold a red battleship linoleum in the U.S. market. It was manufactured by Uni-Walton in Germany. We acquired samples 2 years ago and at the time decided to wait and order it when we were ready to use it. In the intervening time, Armstrong stopped distributing the color in the US. Weeks of persistent nagging phone calls elicited a response in the form of a small cache of the material located in a domestic warehouse. Enough was purchased to complete the kitchen and the storage room above the garage. The former location was laid this spring.

The product color is Deep Red, Uni-Walton 19288-281. It is a dead ringer for the original linoleum used in the kitchen, on the counters and floor. 🍷
