# T H E   G A R D E N   W A L L

WILLEY HOUSE RESTORATION JOURNAL VOLUME 4 ■ ISSUE 3 ■ SUMMER 2005 ■ ■ ■

## THE STATE OF THE HOUSE SUMMER 2005

## CAPPING THE ROOF

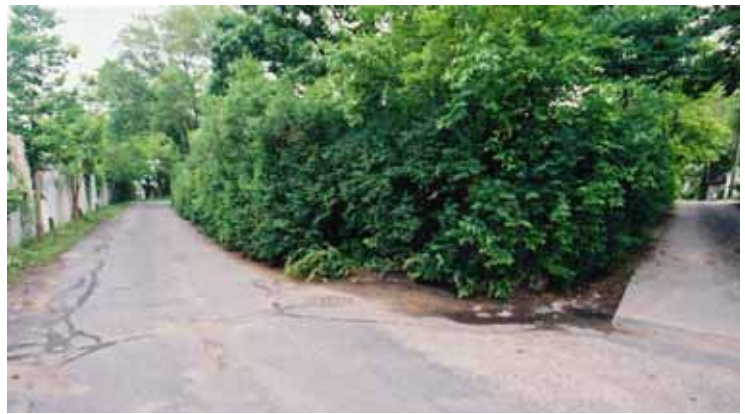
Overgrown honeysuckle bushes at southeast corner of lot prior installation of the hedge

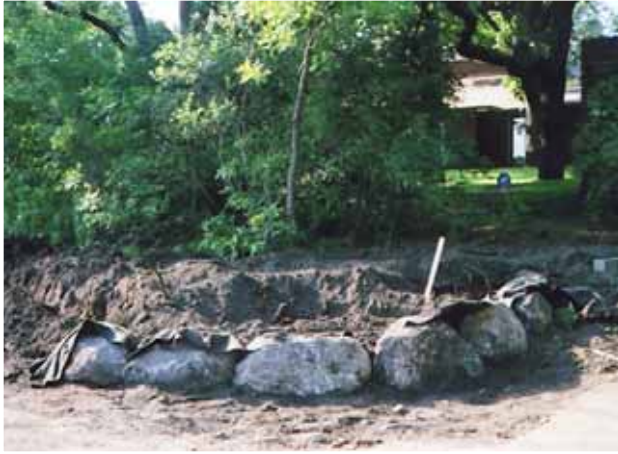
Overgrown plant material being removed.

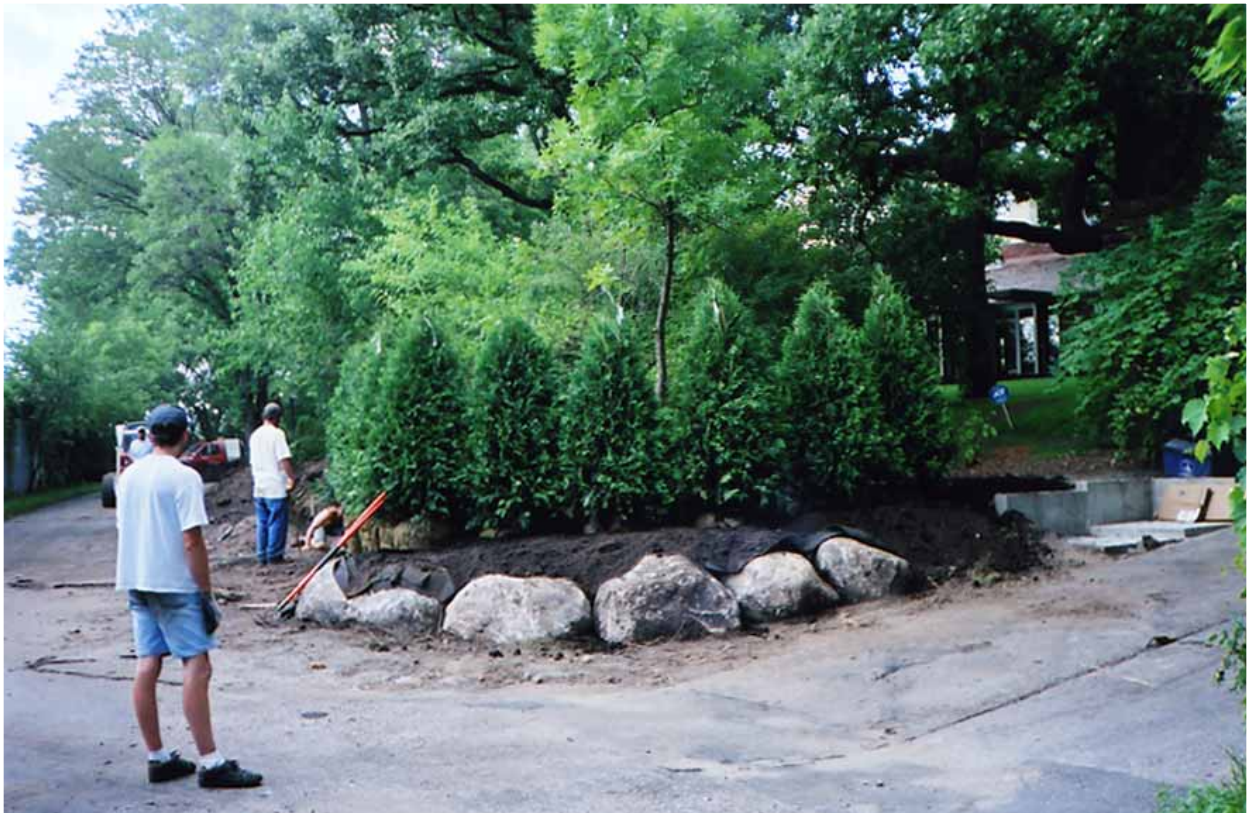
Southeast corner Arborvitaes being planted.

A trench was dug with a backhoe and Arborvitae planted on 3 foot centers.

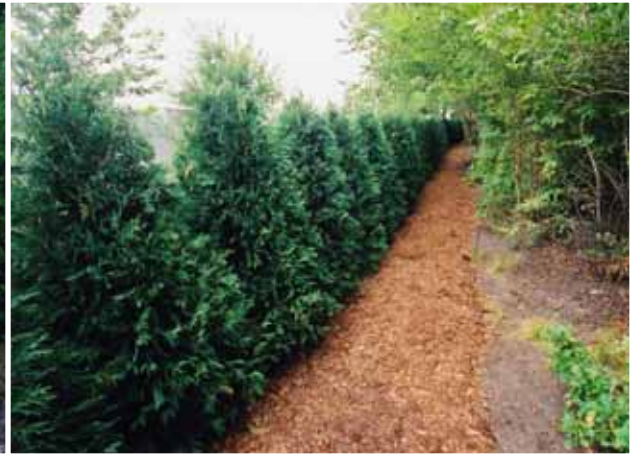
Alley side view of the completed hedge.

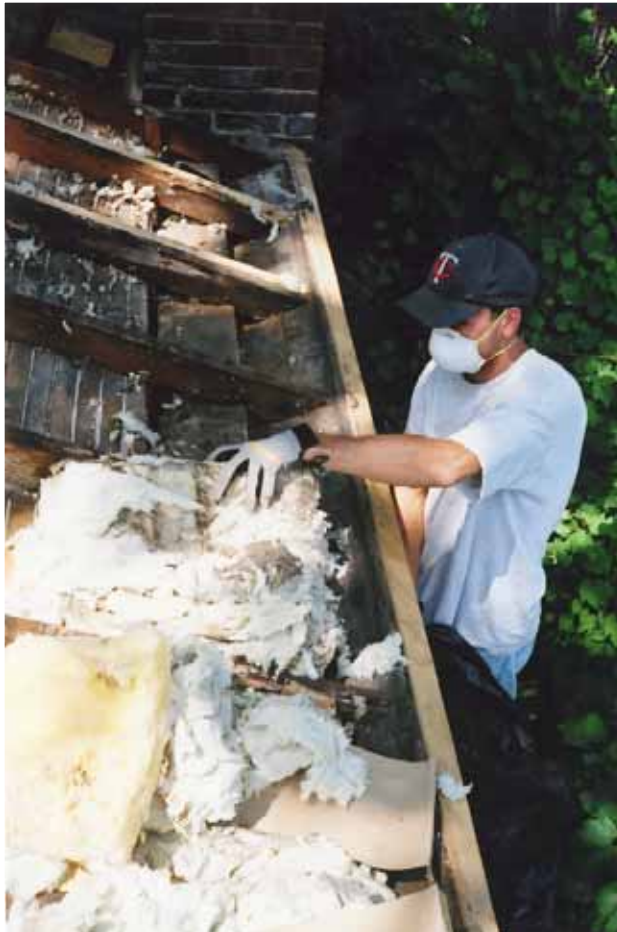
Batted insulation is removed.

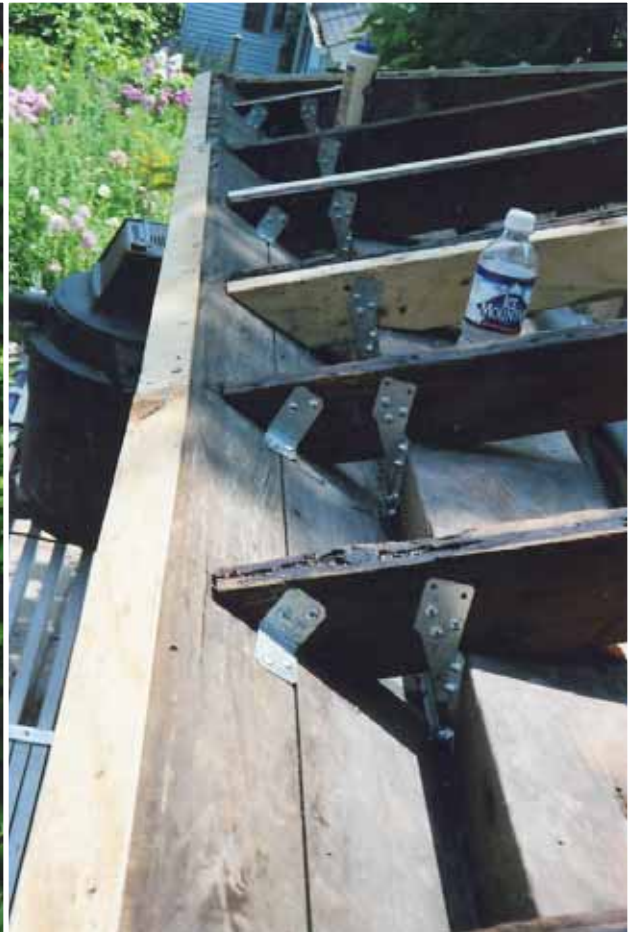
Rafter spaces are vacuumed, tails repaired and metal straps added to secure fascia to rafters.

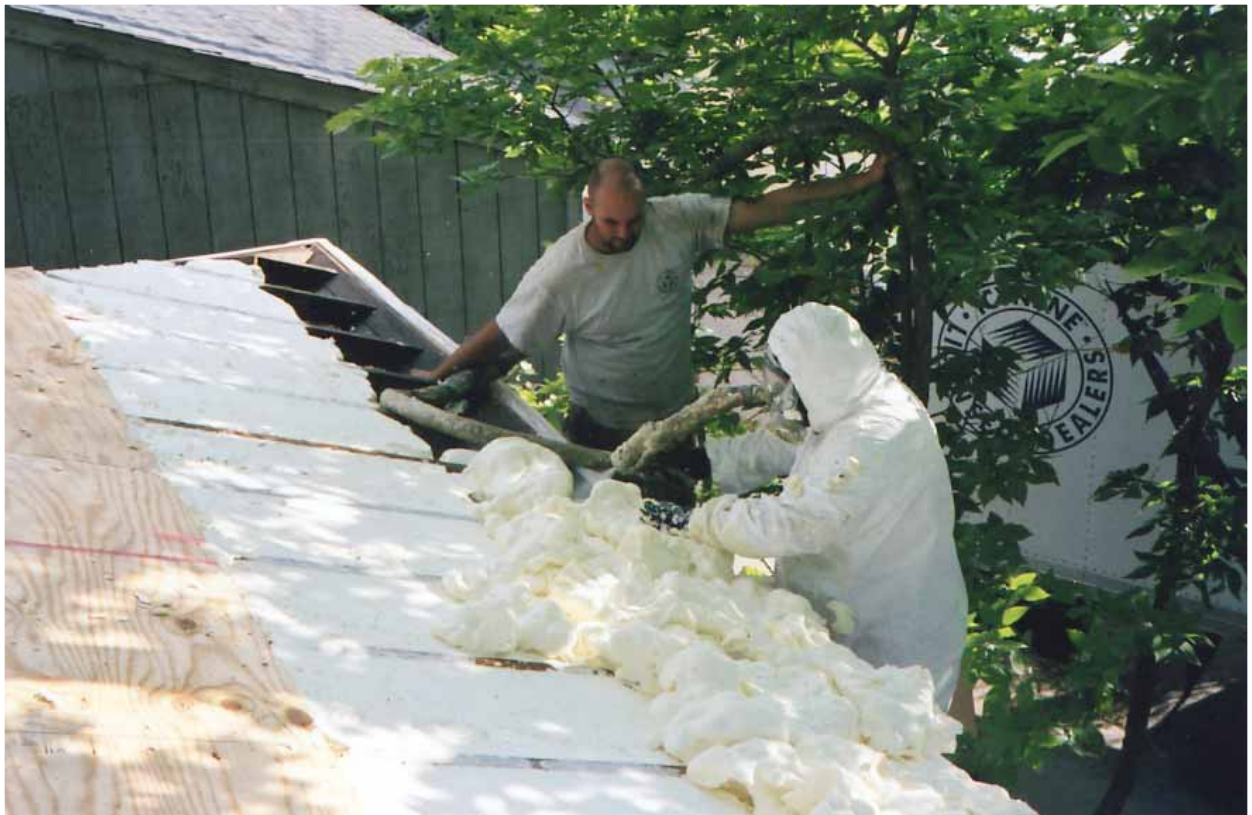
Icenene insulation is sprayed into the voids between rafters.

No more scaffolds, no more rubber membranes. The final sections of roofing along the gallery and northeast sides of the house were opened, damaged rafters repaired, insulation pumped in and cedar shingling laid. A lengthy period of heavy spring rains delayed the completion of the last roofing section. Once summer arrived with the assurance of consecutive sunny and dry weeks, the work commenced. It was a relief to discover that there were no significant problems to be found other than a few rotted rafter tails. 📍

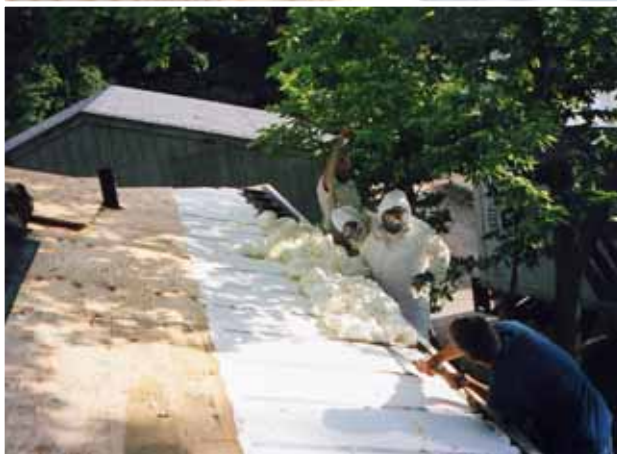
Expanded cured insulation is trimmed flat.

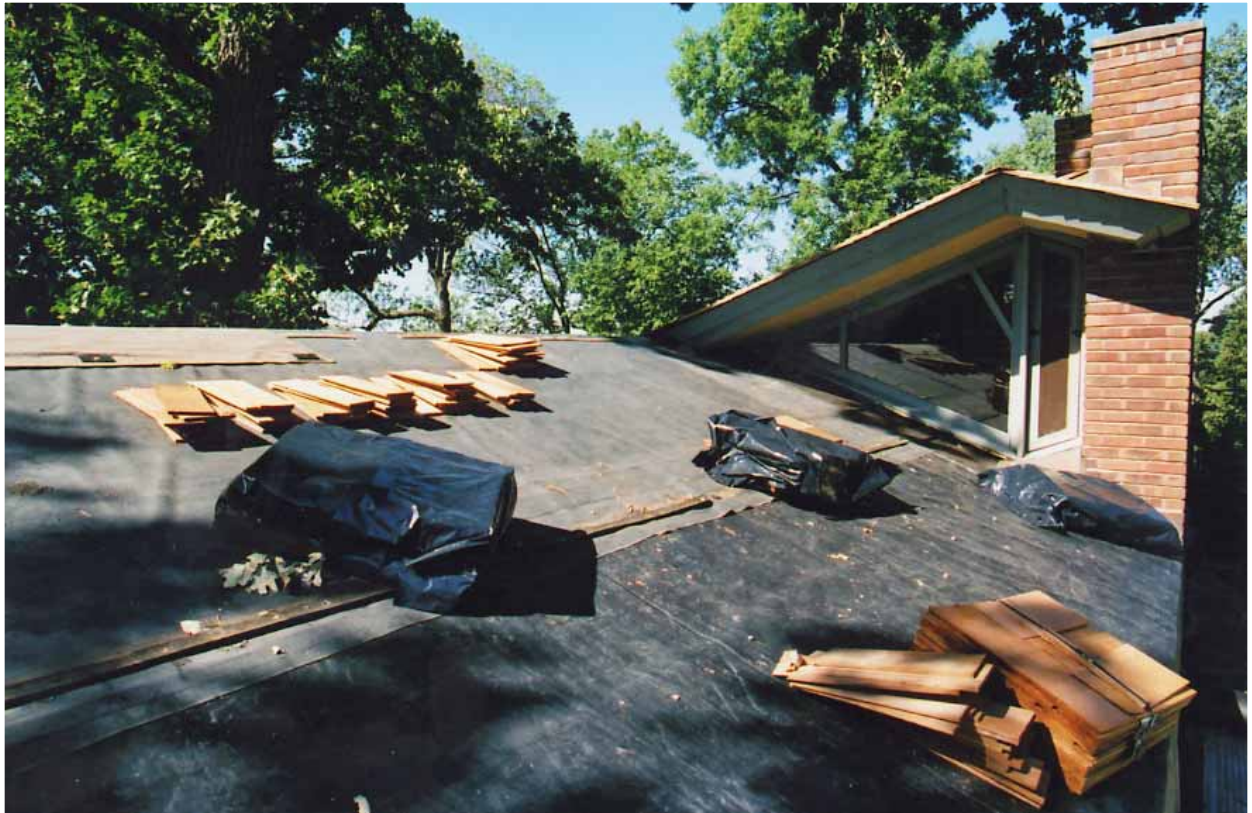
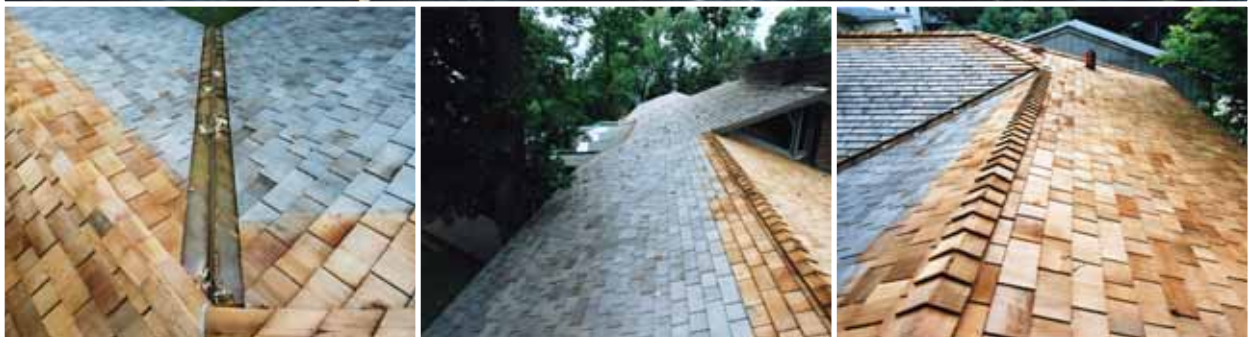
Note color change between fresh cedar shingles and year-old shingles.

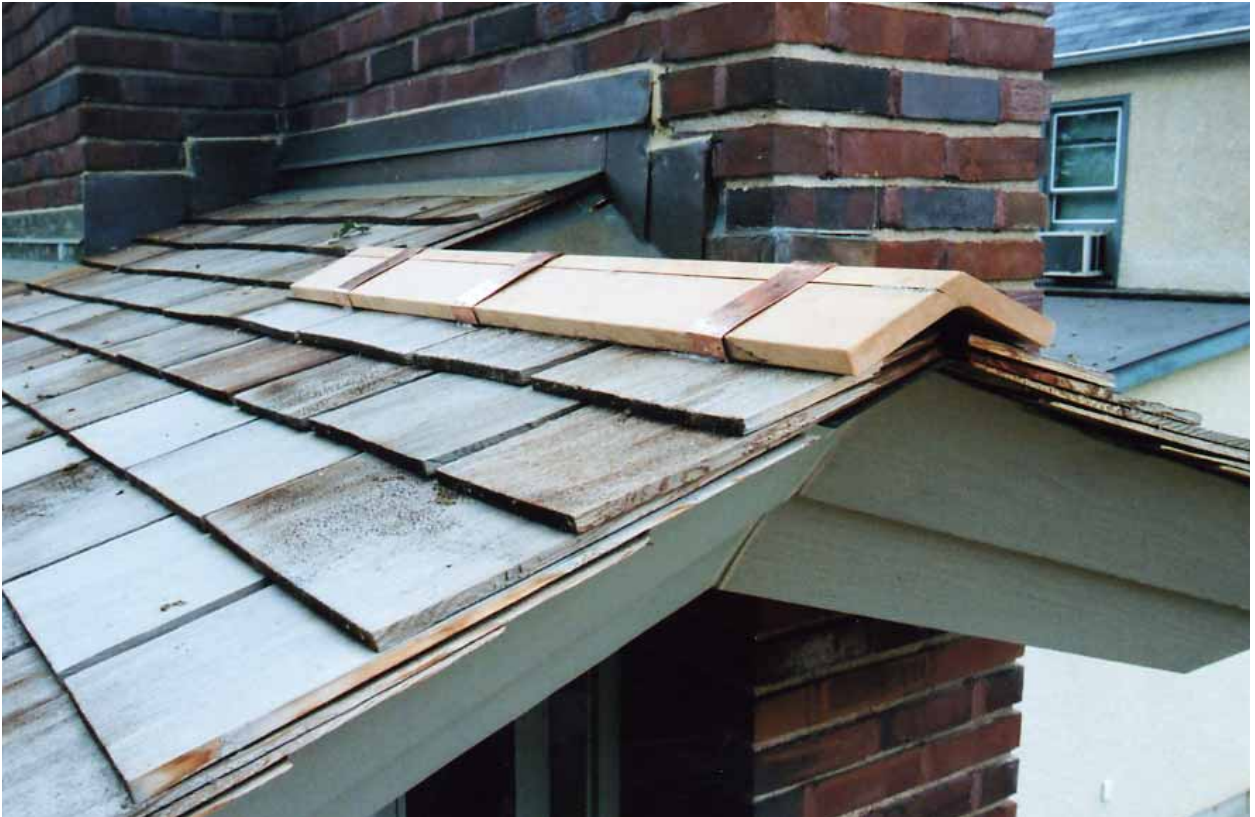
Copper straps secure the solid plank ridge boards.
