WILLEY HOUSE RESTORATION JOURNAL VOLUME 4 ■ ISSUE 4 ■ FALL 2005 ■ ■ ■

THE STATE OF THE HOUSE FALL 2005

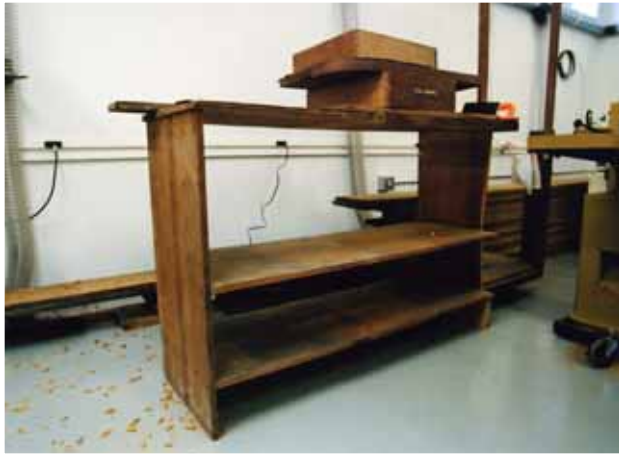
Partially reassembled lower cabinetry for the south wall of the kitchen.

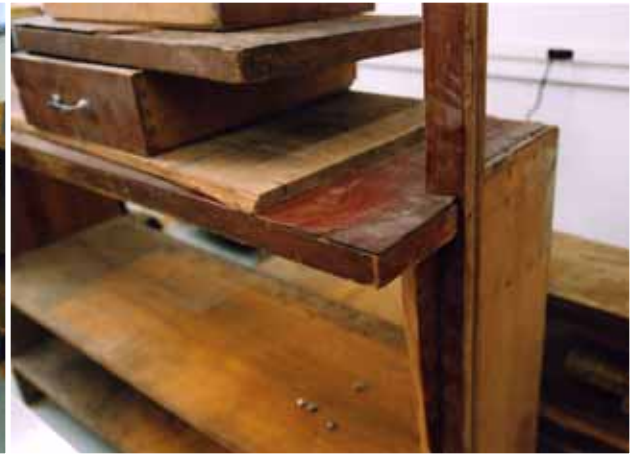
Counter edge meets closet door frame.

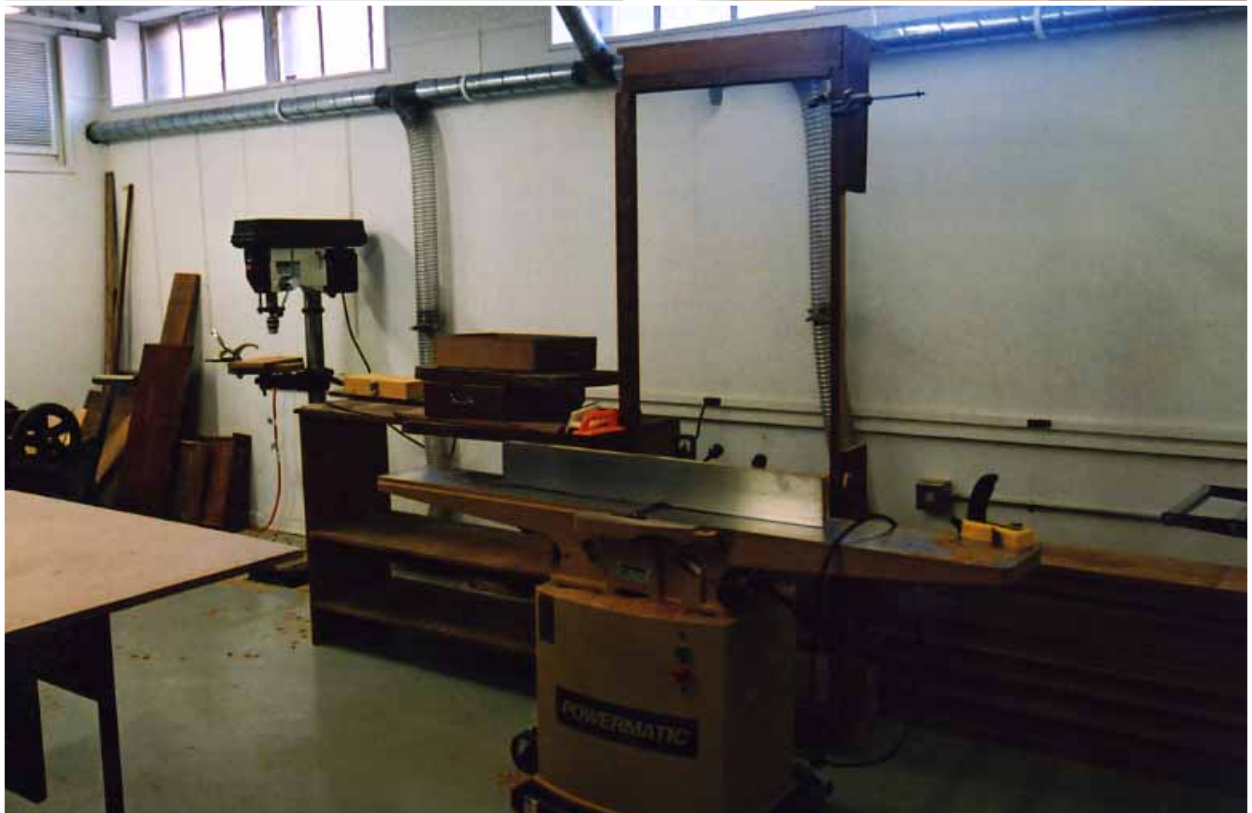
Note free-standing broom closet door frame.

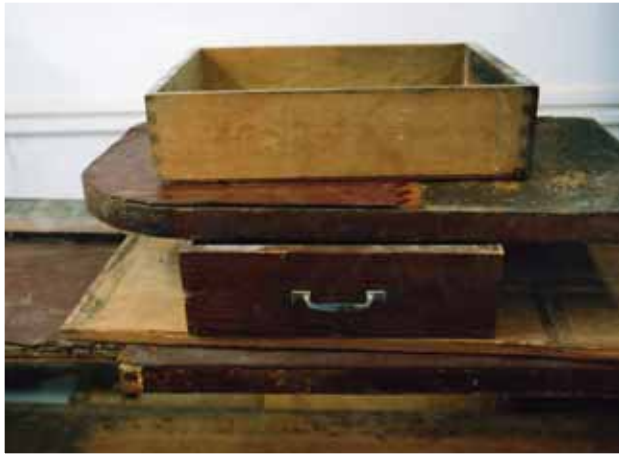
Drawers and fragments of wood edged linoleum countertop.

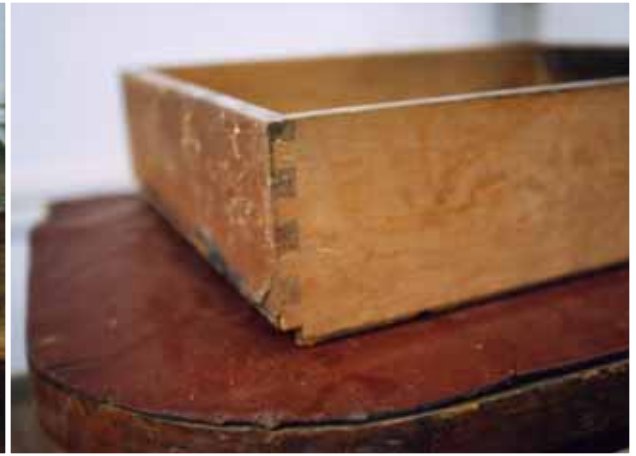
Dovetail joint on drawer.

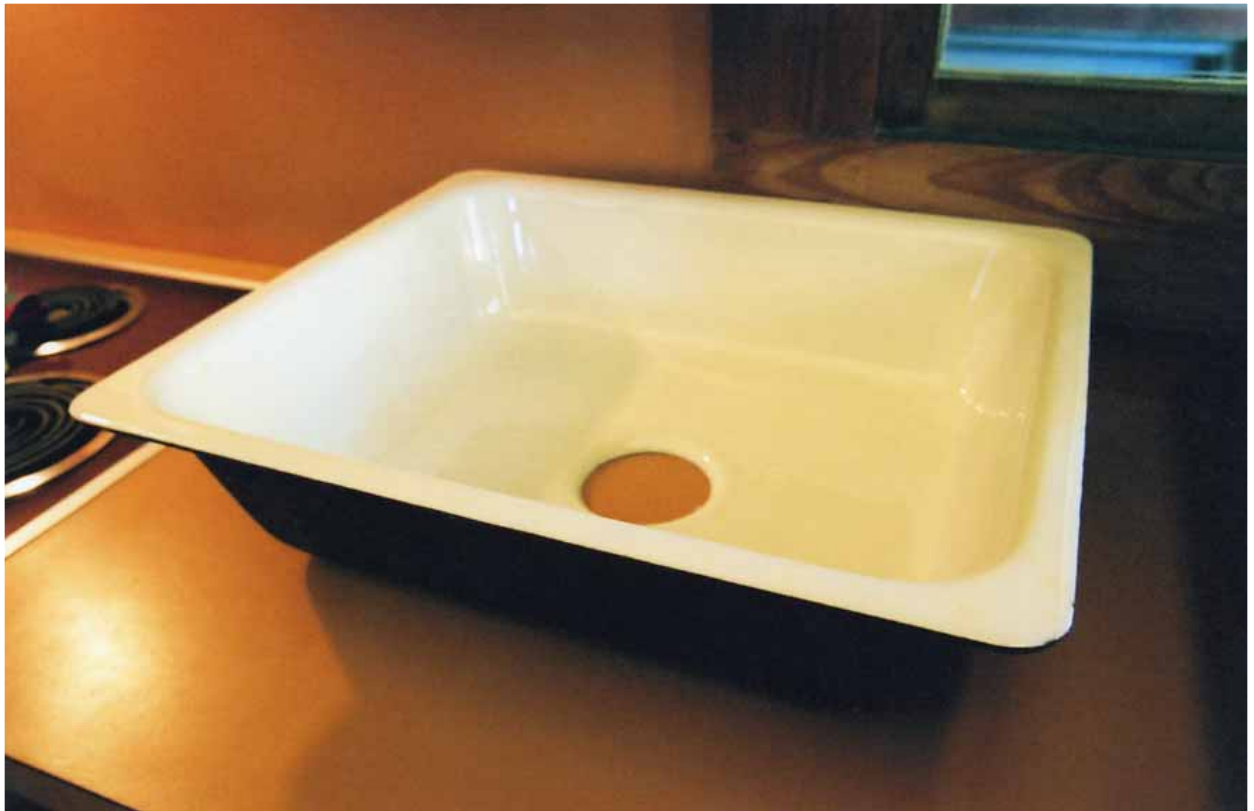
New old stock under counter sink.

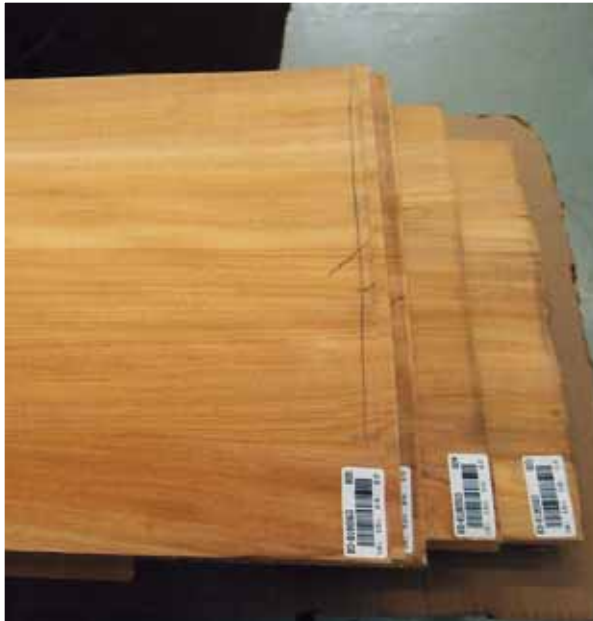
Veneer flitches come stacked as cut from the log.

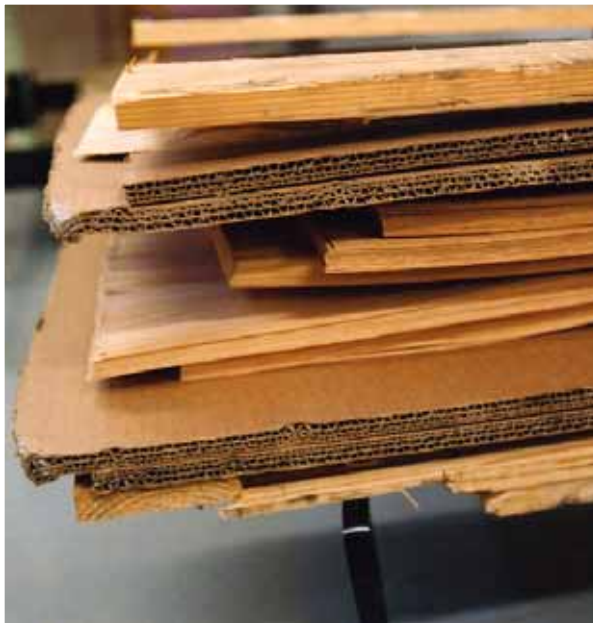
Veneer comes in sandwiched bundles of twenty flitches.

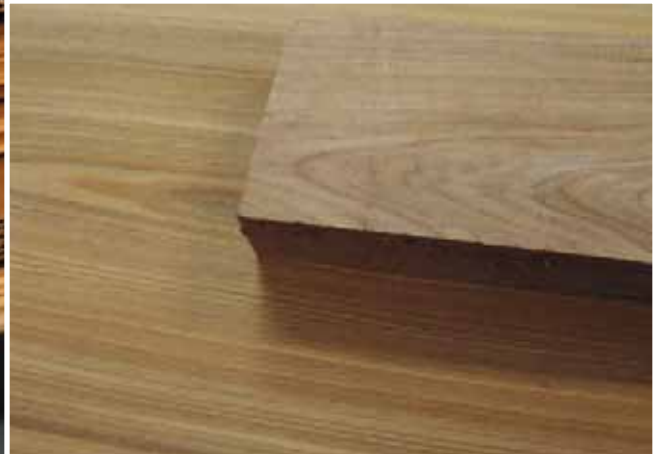
Veneer grain as compared to an old-growth board.

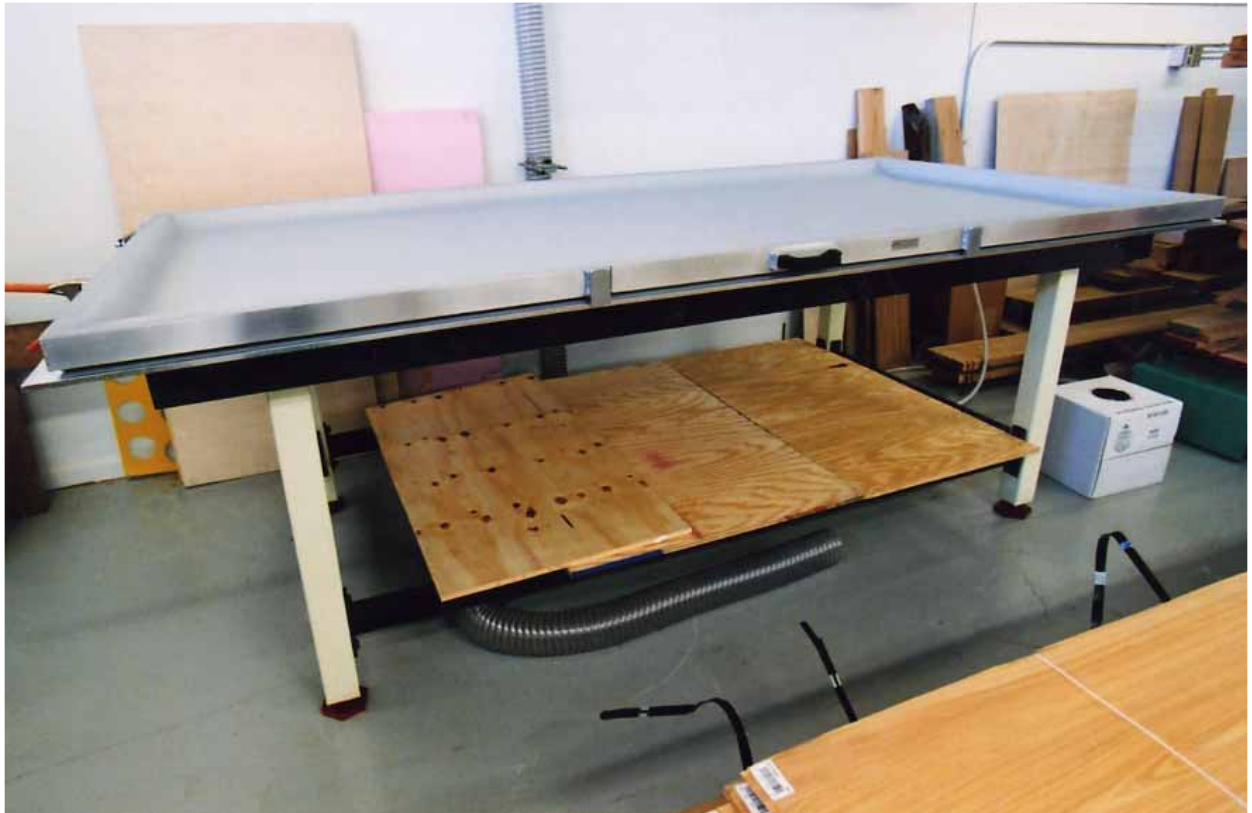
Vacuum table for the manufacture of veneered plywood.

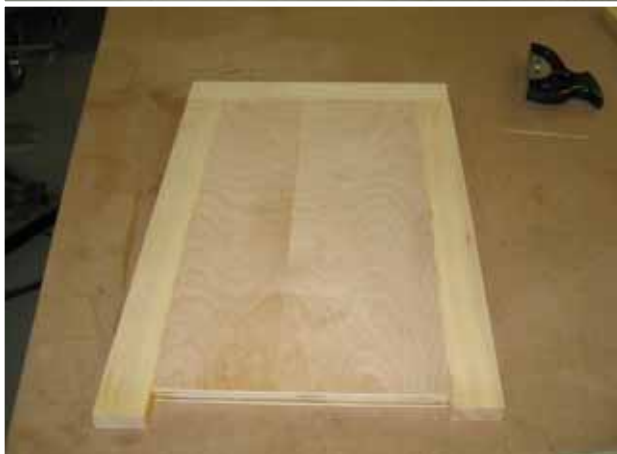
Plywood core with solid cypress edge.

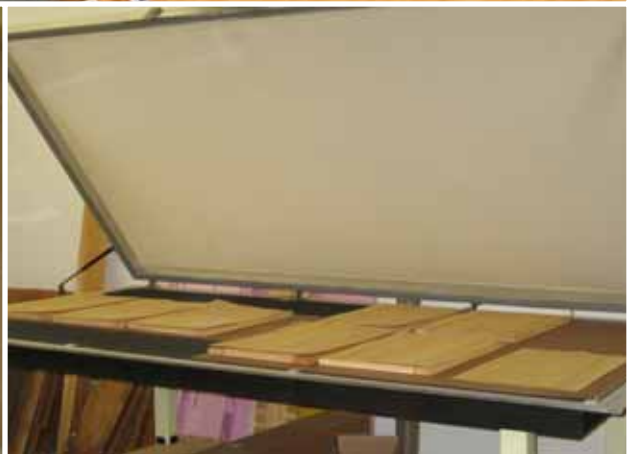
Cabinet doors with cypress veneer in vacuum table.

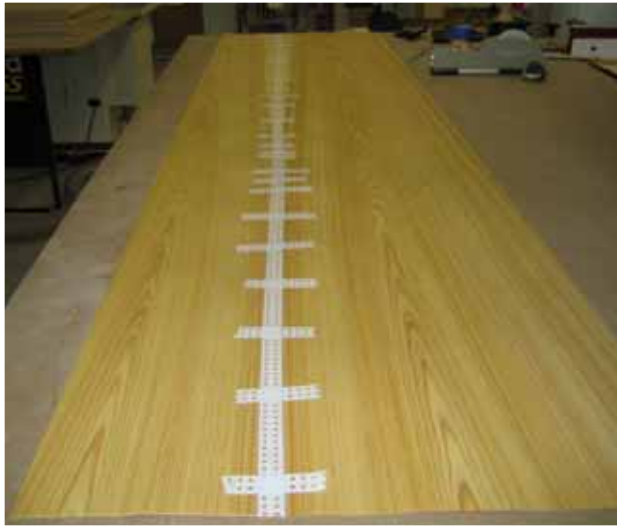
Two large veneer flitches stitched together with tape.

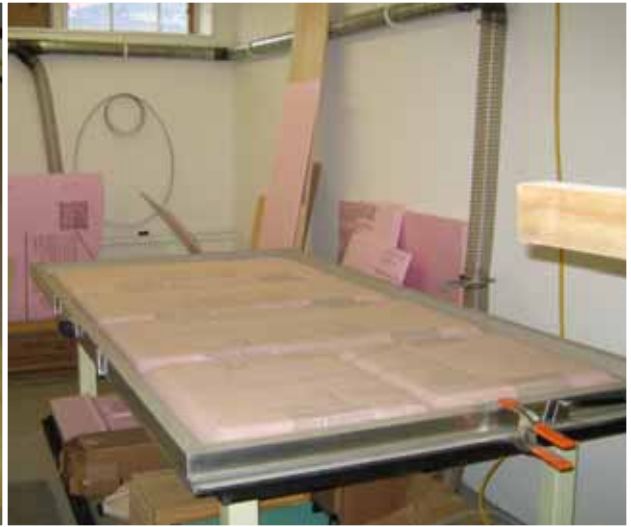
Vacuum table in use.

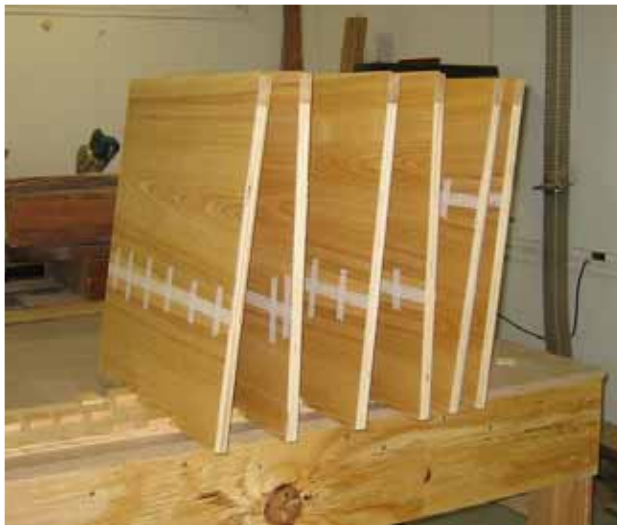
Veneered cabinet doors dry in vertical position.

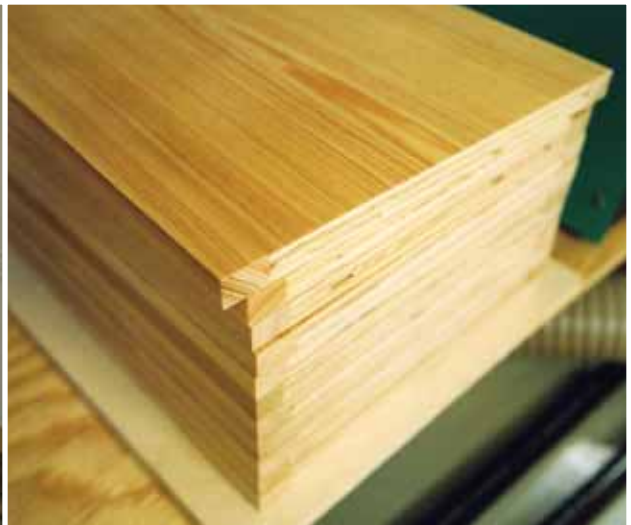
Plywood cabinet doors with solid cypress edges.

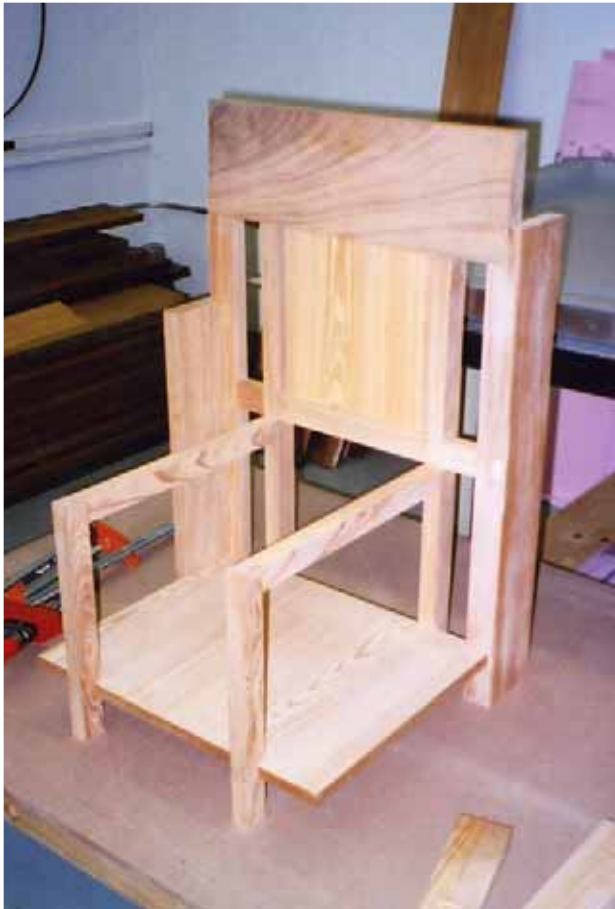
Dining chair being assembled.

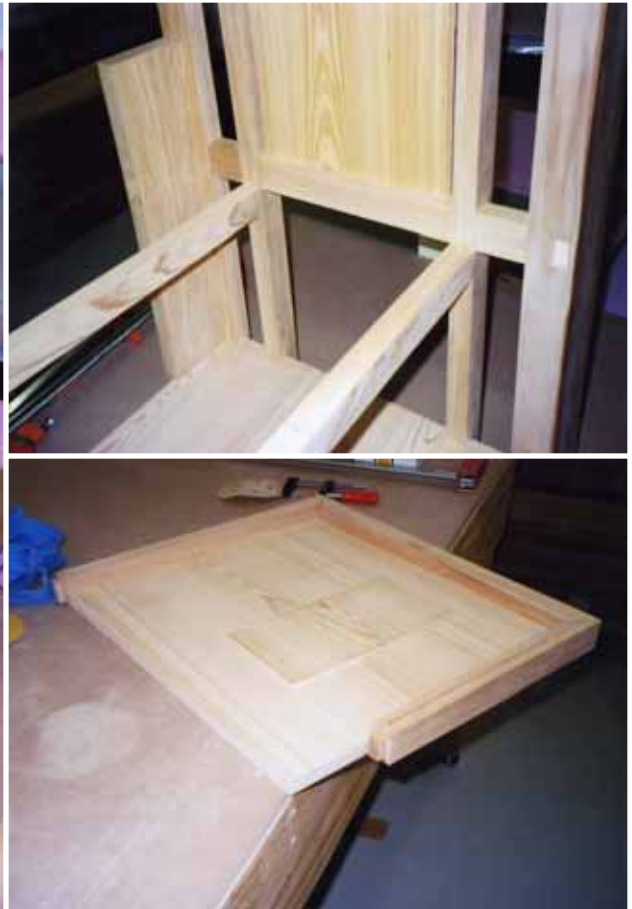
Seat of dining chair.

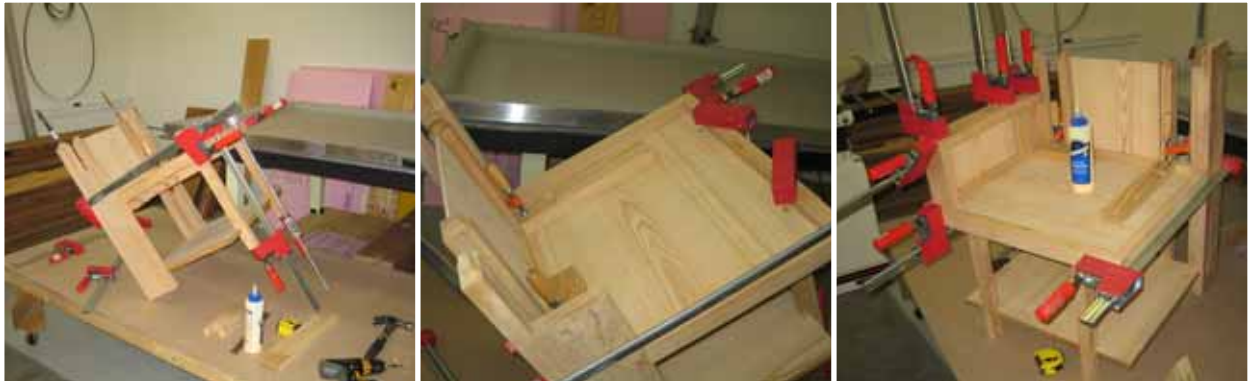
Chair is glued and clamped. No nails are used.

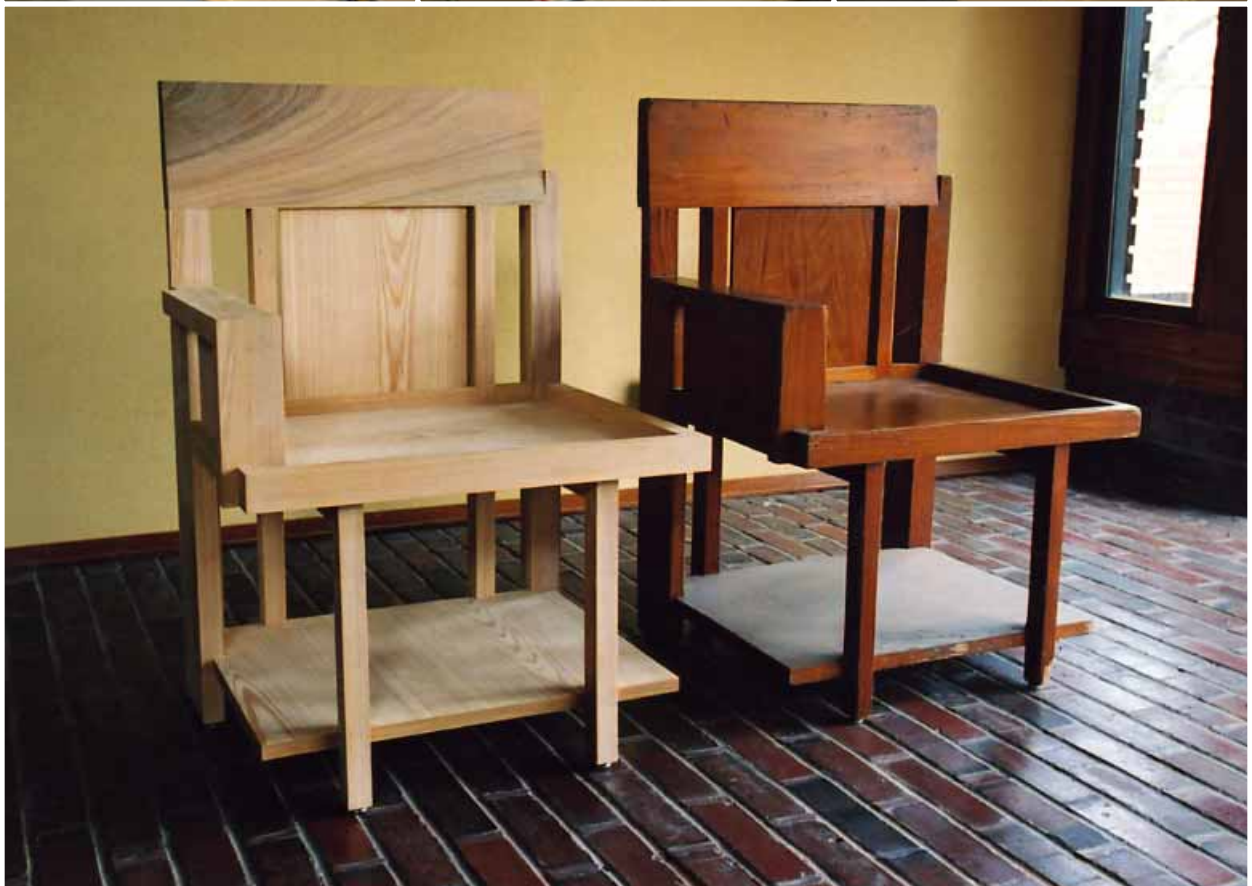
Reproduced dining chair side by side with an original.

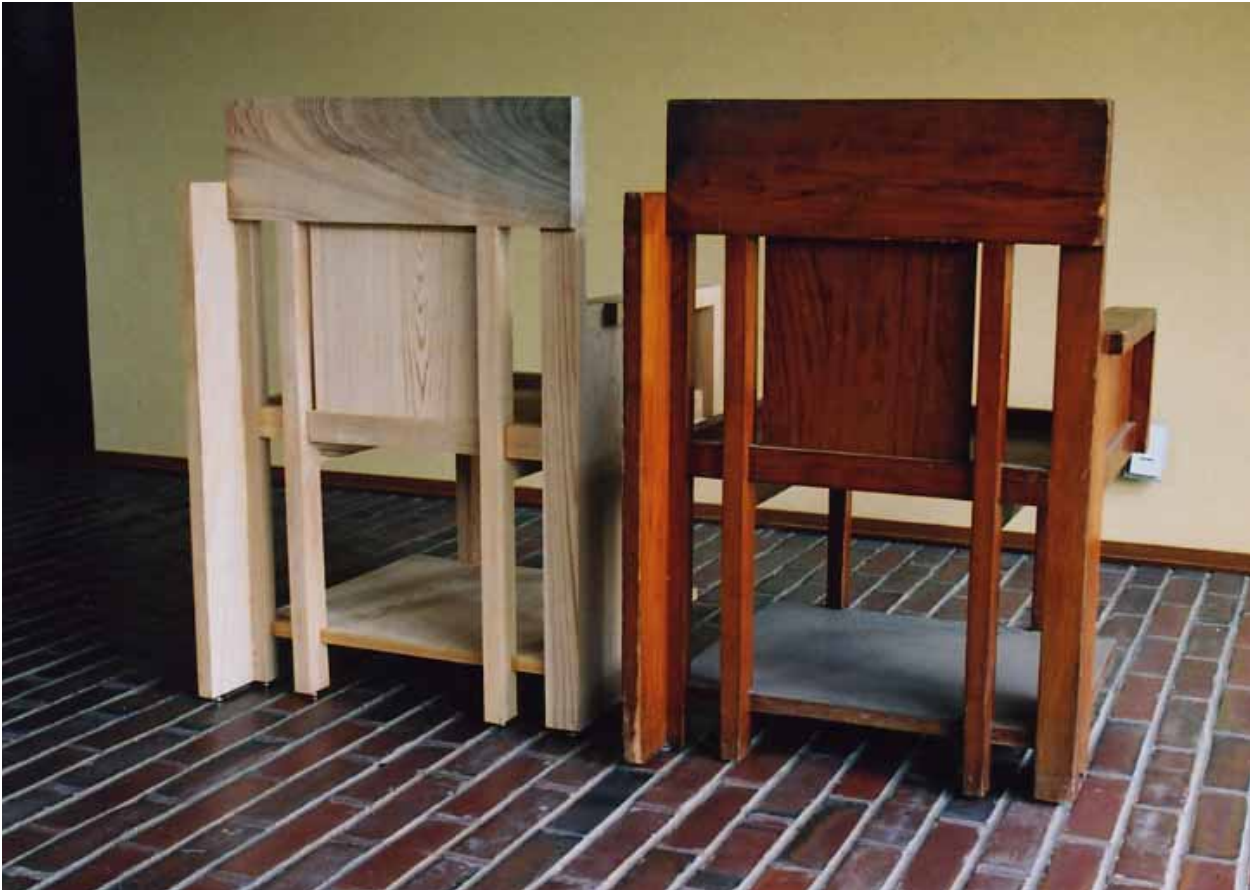
Back view of chairs.

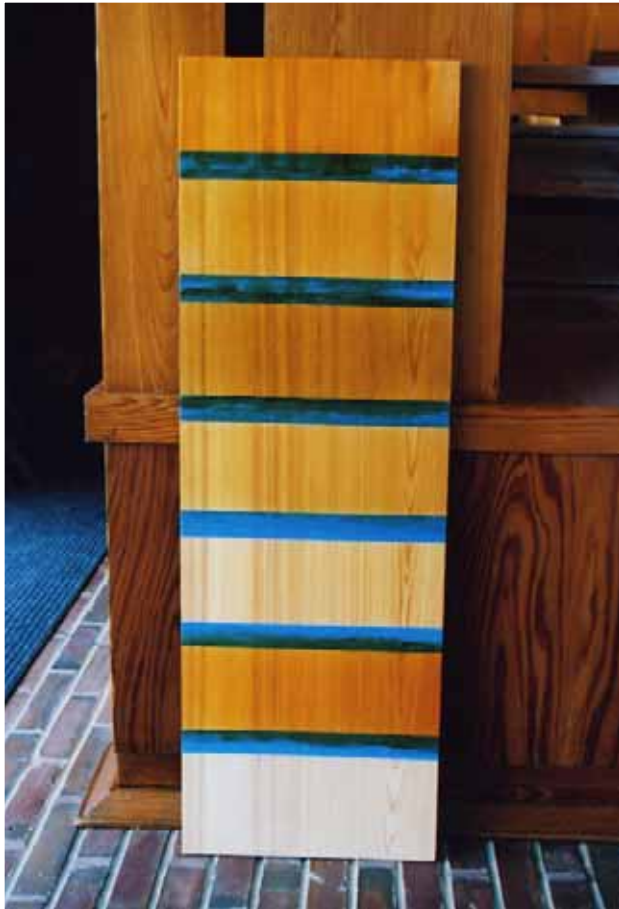
Sample board showing test patches of tinted shellacs on cypress veneer.

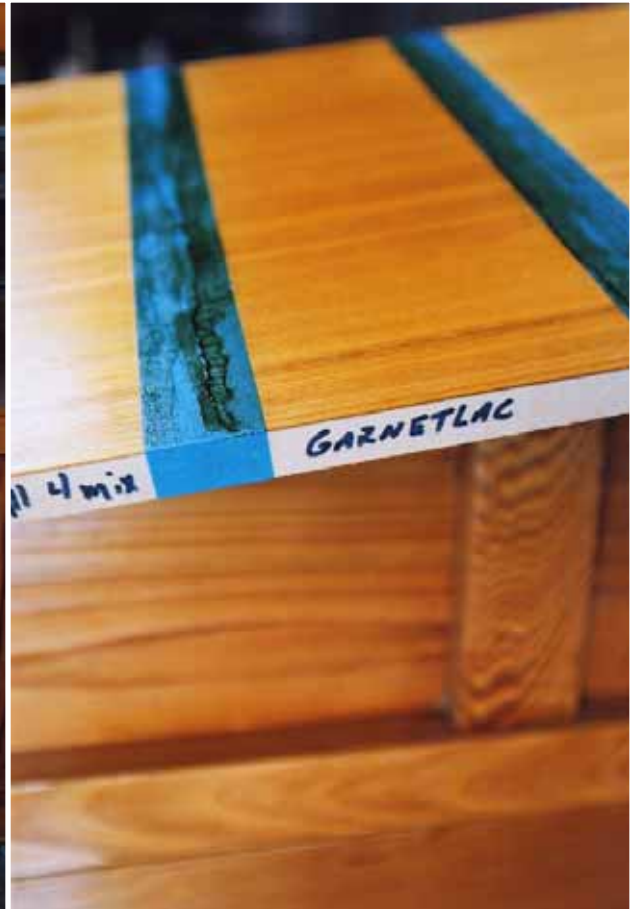
Top contenders for matching new veneer to old darkened and patinaed wood.
