T H E G A R D E N W A L L

WILLEY HOUSE RESTORATION JOURNAL VOLUME 5 ■ ISSUE 2 ■ SUMMER/FALL 2006 ■ ■ ■

THE STATE OF THE HOUSE FALL 2006

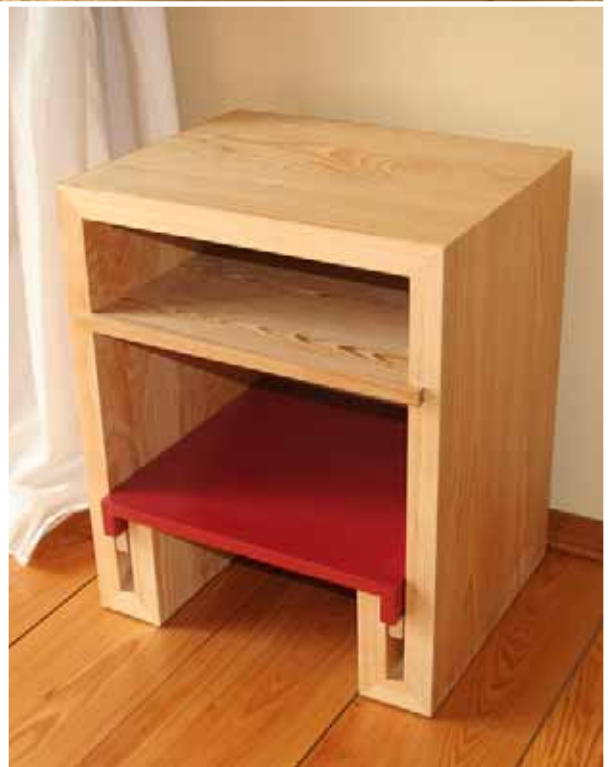
Nightstand constructed from solid cypress slabs. Red breakfast tray is removable.

Specified as being cut from thick slabs of cypress the night stands are as heavy as they appear. Each leg touches the floor and curls back upwards cradling a “breakfast tray” specified to be lacquered red. Since this design was just prior to any red being referred to as Cherokee Red by Frank Lloyd Wright our red will match the original linoleum of the house, which as it turns out is a perfect match to Cherokee Red as it appeared in 1936 at Fallingwater.

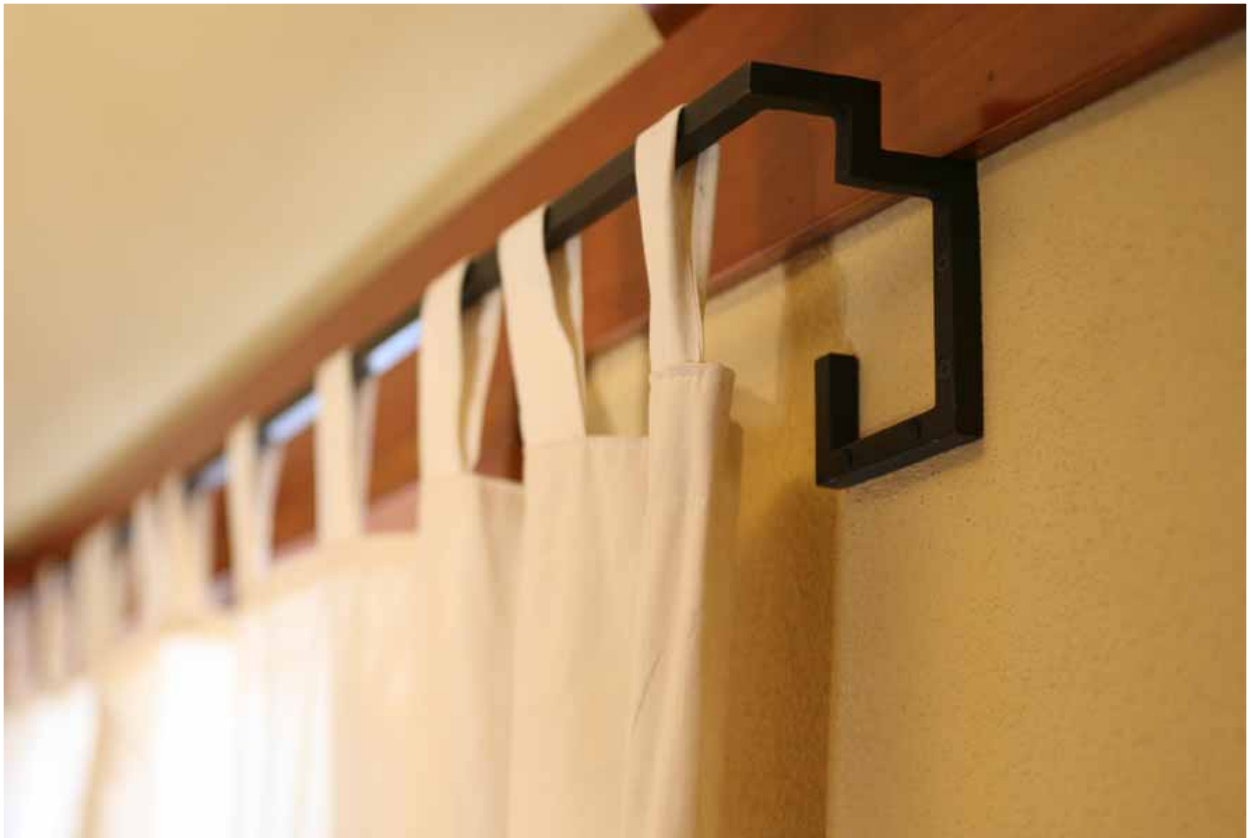
Fabricated curtain rod at the master bedroom French doors.

The guest bedroom uses a surface track for curtains that is a match to the living room. The curtains slide along the bottom of the deck, clear of the arc of the opening internal screens. The height and location is exactly the same as the living room curtains. The master bedroom however is a different matter. From the number of holes in the walls and woodwork it was pretty obvious that many attempts at a curtain solution were tested over the decades. Likely, none of them were particularly successful because none remained when we acquired the house. The challenge has been to find a way to hang curtains that also allows for the opening of interior screen windows and doors. Our solution for the curtains at the French doors was to set the rod high enough so the doors could swing beneath it and the curtains be pulled back out of the way of the doors. The rod wraps around the corner to address the corner windows on the garden side of the bed room. Easy. The other corner windows however are under the deck and there is very little space between them and the ceiling (deck bottom). Here we engineered rods to appear to be like the fixed rod across the room, however they separate at the corner and hinge out to allow the opening of the windows.

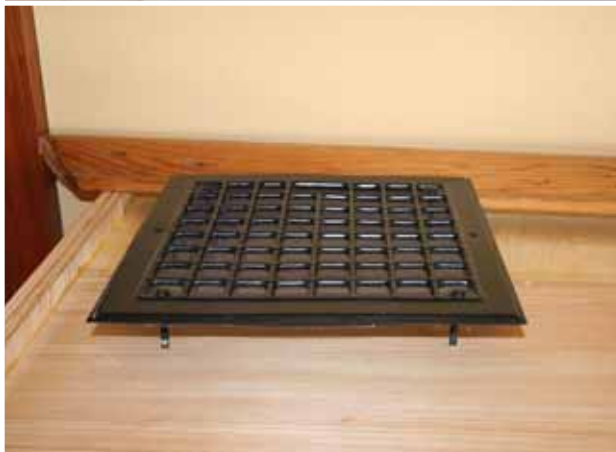
Original metal vent and new cypress vent to air space under floor. Since the bed rests directly over the opening a flush mounted vent solution was required.

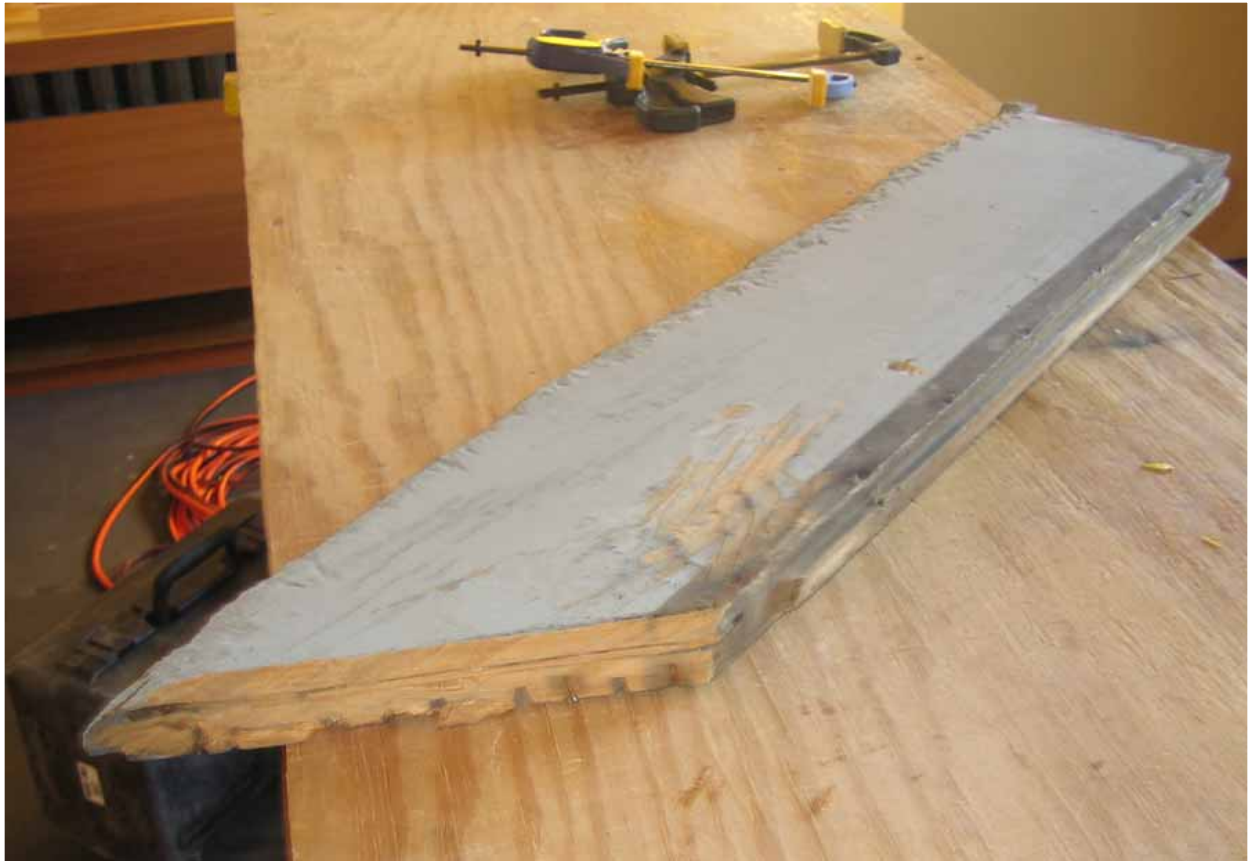
Squirrel-damaged window sill. Note kerfed saw cuts in bottom of board to prevent warping.

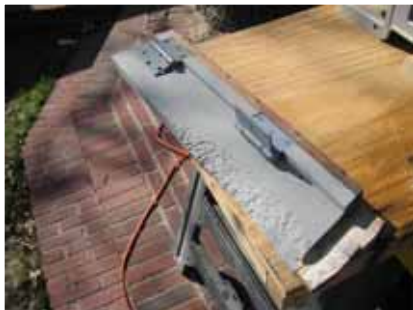
Damaged sill.

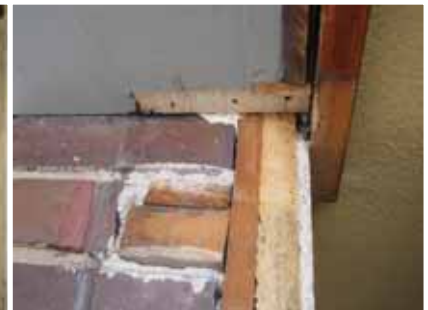
With frame removed the wall structure is revealed. From inside: paint, colored plaster, scratch coat plaster, fiberboard, furring strip, brick and nailer block, stain on exterior brick showing where the window frame ends.

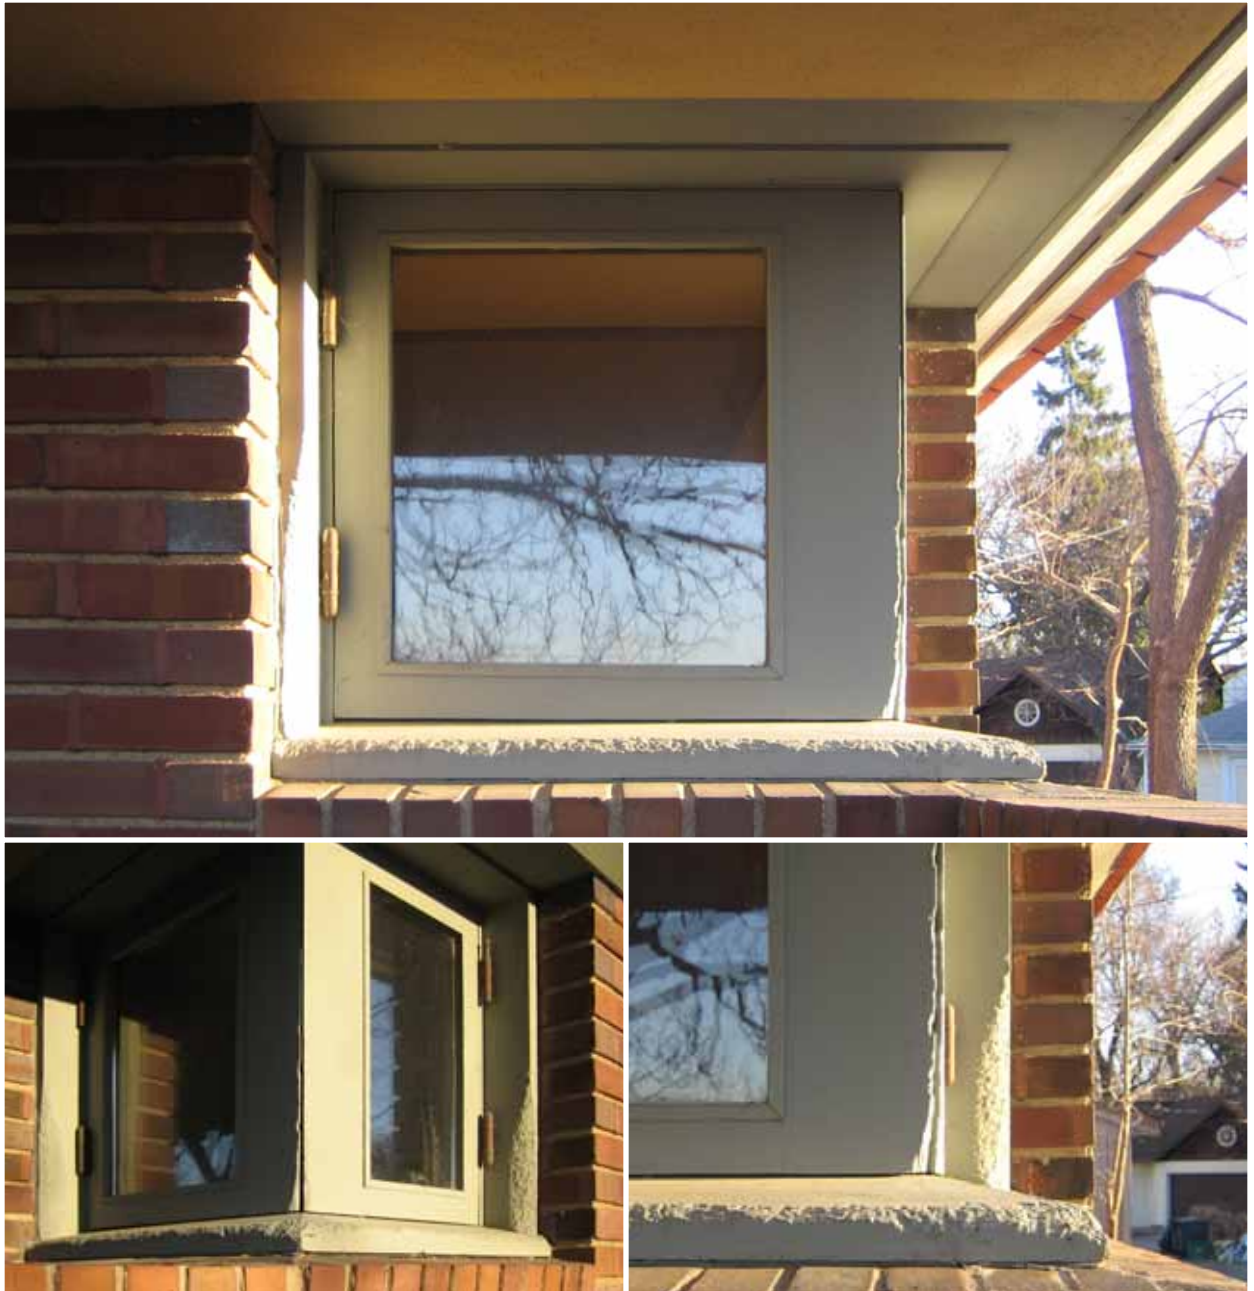
Squirrel-damaged corner window prior to replacement.

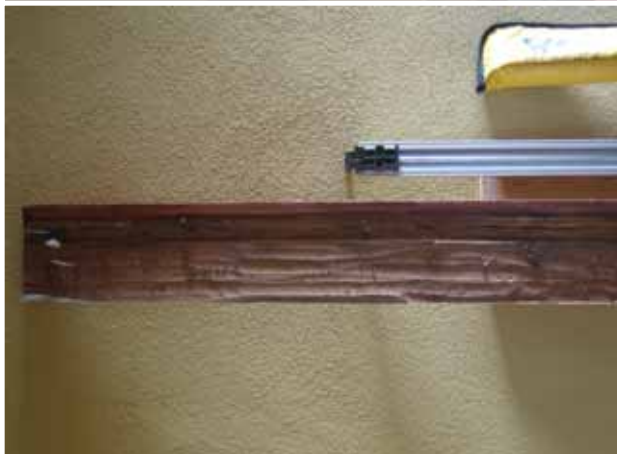
Original sill was hand hewn at the back to fit.

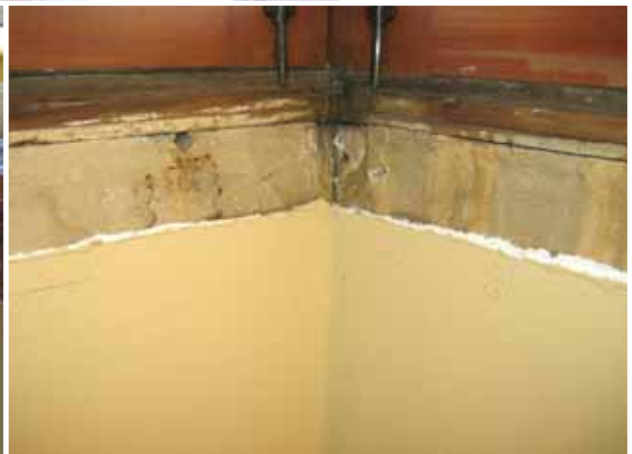
Historic record of leakage, new paint, old paint and tinted plaster.
