T H E G A R D E N W A L L

WILLEY HOUSE RESTORATION JOURNAL VOLUME 6 ■ ISSUE 2 ■ SPRING 2007 ■ ■ ■

THE STATE OF THE HOUSE SPRING 2007

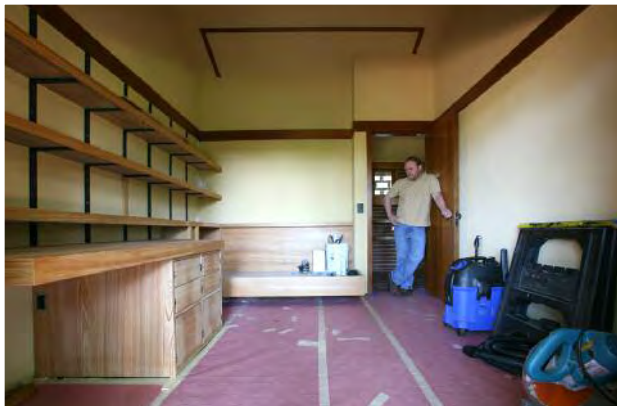
Shelves are supported by welded metal brackets.

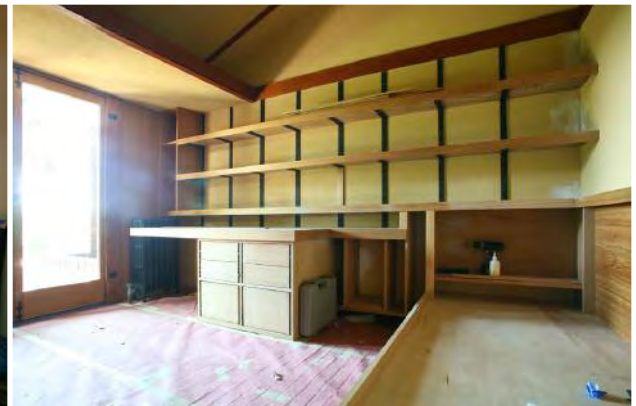
Study underway with doors and drawer fronts not yet in place.

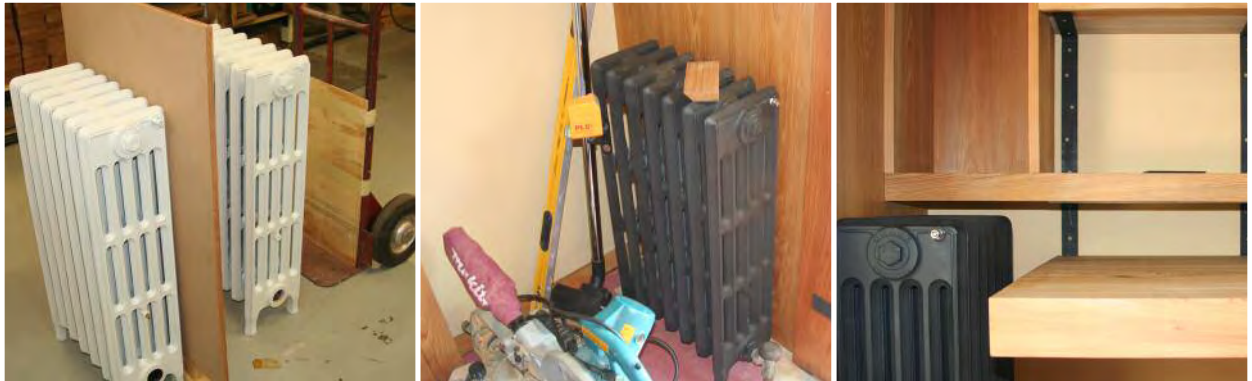
Replacement radiators in primer and in place painted black.

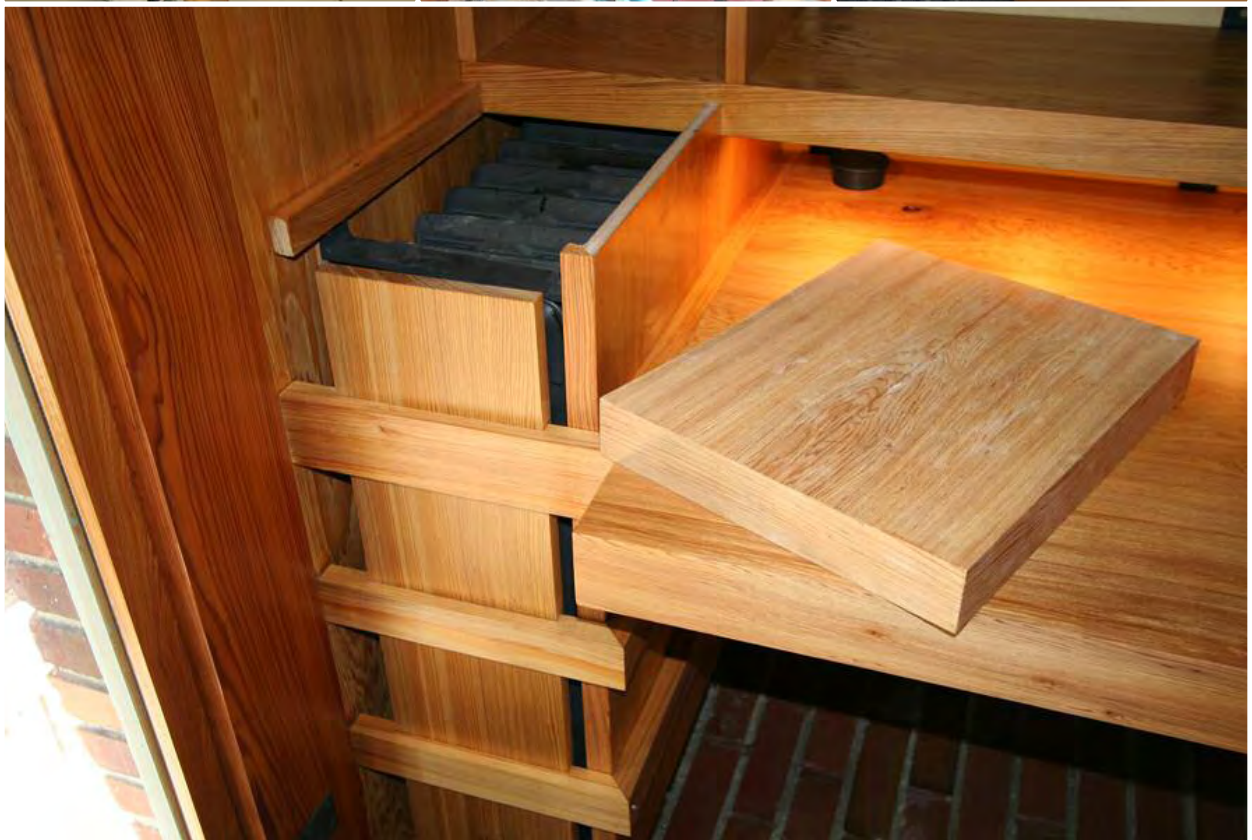
Radiator covers have removable access panels.

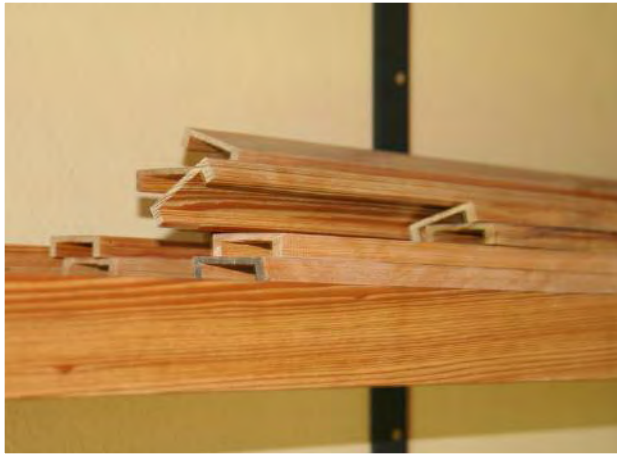
Dado cut bracket caps are cut from solid stock.

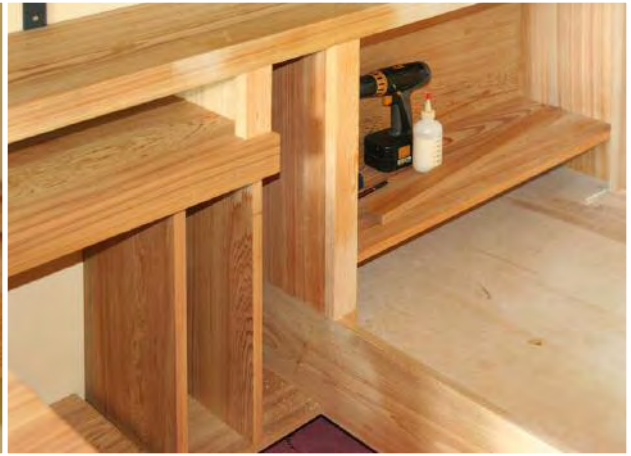
Moveable shelves.

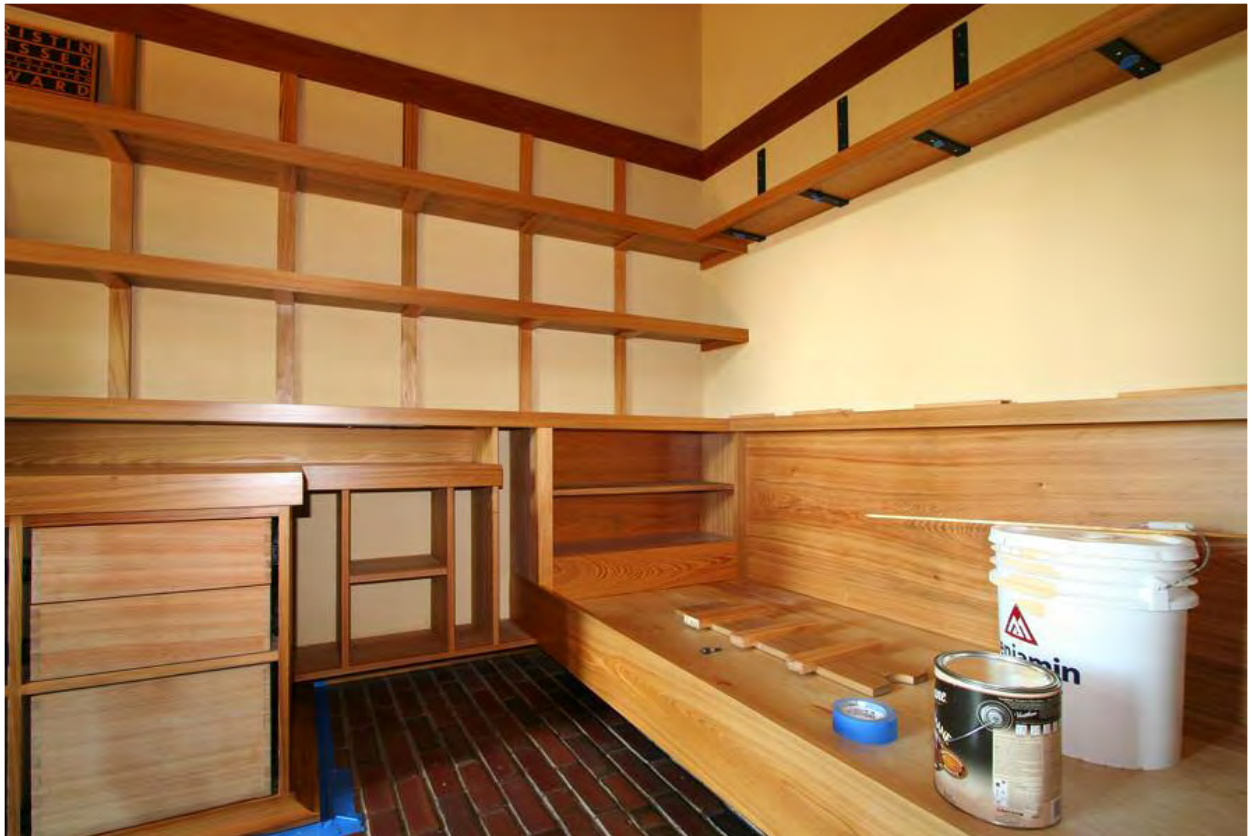
Showing all shelves in place waiting for doors and drawer fronts.

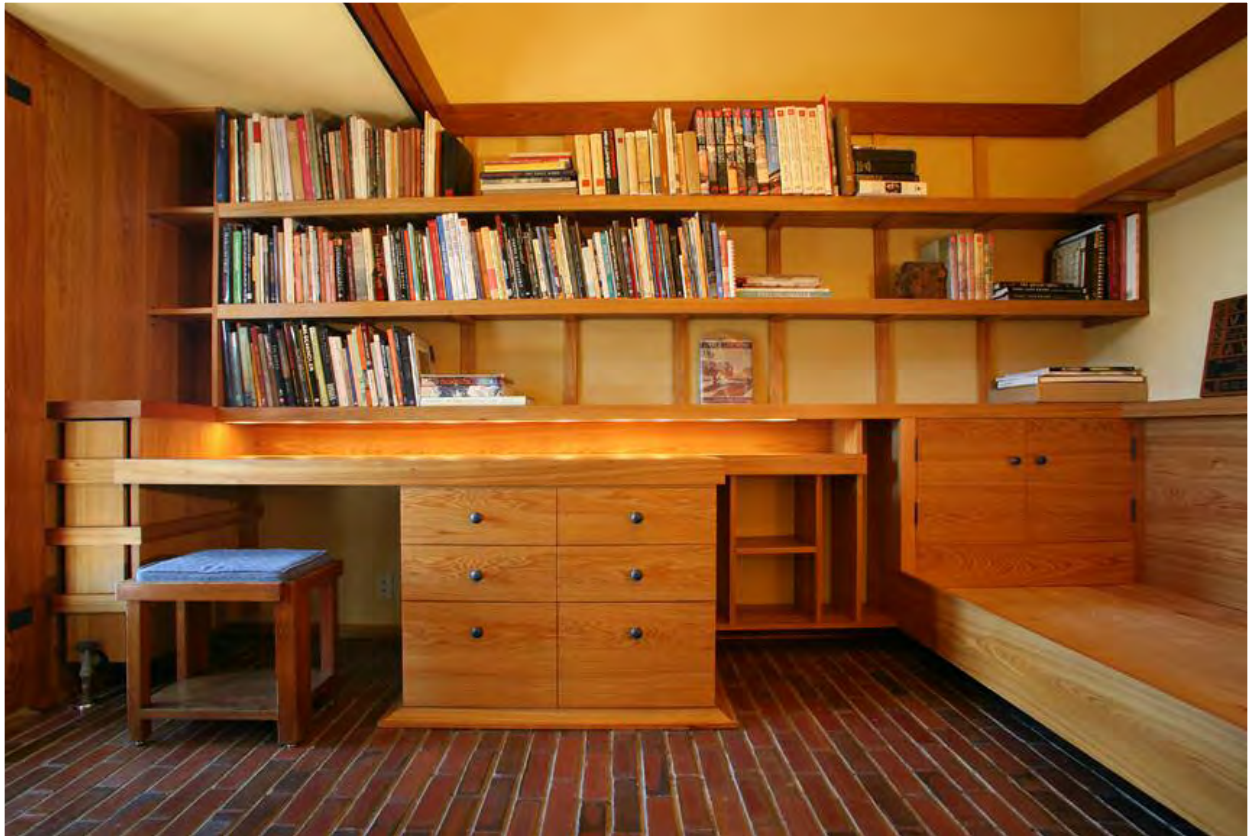
Drawer fronts and doors mounted.

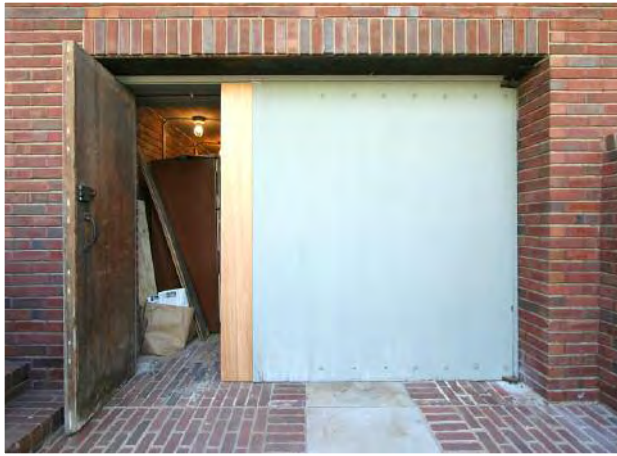
Access door swings out to the left.

The Willey House garage door swings outward in two parts, requiring two steps; first the access door must be unlocked and swung outward before two spring bolts are released at the top and bottom of the large swinging door, allowing it to move freely. The length and substance of the car door caused it eventually to sag. It dragged across the face of the brick floor damaging both bricks and door. The door is built in the same way that interior solid core doors are constructed with sandwiched boards running cross directionally. Three men were required to carry it to the house, Nancy Willey reported to Wright in a letter during construction. The friction of the dragging door bottom created a levering action that eventually caused the door to crack. The door panels have been rejoined with some interior steel reinforcement and the hinges shimmed-up to a height that no longer causes it to snag on the bricks. In correspondence between Nancy and Wright there is mention of the door initially being installed improperly. Ample evidence demonstrates how it was originally hung. The access door swung in rather than out. Hinge ghosts are still visible and mismatched bricks appear in the wall where the original hinge blocks were fastened into the corner of the wall. 📐

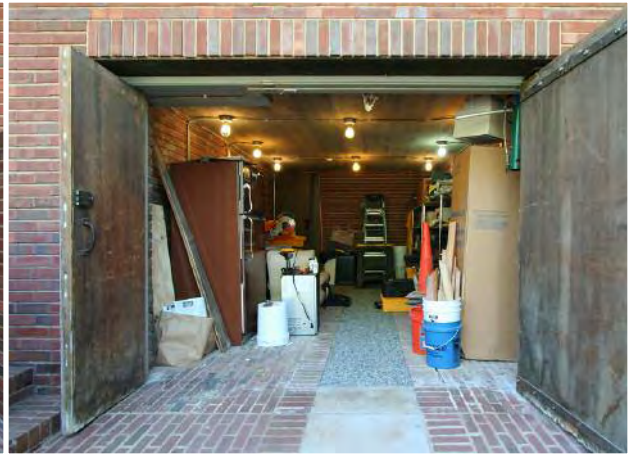
Main door swings out to the right.

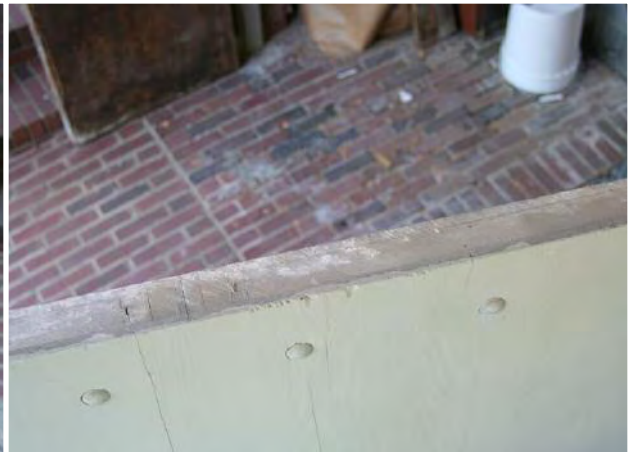
Top of main door showing construction.

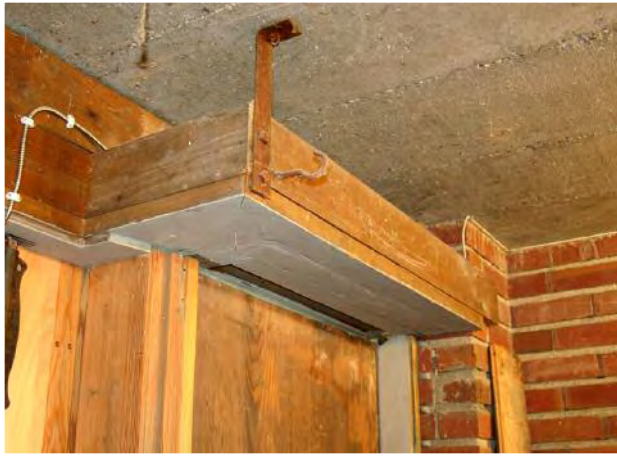
Stop is suspended from the ceiling with a metal strap.

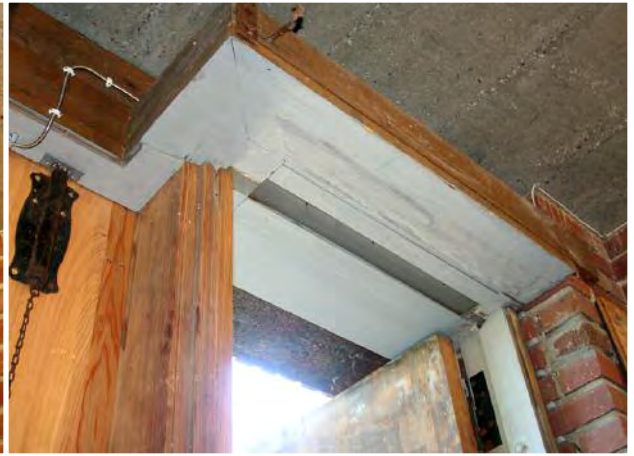
Access door is slightly recessed from main door.

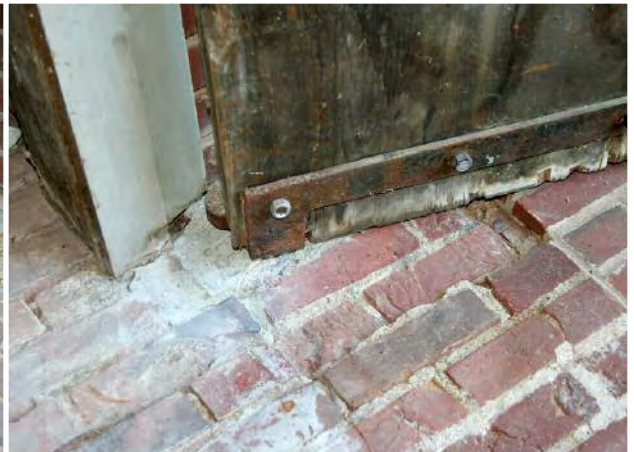
Binding hinge on main door damaged bricks.

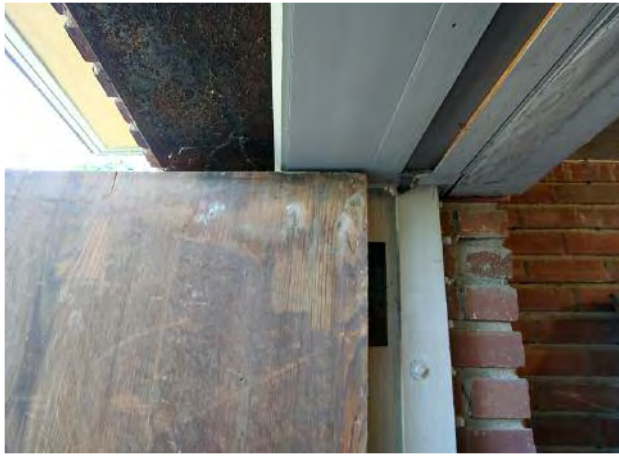
Ghost of mistaken hinge placement.

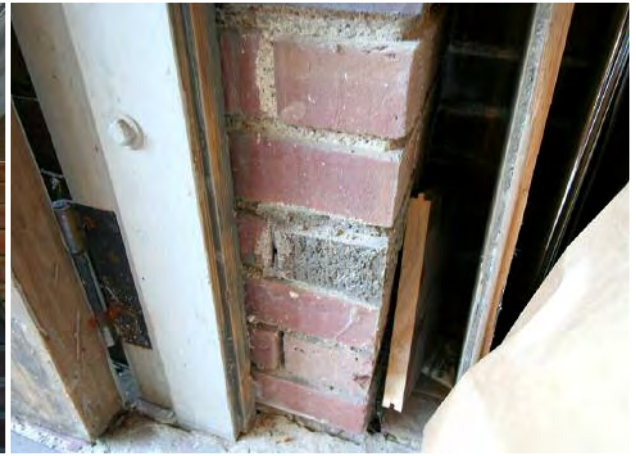
Mismatched bricks where hinges formerly mounted to wall.

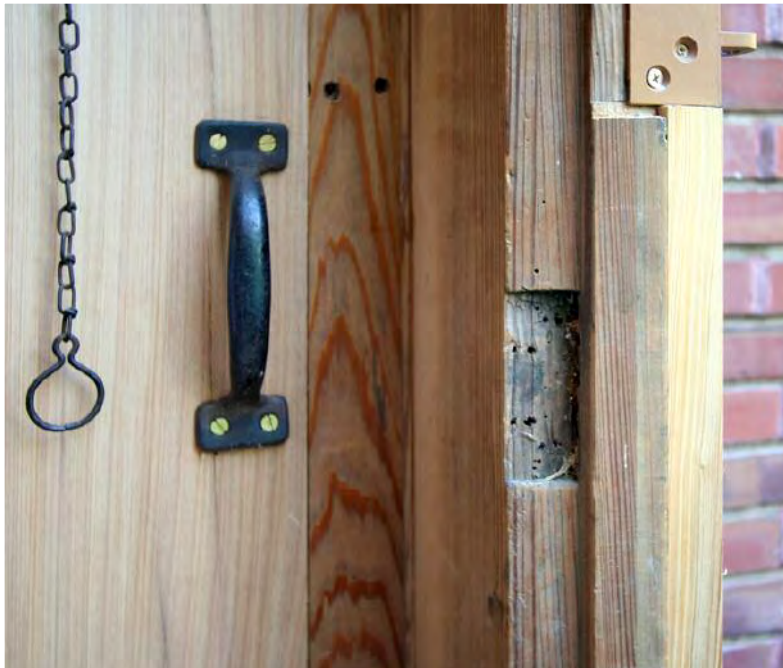
Latch position from mistake.

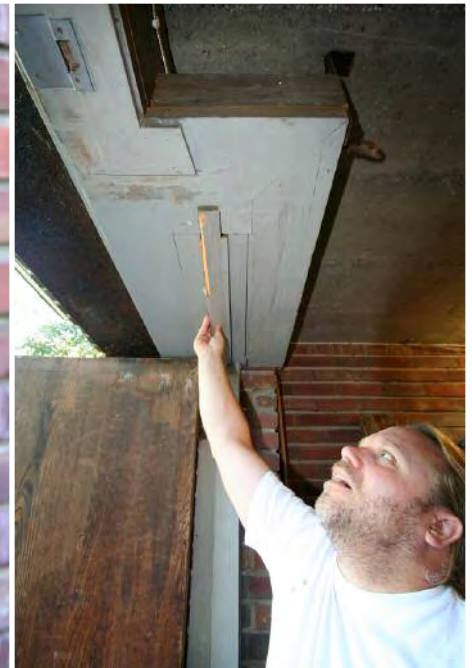
Door stop was improvised from Willey House indoor base shoe.

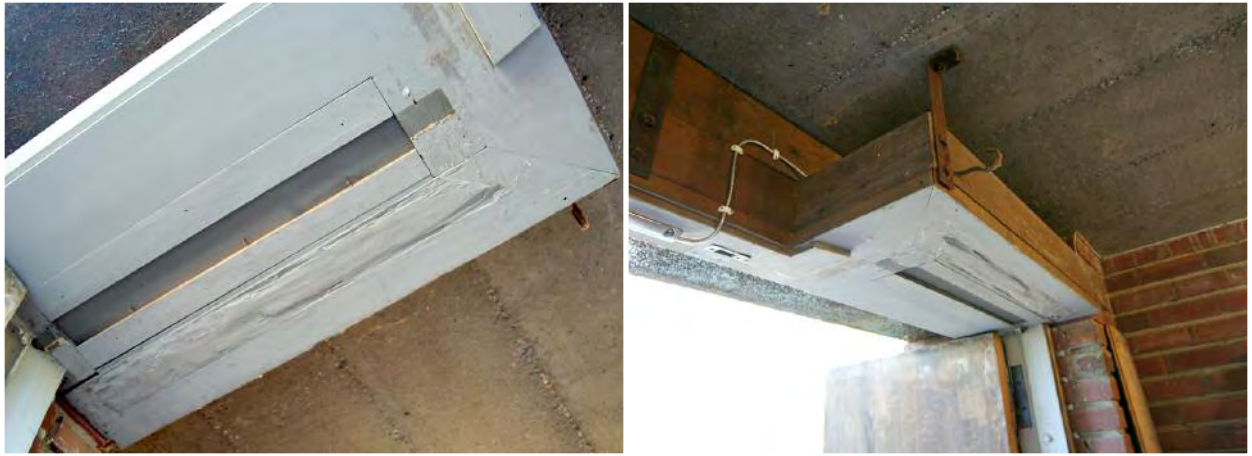
Top of door stop reconstructed after originally being installed backwards.
