WILLEY HOUSE RESTORATION JOURNAL VOLUME 2 ■ ISSUE 2 ■ SPRING 2003 ■ ■ ■

## THE STATE OF THE HOUSE SPRING 2003

Exterior brick restoration, returned mobility to the fireplace arm and miscellaneous interior work waiting for warm weather.

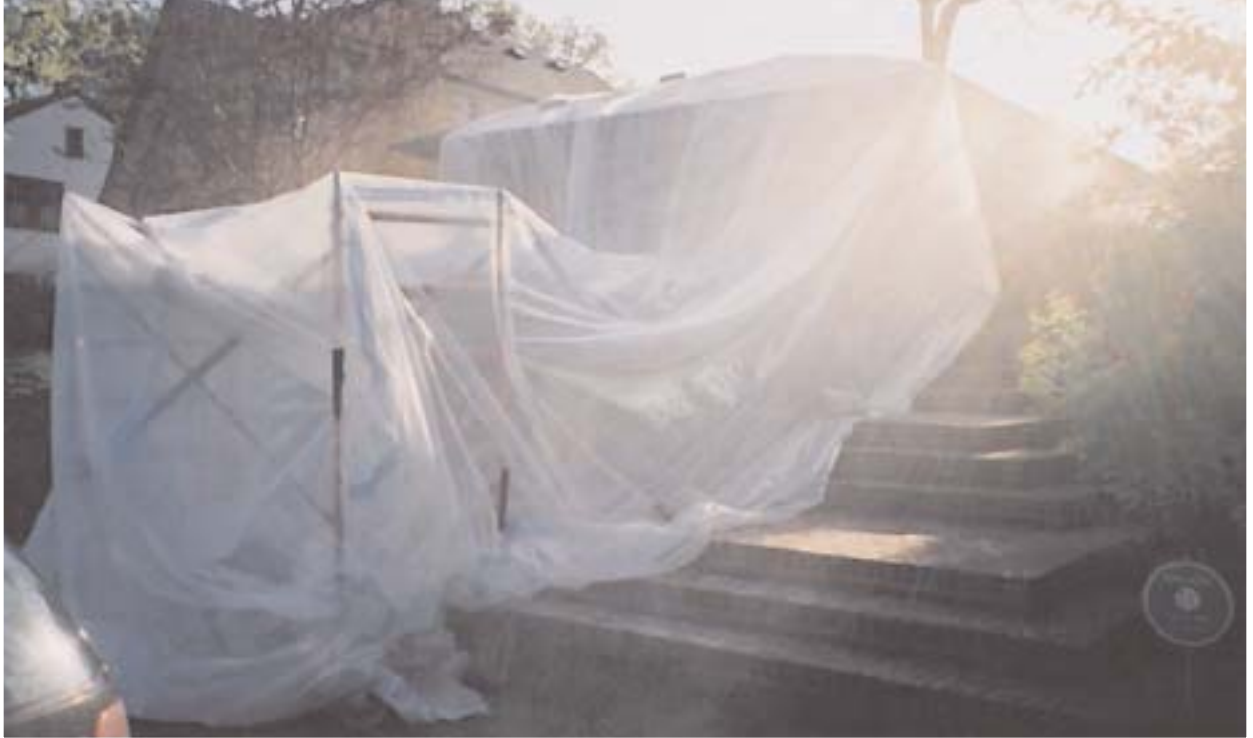
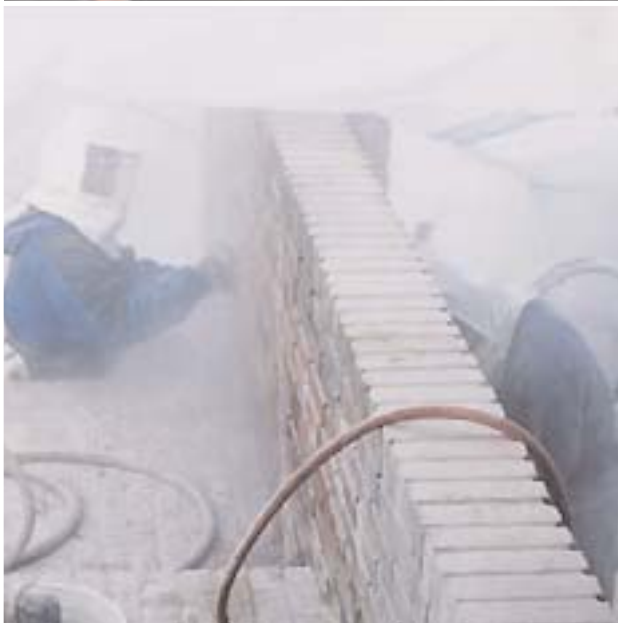
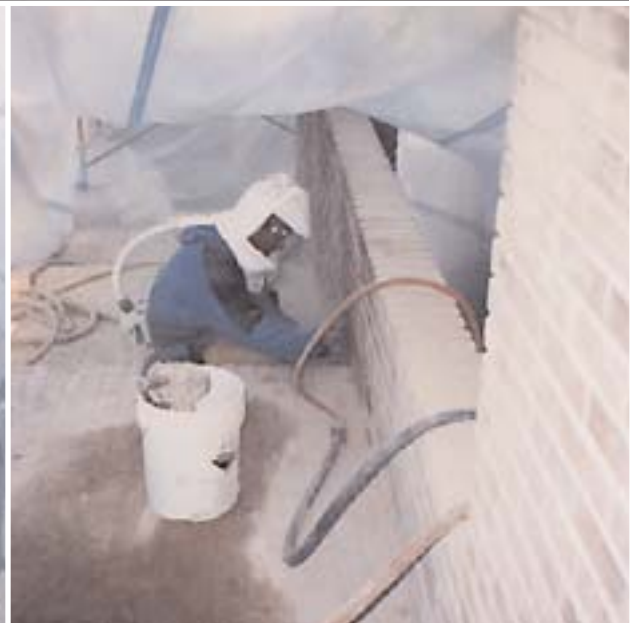
## WORK ENCLOSURES

Plastic enclosures were erected around the house to contain clouds of mortar dust. Tuck pointers worked in space suits.

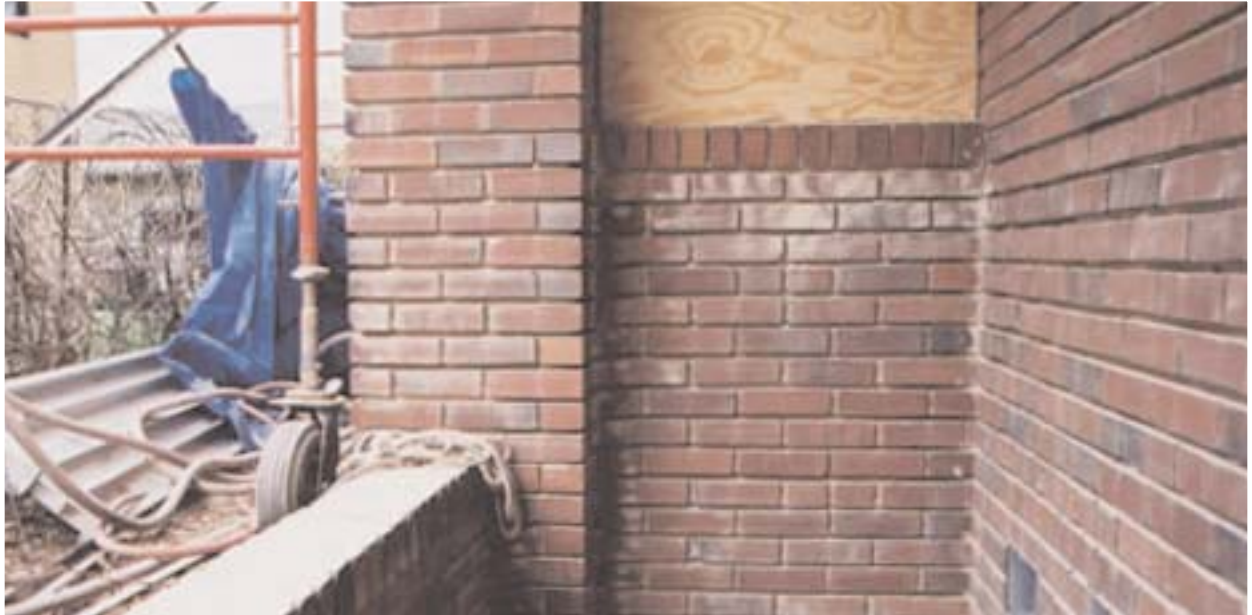
### THE GRIND BACK

Every bed joint (the horizontal ones) and head joint (the vertical ones) must be carefully ground out. Plywood

protects the kitchen window frame.

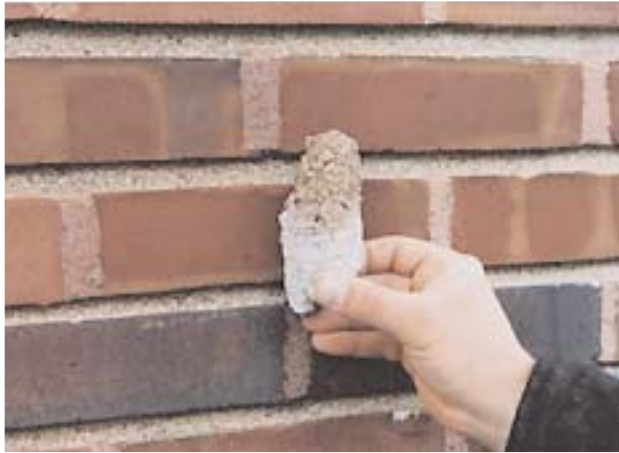
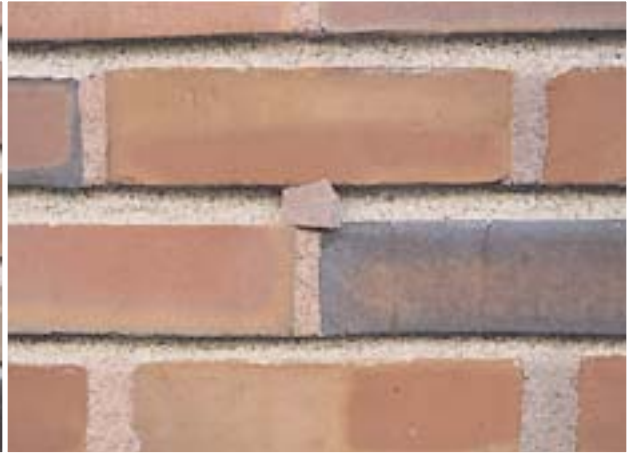
### MATCHING MORTAR

Bed joint mortar was matched using previously unexposed samples of original mortar.
