# T H E   G A R D E N   W A L L

WILLEY HOUSE RESTORATION JOURNAL VOLUME 2 ■ ISSUE 1 ■ WINTER 2003 ■ ■ ■

## THE STATE OF THE HOUSE WINTER 2003

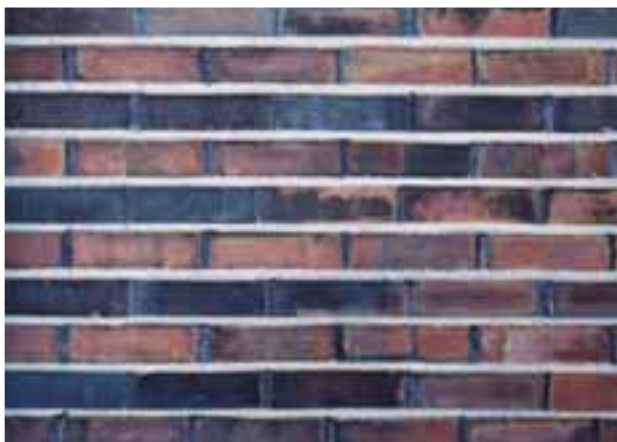
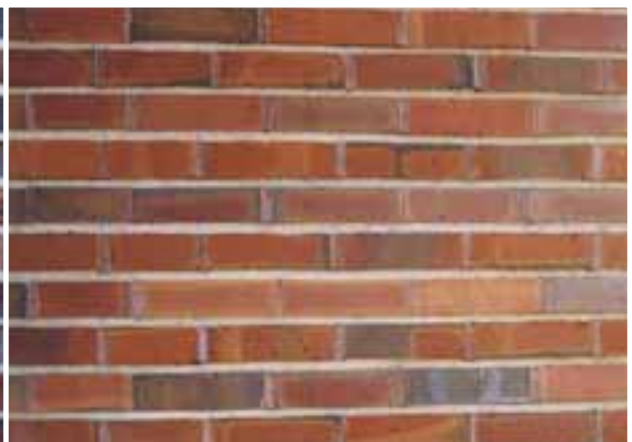
## PIT WALL

The interior brick badly needed cleaning. The chimney mass was blackened from decades of smokey fires and chalky with efflorescence from water seeping through the

brick from the leaky the inner cavities. All interior wood was carefully prepped prior to cleaning.

Radiator pit wall before (left) and after (right) cleaning.
