WILLEY HOUSE RESTORATION JOURNAL VOLUME 3 ■ ISSUE 3 ■ SUMMER 2004 ■ ■ ■

THE STATE OF THE HOUSE SUMMER 2004

A return to the roof, structural repairs, and modern insulation.

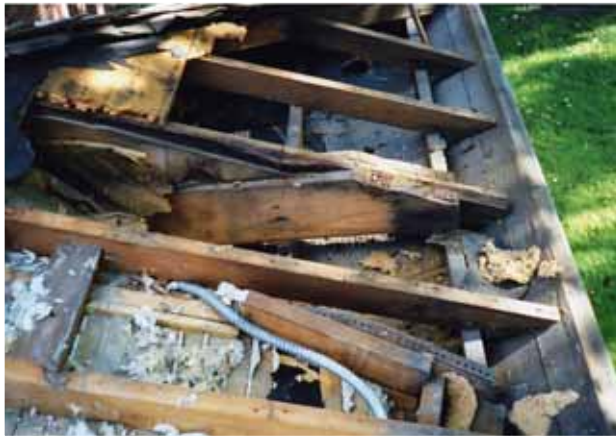
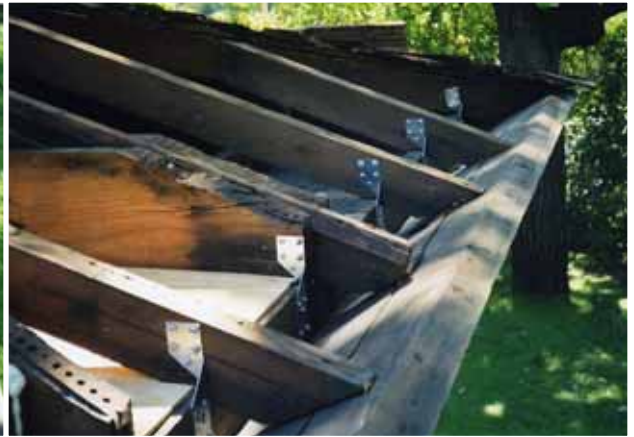
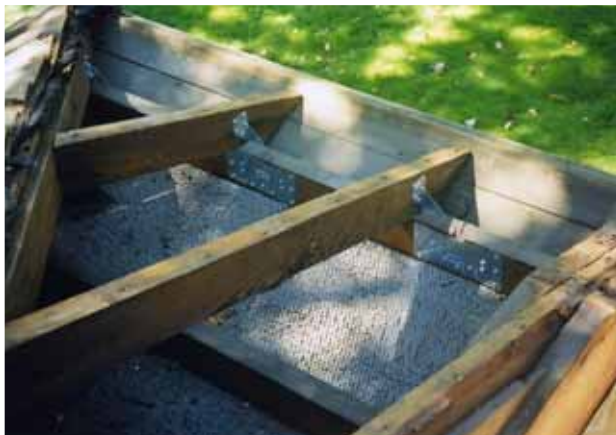
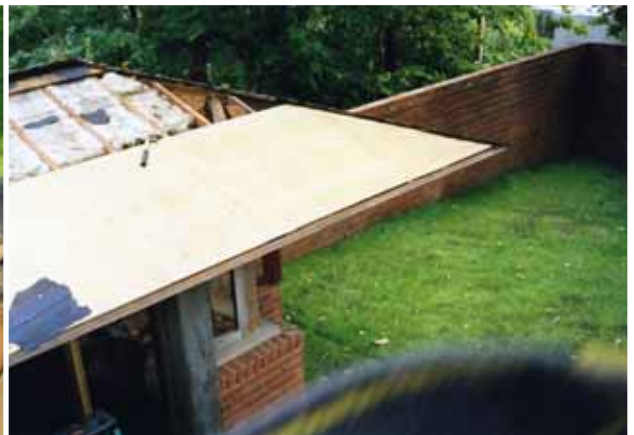
The roof above the master bedroom had never been open since 1934. The vintage tar paper and sheathing were still in place. But, the original materials had to be removed in order to insulate. Since the roof was fully

open, the spaces between the rafters were vacuumed free of debris and the cantilever that extends off the end of this wing was reinforced with hurricane brace straps. ☐

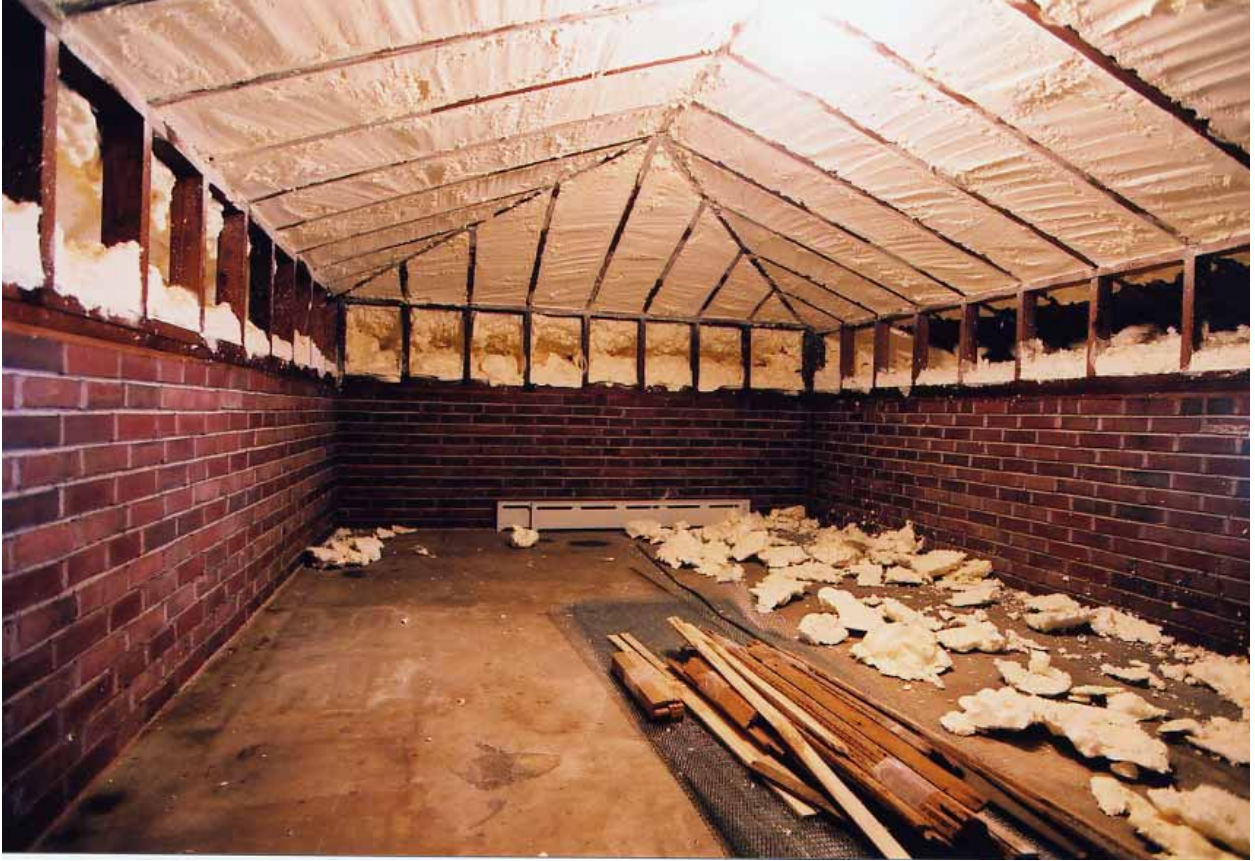
In the storage area above the garage Mr. Wright had specified plaster. For cost savings the room had never been finished by the Willey's. Out of necessity, it now is on its way to completion. The room needs to be heated and fully insulated because it will soon be housing the air

handling equipment for the air conditioning system. Since the storage room had an open ceiling, Icynene insulation was applied in the conventional manner, from inside before plastering. 📷
